Inspection Date: 12th of Never

Prepared For: Jane and John Doe

Gunstock Home Inspection LLC
33136 East Bay Lane Polson, MT 59860
(406) 887-2058 (406) 253-8333
montanamike1@centurytel.net

Report Number: 12000000

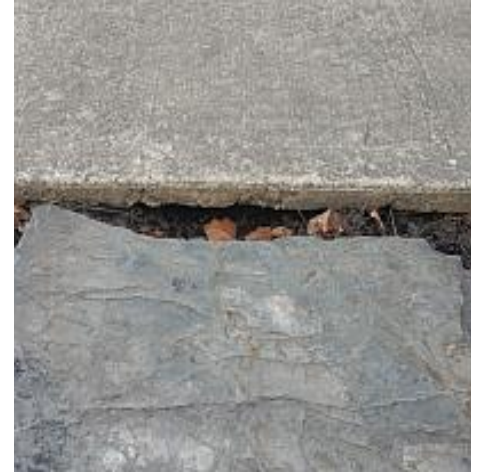
The service walks are properly pitched away from the home.

Material has eroded from underneath the service walks. Recommend Repair (backfill).

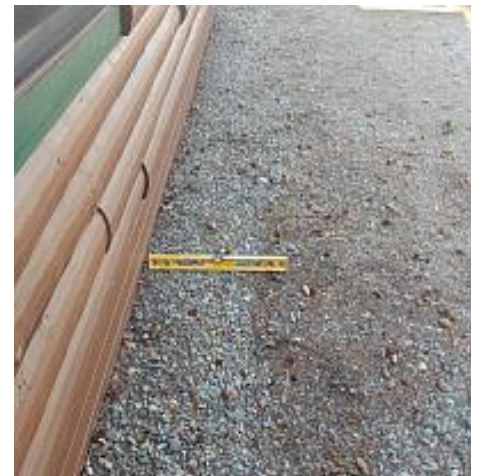
The driveway is pitched toward the home. Recommend Repair.

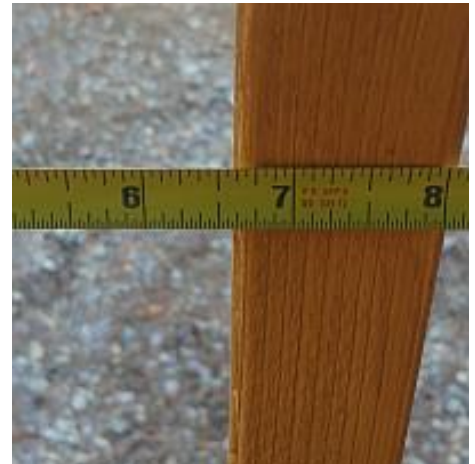
Balusters are improperly spaced. Recommend Repair.

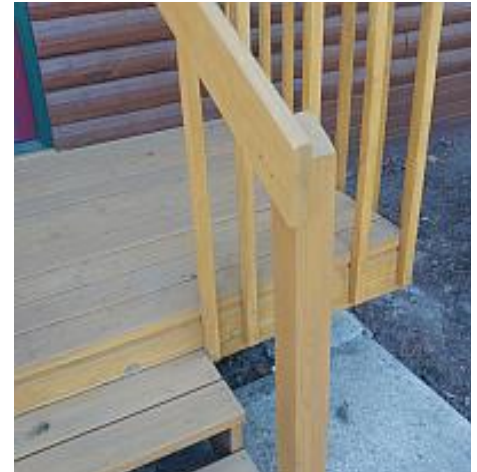
There are no balusters installed.
Recommend Repair.

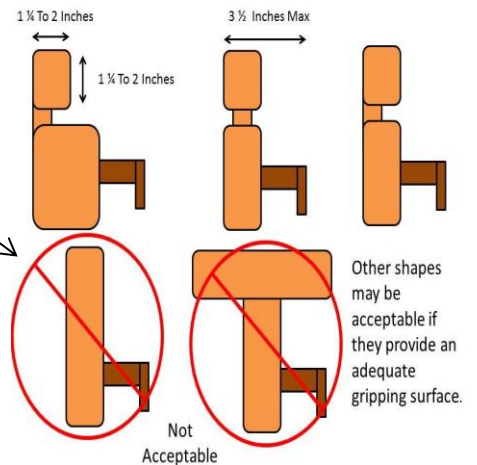
The grip surface is not proper.
Illustrated are a few (but not the only) types of proper grip surfaces.
Recommend Replacement.

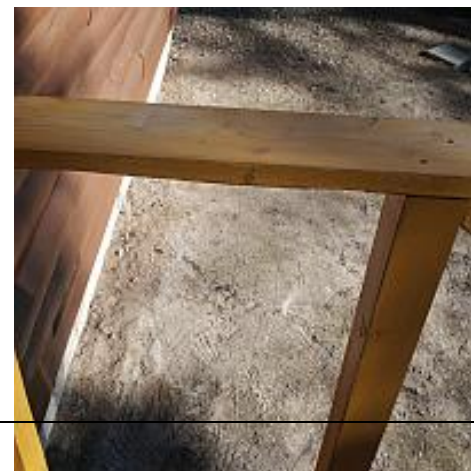
Balusters are not installed. Recommend Repair.

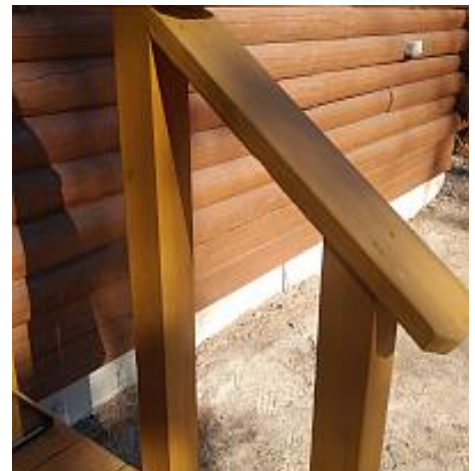
Balusters are not installed
 Recommend Repair.

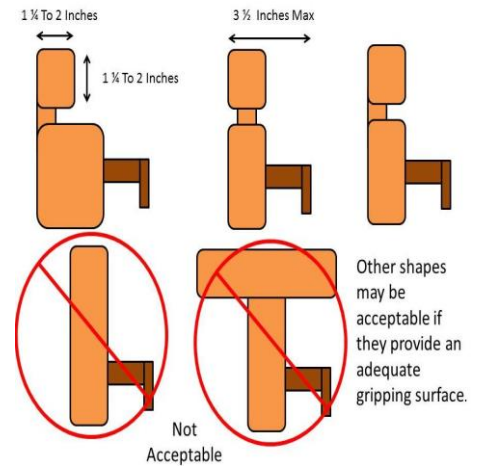
The grip surface is not proper. Illustrated are a few (but not the only) types of proper grip surfaces. Recommend Replacement.

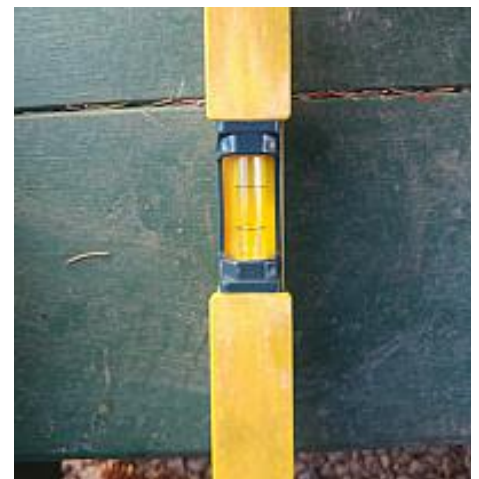
Wood to concrete contact. Untreated wood should never be allowed to be in contact with concrete (can cause deterioration).

The steps are not properly pitched. Recommend Repair.

No deterioration detected at the time of the inspection. Recommend Monitoring.

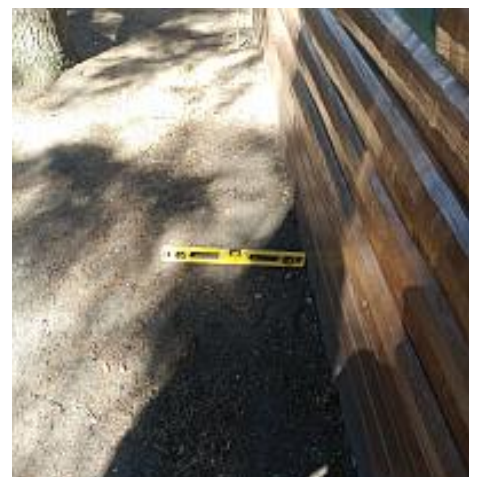
Vegetation in several areas is in direct contact with/overgrowing the home. Recommend Trimming.

Negative grade observed in several areas. Recommend Repair (backfill).

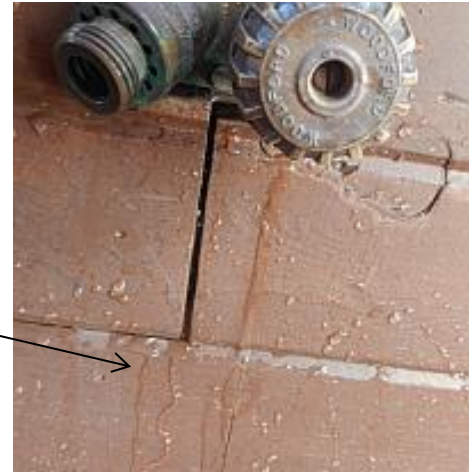
When the bibs are turned on and then off the anti-siphon valves are briefly directing water back toward the home. As the valves are not flush mounted with the log siding the water is getting behind the logs. Recommend Repair.

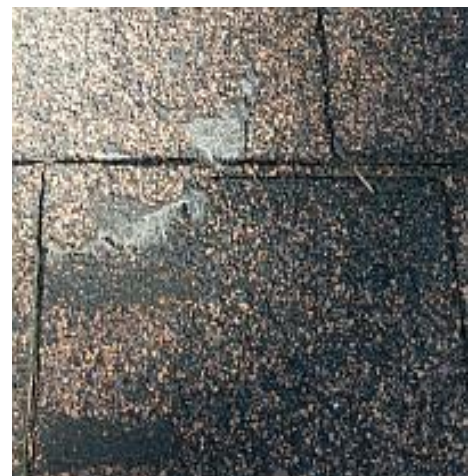
Broken/missing shingles observed. Granule loss observed. Recommend Repair/Replacement.

Exposed nail heads observed. Recommend sealing to help prevent moisture intrusion.

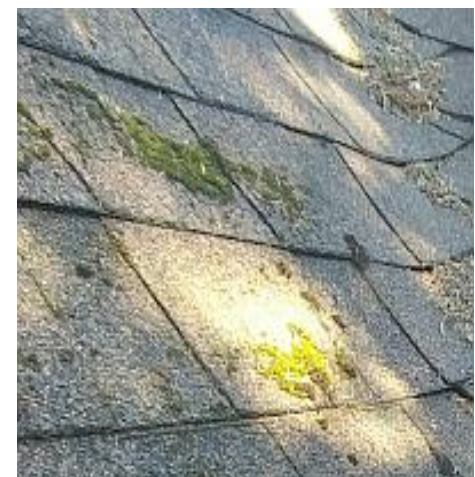
Slight 'bow' observed in the roof cover in one area (not really visible in the photo). Cause unknown. Recommend Repair.

Moss/lichen growth observed. This growth can, over time, deteriorate a roof cover. Recommend Removal.

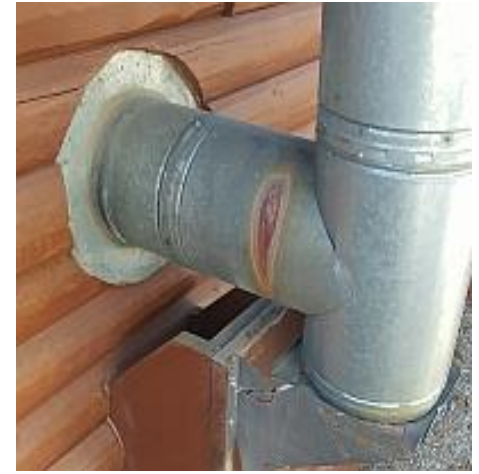
Indications of creosote buildup observed. Recommend cleaning and seasonal cleaning thereafter.

Some rusting observed. Recommend Repair.

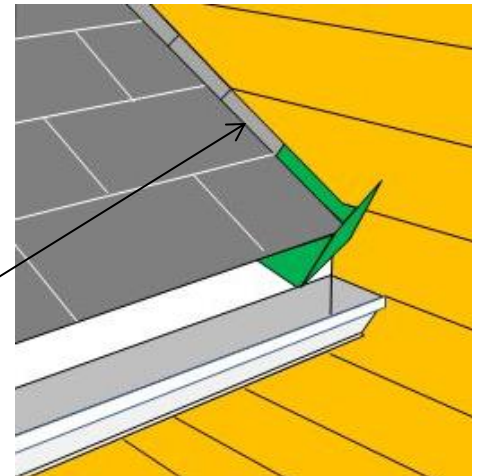
The siding is in direct contact with the roof cover (a one inch offset is recommended). Recommend Repair.

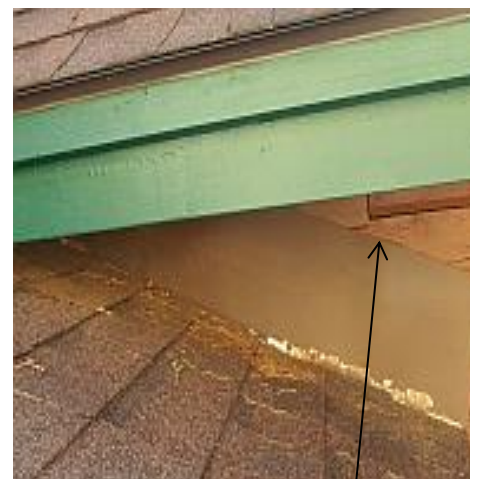
There is no visible headwall flashing. Headwall flashing helps prevent leaks at the wall/roof cover junction. Recommend Repair.

The flashing on the kitchen entry is not correctly installed (the top edge of the flashing should be under, not on top of, the siding). Recommend Repair.

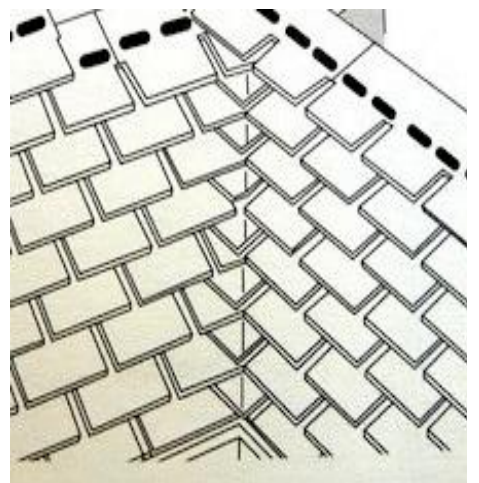
A weave pattern is being used in the valleys. The weave should be tight and the shingles should lay flush with the roof surface to help prevent leaks.

Raised shingles observed in all of the valleys. Recommend Repair.

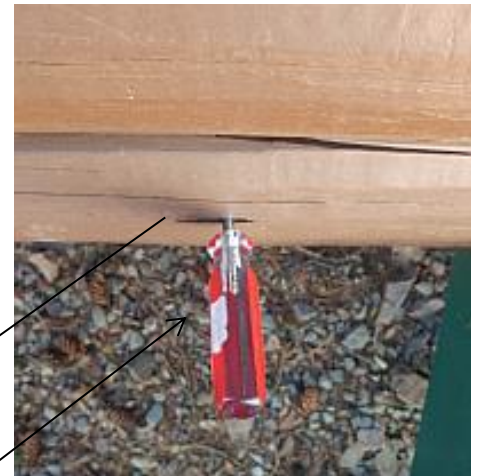
Two deteriorated logs where indicated. The log siding is the load bearing component of a log home. This is a Major Concern. Recommend Evaluation/Repair by a licensed contractor.

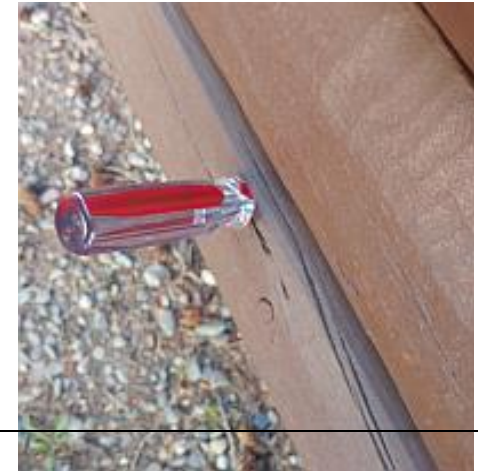
Birds are nesting in this deteriorated log.

Inspector's Note: This deterioration could be the result of moisture infiltration. Anytime there is moisture infiltration there is the possibility of hidden damage.

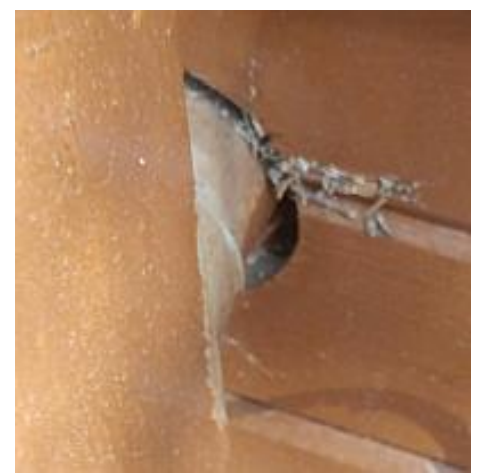
There is no visible chinking/sealing between the logs. There are several large gaps observed. Chinking helps seal out moisture and air and helps with the overall insulation of the structure. Recommend Repair.

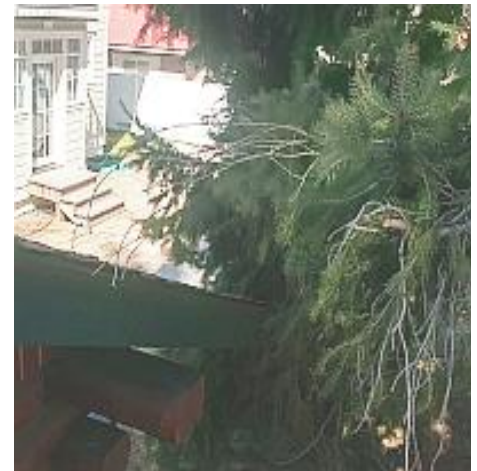
Moss/lichen growth observed. This growth can, over time, deteriorate a roof cover. Recommend Removal.

Vegetation is overgrowing/in contact with the roof cover. Recommend Trimming.

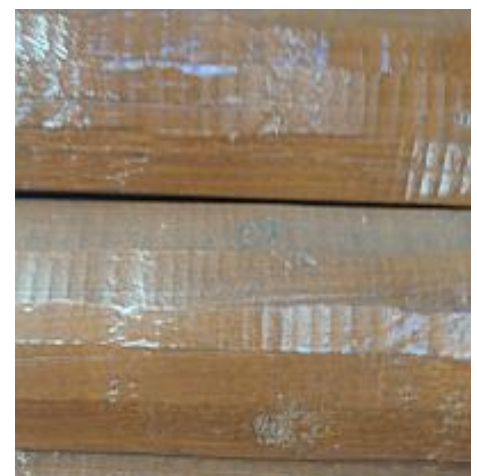
There is no visible chinking/sealing between the logs. There are several large gaps observed. Chinking helps seal out moisture and air and helps with the overall insulation of the structure. Recommend Repair.

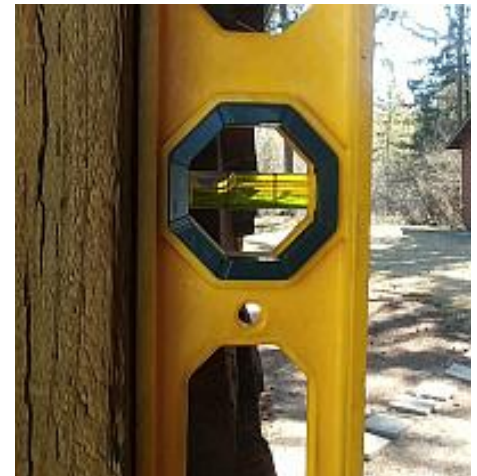
The entry structure is leaning noticeably. This is a Major Concern. Recommend Repair.

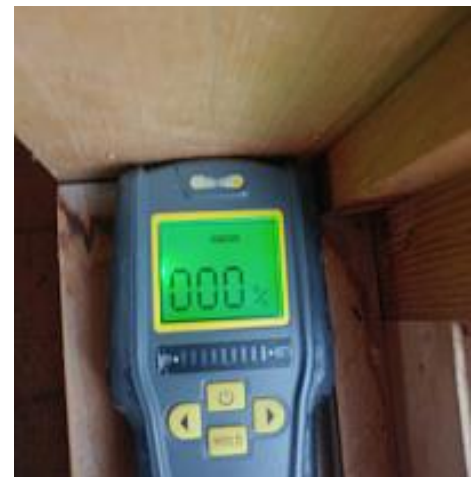
Moisture stains observed on the window sill. Although the area tested dry with a moisture meter, the stains came from somewhere. Recommend Repair.

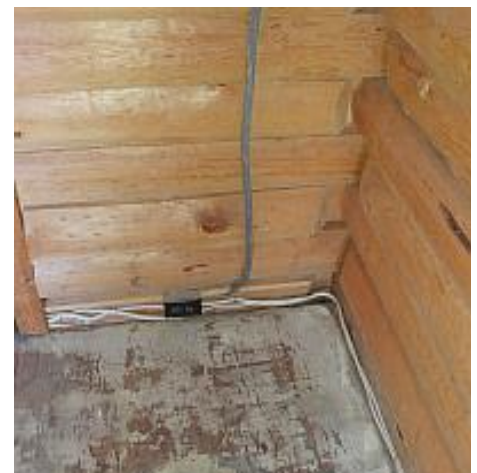
Wiring should not be exposed within a living area. Recommend Repair.

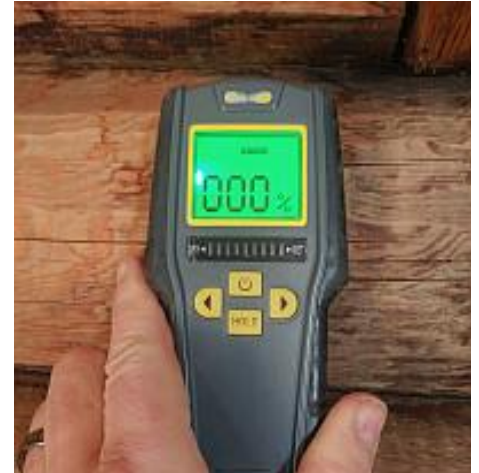
There are numerous moisture stains on the walls, particularly where indicated. While testing with a moisture meter showed the walls to be dry, the stains came from somewhere. Anytime there is

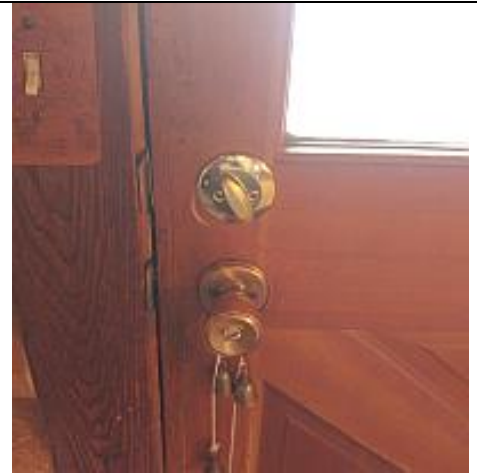
The door has to be lifted slightly for the dead bolt to engage. Recommend Repair/Adjustment.

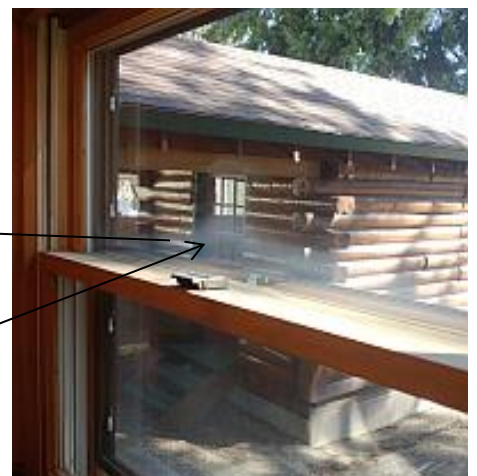
Moisture stains observed in the windows indicated. Indications of leaking insulated glass observed in the window indicated. Recommend Repair/Replacement.

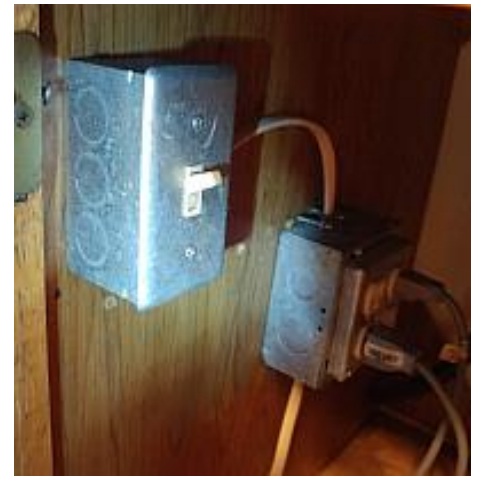
The disposal is not operating.
Recommend Repair/Replacement.

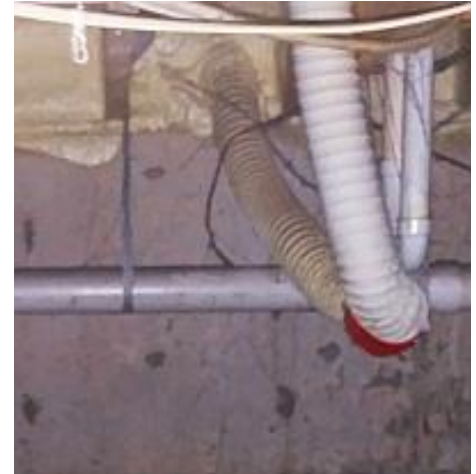
Flexible line is being used for the dryer duct. Current requirements call for metal ducting, fastened without screws (foil tape is used to connect the sections together). The line should be as straight as possible and be no more than 35 feet in length.

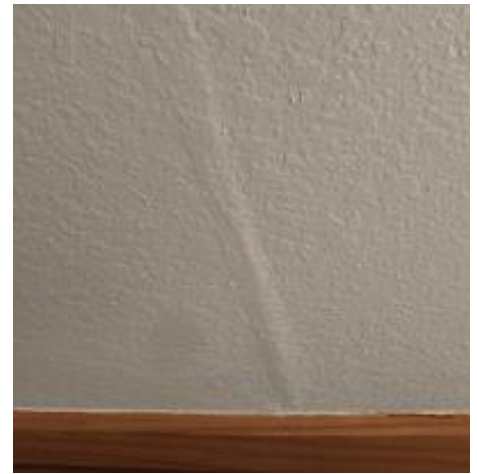
There are numerous moisture stains on the exterior wall and bubbled paint on the ceiling. While testing with a moisture meter showed the walls to be dry, the stains came from somewhere. Anytime there is moisture penetration there is the possibility of hidden damage. Recommend Repair.

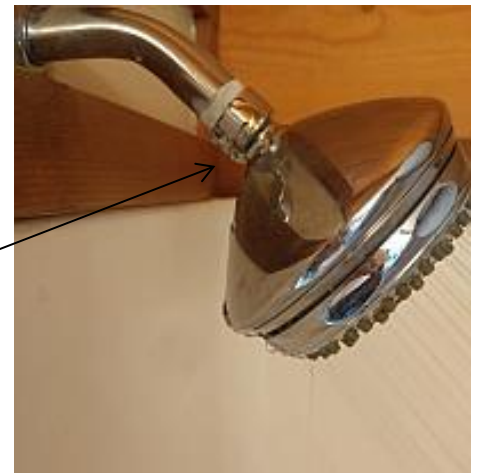
The showerhead is leaking. Recommend Repair.

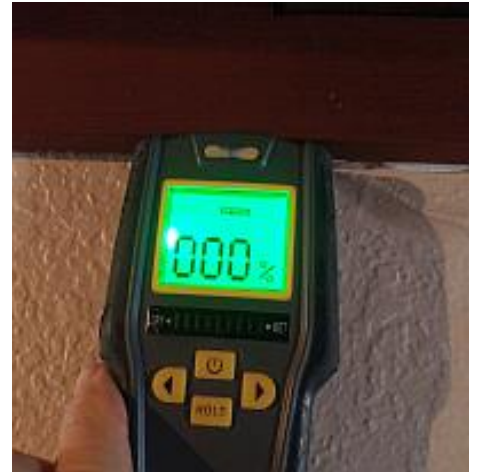
There are numerous moisture stains on the exterior walls and bubbled paint on the walls. While testing with a moisture meter showed the walls to be dry, the stains came from somewhere. Anytime there is moisture penetration there is the possibility of hidden damage. Recommend Repair.

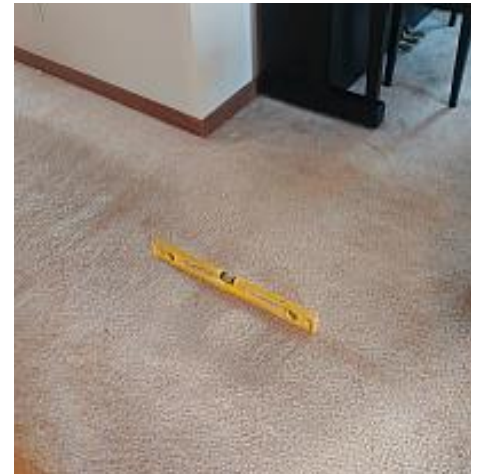
The floor slopes where indicated. Recommend Repair.

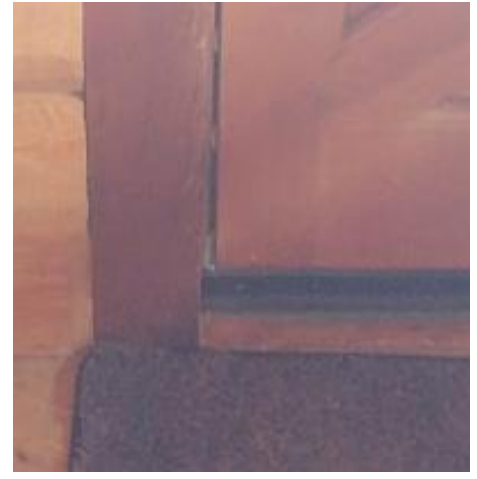
The door is gapped where indicated. Recommend Repair/Adjustment.

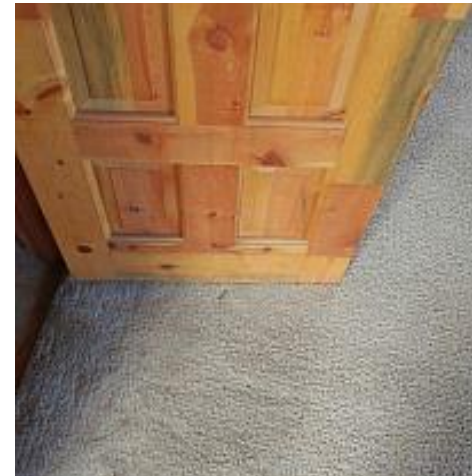
The door to the water heater scrapes on the floor cover when opened/closed. Recommend Repair/Adjustment.

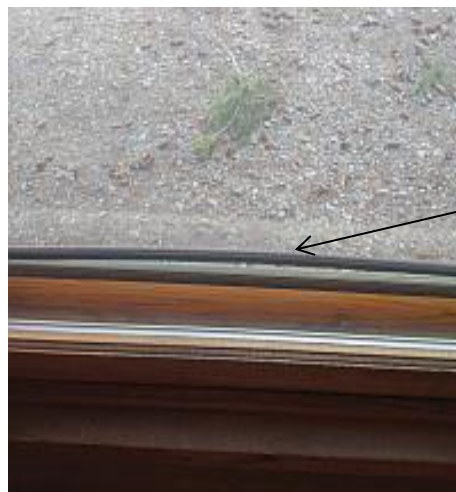
The screen indicated is holed/bent. Recommend Replacement.

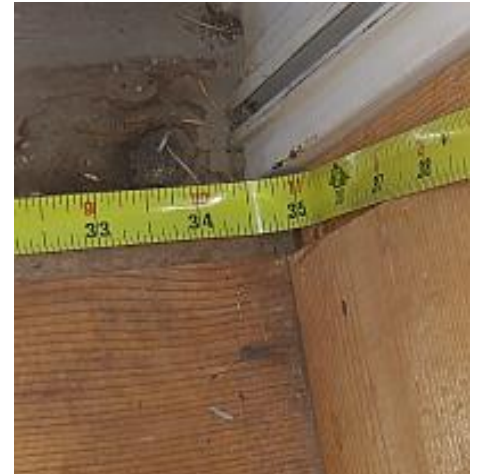
The window is too small and does not open far enough to be considered an egress window. Recommend Replacement.

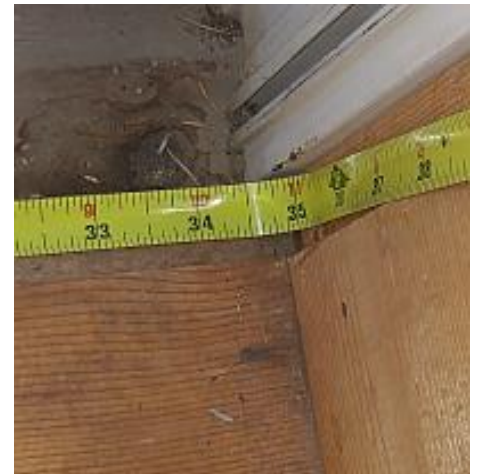
The window is too small and does not open far enough to be considered an egress window. Recommend Replacement.

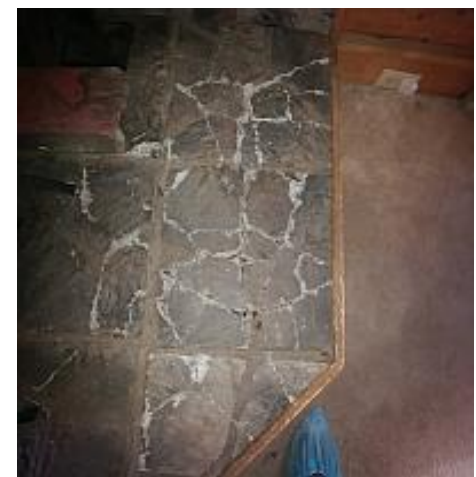
According to the owner’s manual there should be 16 inches of hearth in front of the unit. The hearth only extends 9 inches to the front of the unit. This is a potential Safety Hazard. Recommend Repair.

Cracked/loose hearth stones observed. Recommend Replacement.

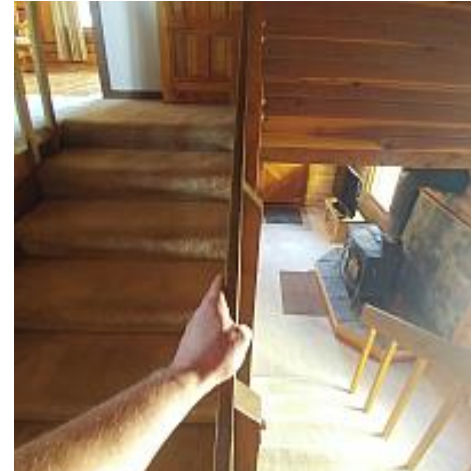
The stair guard/stair rail is the proper height (36 inches minimum). The balusters are not properly spaced (4 inches maximum). Recommend Repair.

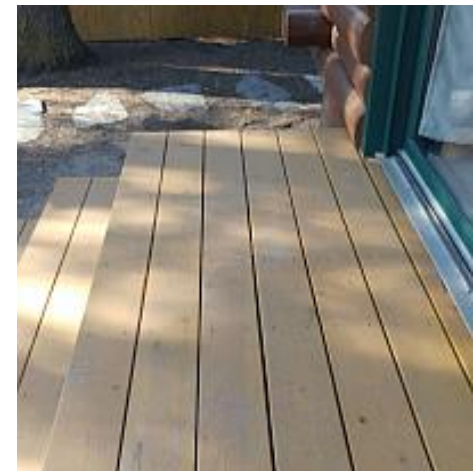
The grip surface is not proper. Illustrated are a few (but not the only) types of proper grip surfaces. Recommend Replacement.

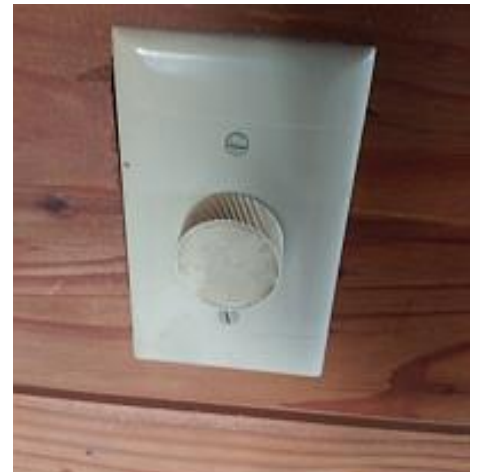
The variable speed controller will only turn the ceiling fan on – it does not vary the speed. Recommend Replacement.

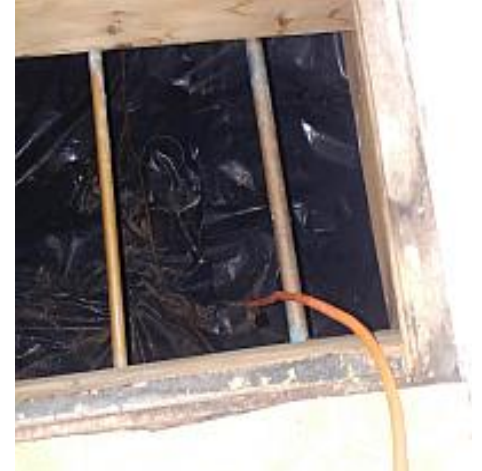
The crawl space access is too small (18 x 24 inches minimum). IN addition to being too small the access is blocked by one electric and two water lines that run across the crawl space opening. Because of this the inspector was not able to get completely into the crawl space.

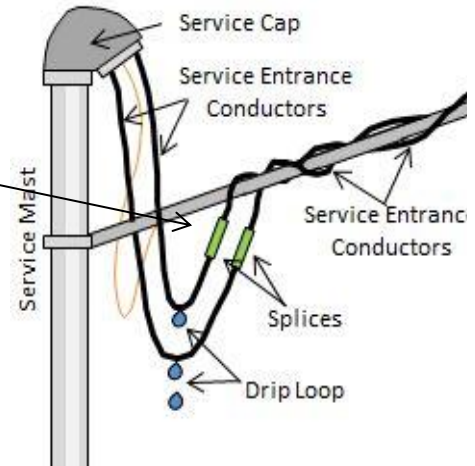
The weather boot is cracked/holed. This is a Major Concern. Recommend Replacement.

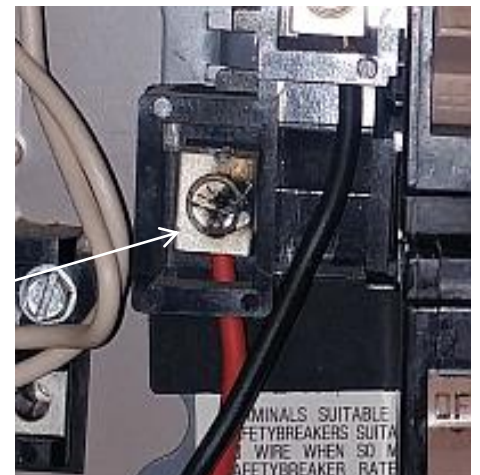
There are numerous double tapped neutral wires. Unless otherwise marked these terminals are designed for one wire per lug. Recommend Repair.
