**Inspection Date: 12<sup>th</sup> of Never**

**Prepared For: John and Jane Doe**

Gunstock Home Inspection LLC

**Report Number: JJD12NEVER**

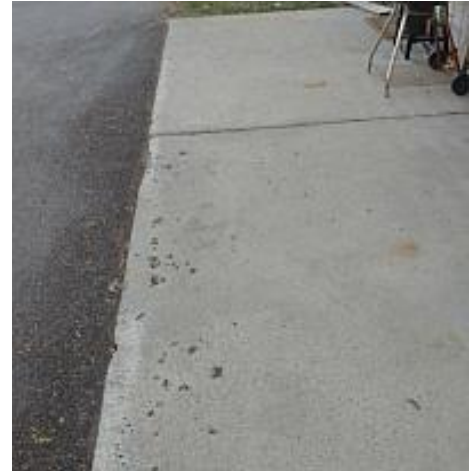
The service walks are in Satisfactory Condition. Properly pitched away from the home.

Minor scaling observed. Repairs would be cosmetic.

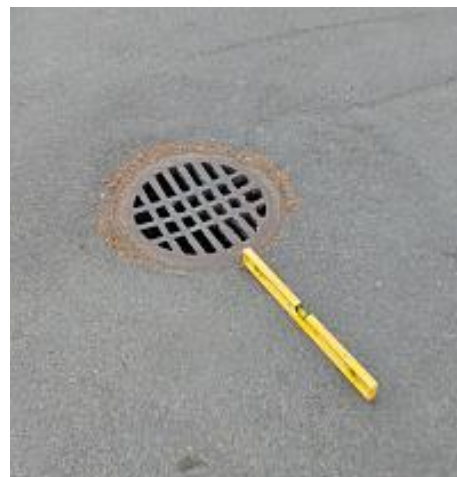
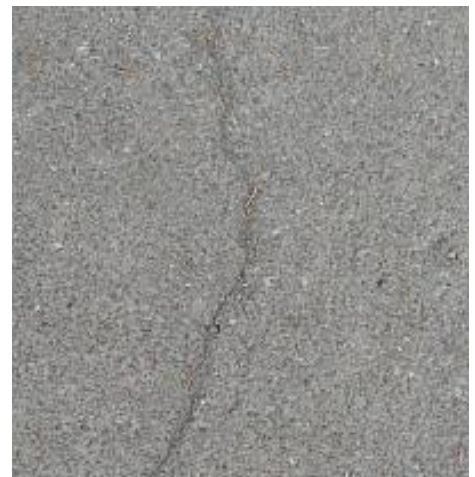
The driveway is in Satisfactory Condition. Properly pitched away from the building.

Typical cracks on driveway. No indication of recent movement, no trip hazard.

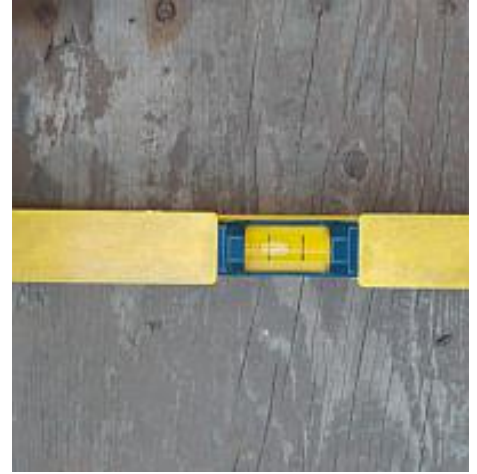
Wood to concrete contact. Untreated wood should never be allowed to be in contact with earth/concrete (can cause deterioration). No deterioration detected at the time of the inspection. Recommend Monitoring.

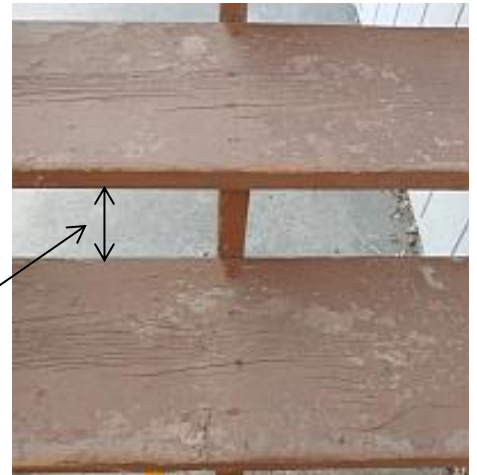
Cracks observed in the stringers. One step support is completely loose. This is a Major Concern. Recommend Repair/Replacement.

The steps are weathering. Recommend prepping and sealing (painting/staining). Recommend Repair.

There is too much of a gap in the open risers (4 inches maximum). Recommend Repair.

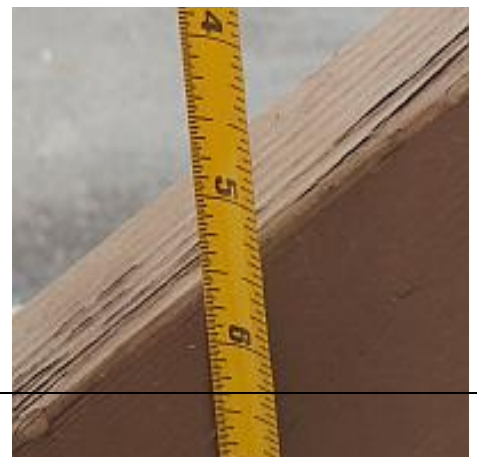
The railing is the proper height. Balusters are improperly spaced. Recommend Repair.

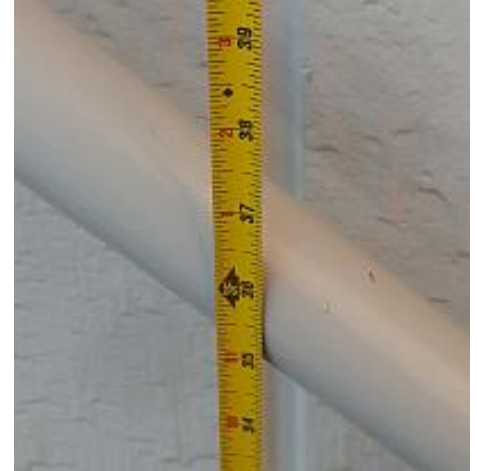
The railing is deteriorated in areas. This is a Major Concern. Recommend Repair/Replacement.

The railings are weathering. Recommend prepping and sealing (painting/staining). Recommend Repair.

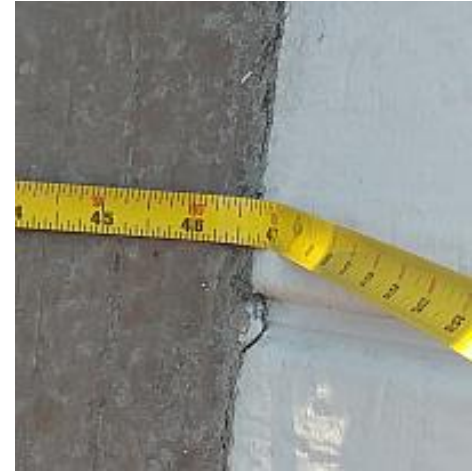
The floor is cantilevered 47 inches. According to current standards, cantilevers can extend up to one-fourth the back span of the joist. So the un-spliced joist would have to span 16 feet to allow the additional 47 inch cantilever. The joist structure is not visible so the inspector cannot make a determination if the cantilever is proper.

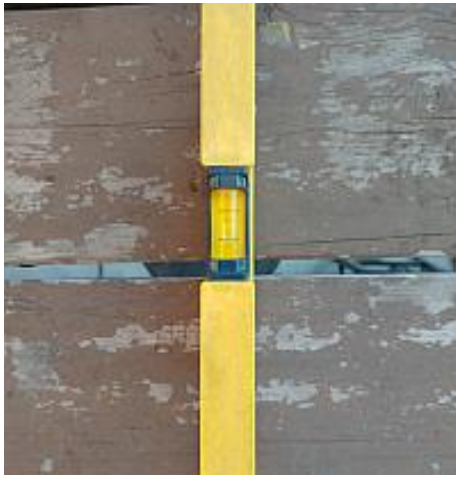
There are no joist hangers installed on the rim joist. Although not specifically required as the rim joists carry little load on a cantilevered deck, the inspector recommends properly installed joist hangers to help ensure positive attachment between the joists and rim joist.

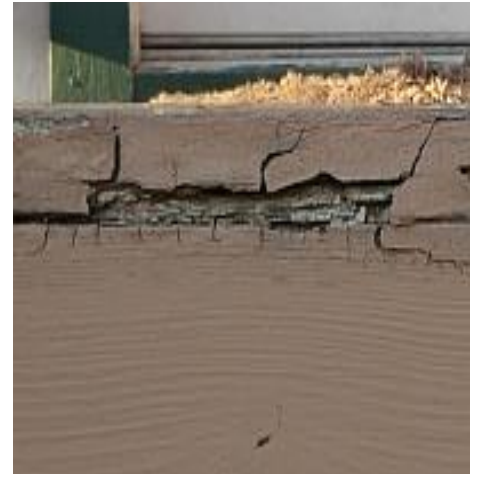
The floor is deteriorated in several areas. This is a potential Safety Hazard. Recommend Repair/ Replacement.

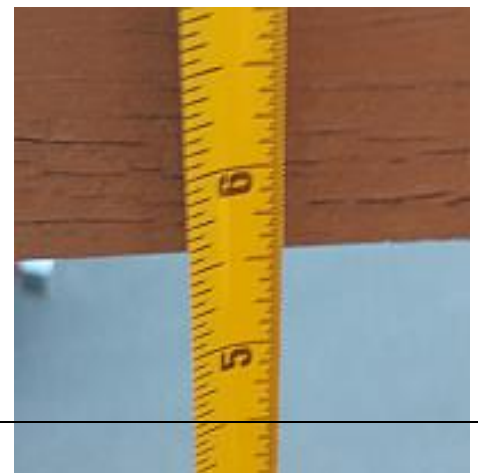
Balusters are improperly spaced. Recommend Repair.

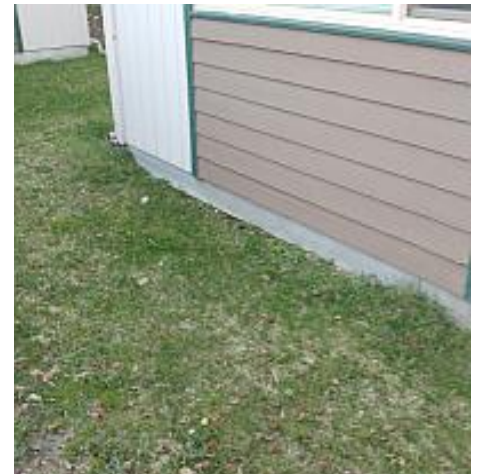
Negative grade where indicated. Recommend Repair (backfill).

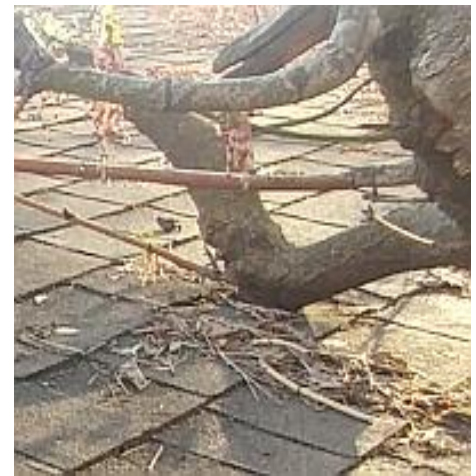
Most of the roof cover is in Satisfactory Condition. Trees are overgrowing the roof cover. Branches scraping on the roof cover have damaged shingles. This is a Major Concern. Recommend Repair/Replacement.

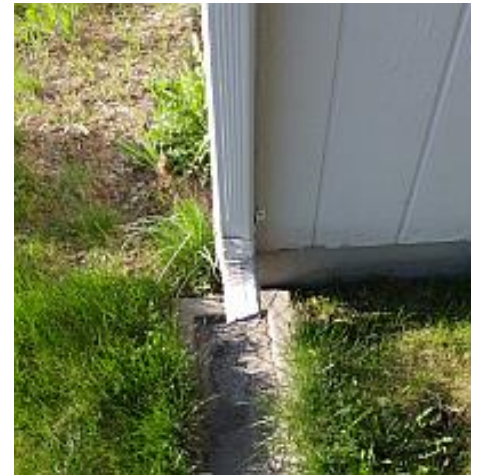
The gutters are dirty. Recommend Cleaning and seasonal cleaning thereafter.

Down spout extensions needed. Extensions should be a minimum of three feet in length and carry runoff directly away from the home.

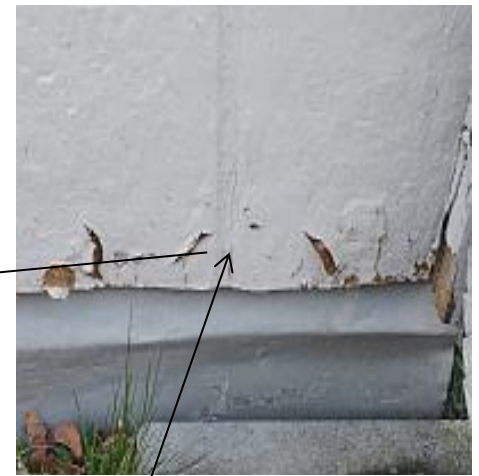
The siding is weathering. Recommend prepping and sealing (painting/staining). Recommend Repair.

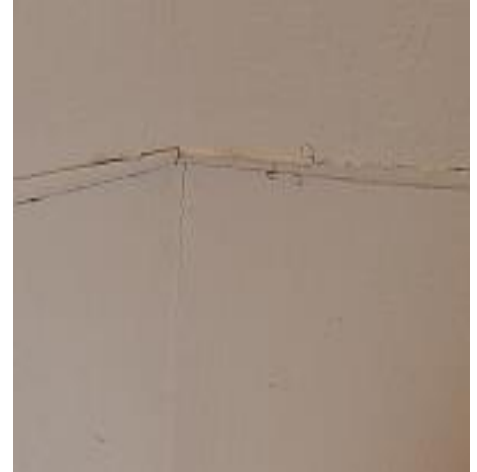
The soffit is loose in several areas. Recommend Repair.

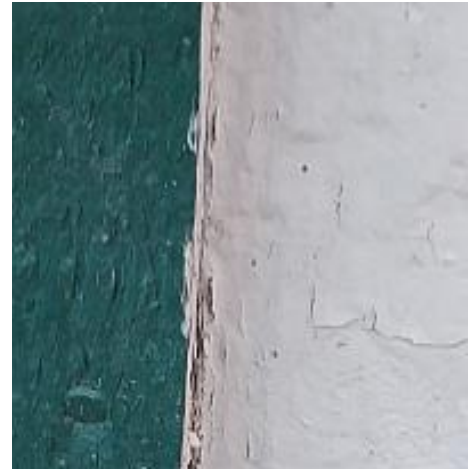
There is no visible calk at the siding transitions. Installed calk is cracked. Recommend Repair (re-caulking).

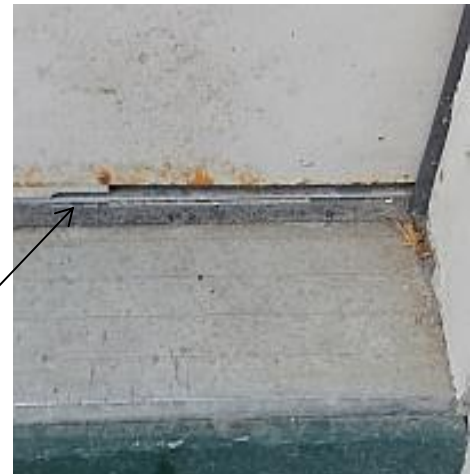
The exterior door frame is weathered. Recommend prepping and sealing (painting/staining). Recommend Repair

The door is dinged/rusted. The threshold weather stripping is torn. Recommend Repair/replacement.

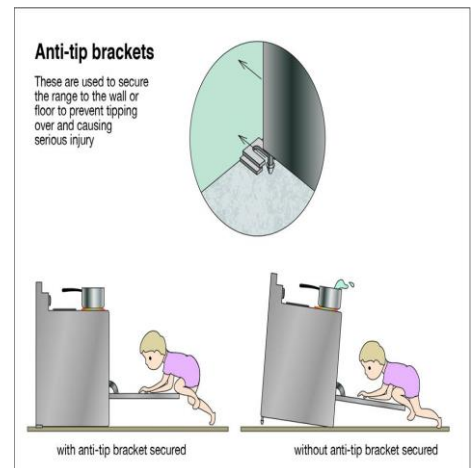
The range tip bracket is missing. The tip bracket keeps the range from tilting forward (could happen with the oven door open). Recommend Replacement.

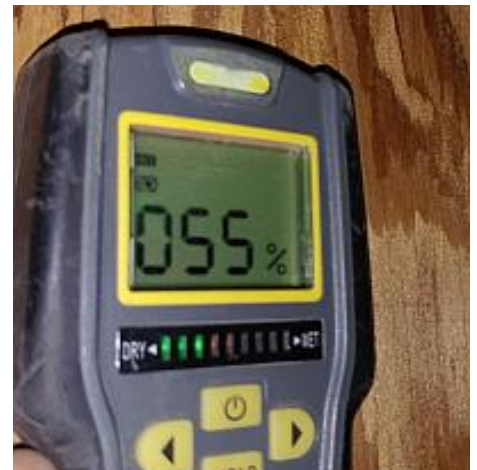
The tub bottom is cracked. In the crawl space the area immediately under the tub is moisture stained. The testing with a moisture meter shows the area is wet. Recommend Repair.

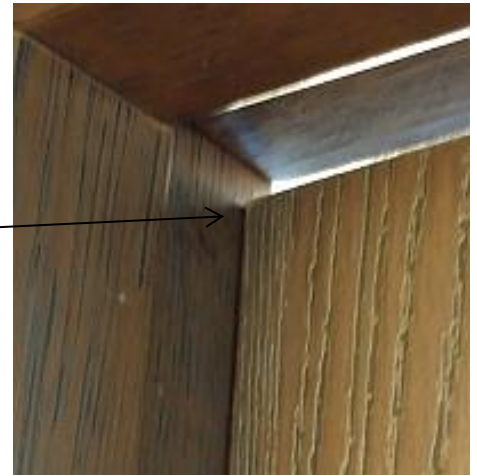
The latch bolt does not engage the strike plate. The door scrapes on the frame. Recommend Repair/Adjustment.

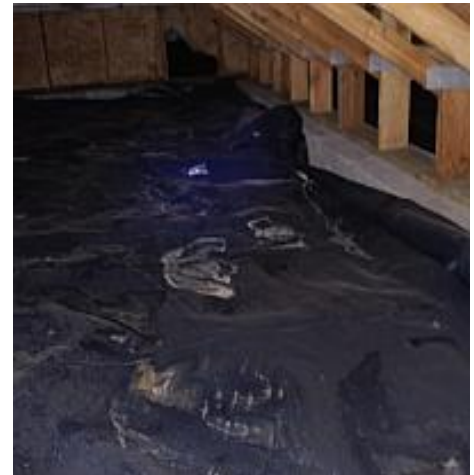
There are indications of moisture in the crawl space. This appears to be ground sourced. Recommend Repair.

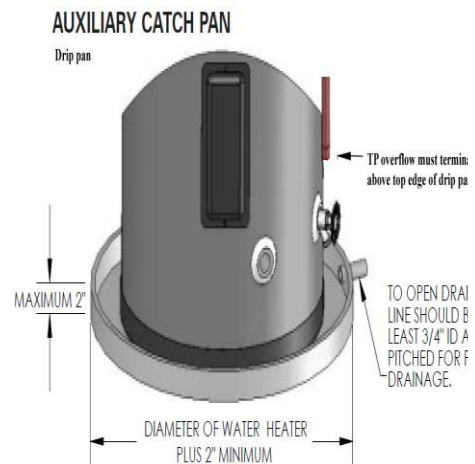
There is no drip pan installed. Current standards state that where water heaters tanks are installed in locations where leakage of the tanks or connections will cause damage, the tank shall be installed in a galvanized steel pan having a minimum thickness of 24 gage, or other pans approved for such use. Ideally the pan should be plumbed to an approved drain. Recommend Repair.

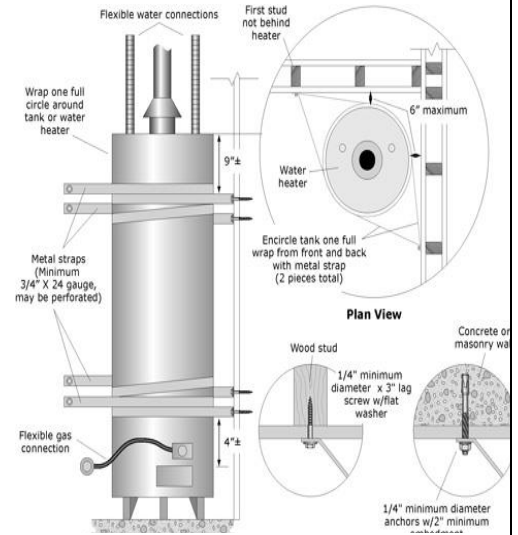
There are no seismic restraints on the water heater. Current standards require seismic restraints in this region of Montana. Water heaters shall be anchored or strapped to resist horizontal displacement due to earthquake motion. Strapping shall be at points within the upper one-third (1/3) and lower one third (1/3) of its vertical dimensions. At the lower point, the strapping will be a minimum distance of four (4) inches above the controls.

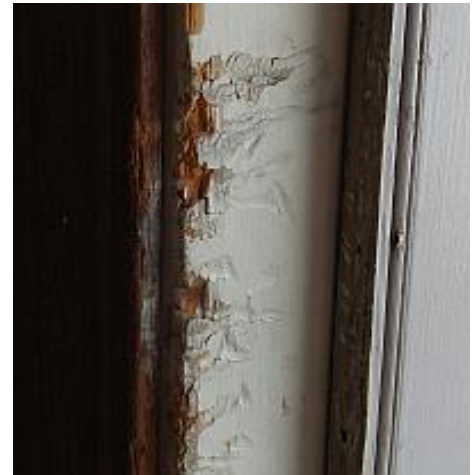
The exterior door frame is weathered. Recommend prepping and sealing (painting/staining). Recommend Repair

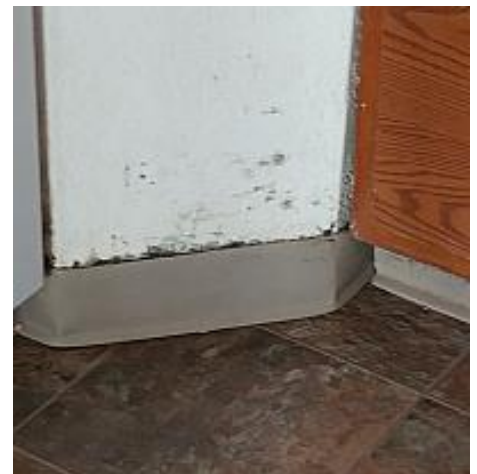
Indications of mold growth in numerous areas. The presence or absence of mold can only be verified by testing. Recommend Removal.

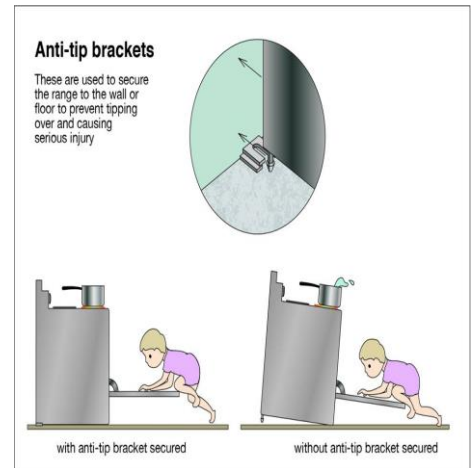
The range tip bracket is missing. The tip bracket keeps the range from tilting forward (could happen with the oven door open). Recommend Replacement.

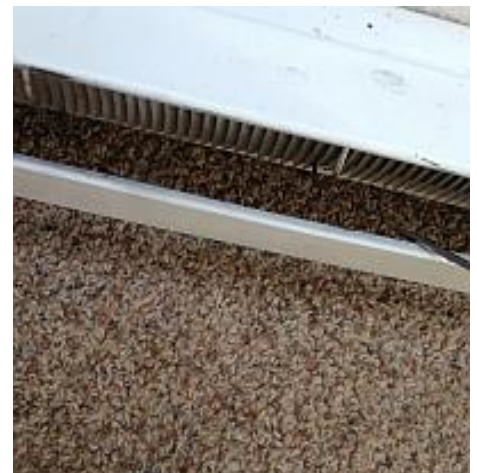
Part of the housing is loose. Recommend Repair.

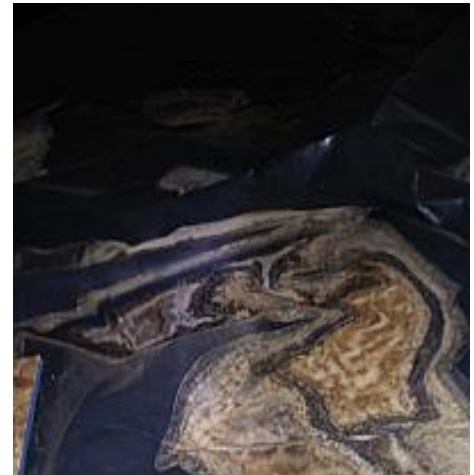
There are indications of moisture in the crawl space. This appears to be ground sourced. Recommend Repair.

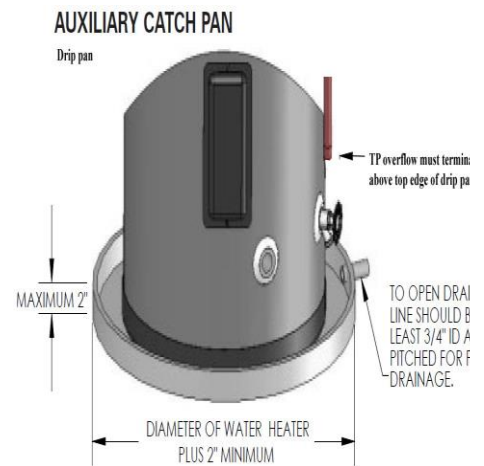
There is no drip pan installed. Current standards state that where water heaters tanks are installed in locations where leakage of the tanks or connections will cause damage, the tank shall be installed in a galvanized steel pan having a minimum thickness of 24 gage, or other pans approved for such use. Ideally the pan should be plumbed to an approved drain. Recommend Repair.

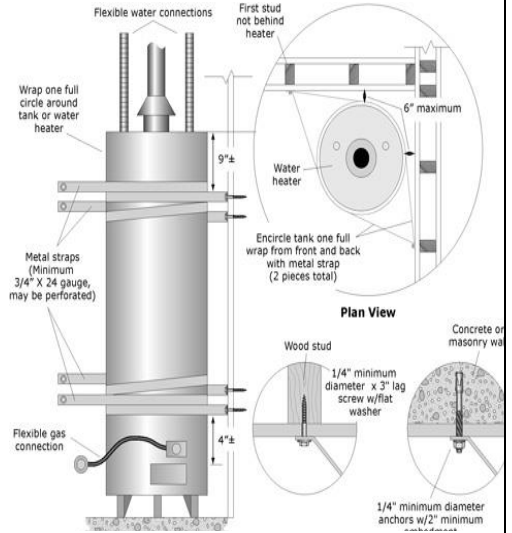
There are no seismic restraints on the water heater. Current standards require seismic restraints in this region of Montana. Water heaters shall be anchored or strapped to resist horizontal displacement due to earthquake motion. Strapping shall be at points within the upper one-third (1/3) and lower one third (1/3) of its vertical dimensions. At the lower point, the strapping will be a minimum distance of four (4) inches above the controls.

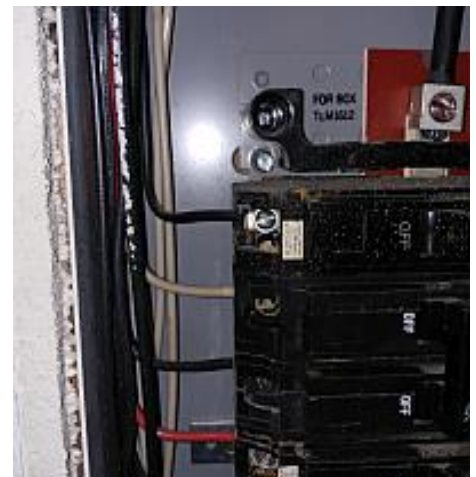
White (neutral) wires used as black (live or line) wires should be color coded black.

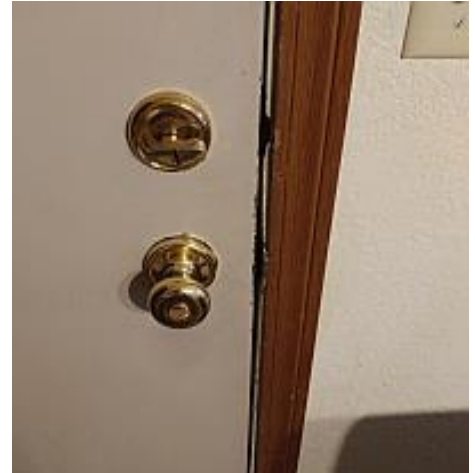
The weather stripping is torn/holed. The door frame is dinged/cracked. Recommend Repair/ Replacement.

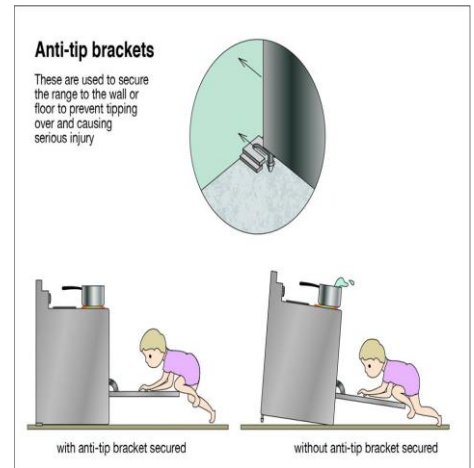
The range tip bracket is missing. The tip bracket keeps the range from tilting forward (could happen with the oven door open). Recommend Replacement.

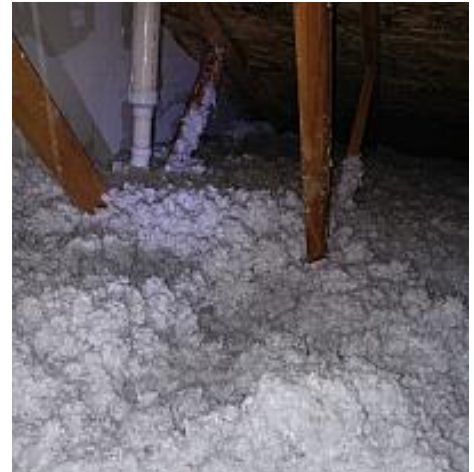
The insulation is displaced in areas. Recommend Repair.

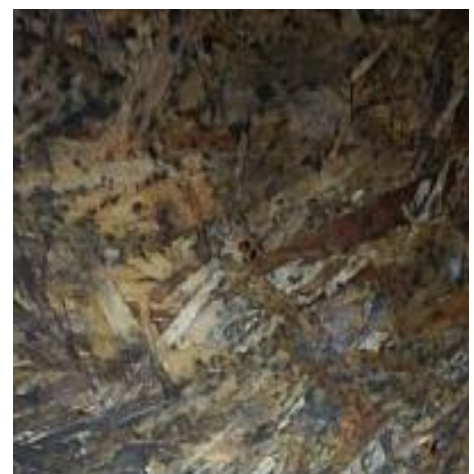
Possible mold growth observed around the kitchen exhaust fan ducting. The actual presence or absence of mold can only be verified by testing. Recommend removal.

The exhaust fan ducting should be insulated to help prevent condensation.

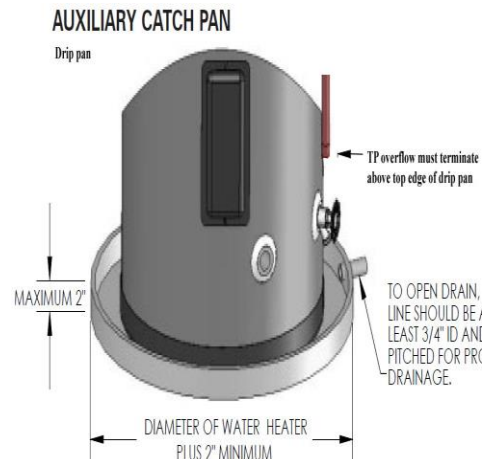
There is no drip pan installed. Current standards state that where water heaters tanks are installed in locations where leakage of the tanks or connections will cause damage, the tank shall be installed in a galvanized steel pan having a minimum thickness of 24 gage, or other pans approved for such use. Ideally the pan should be plumbed to an approved drain. Recommend Repair.

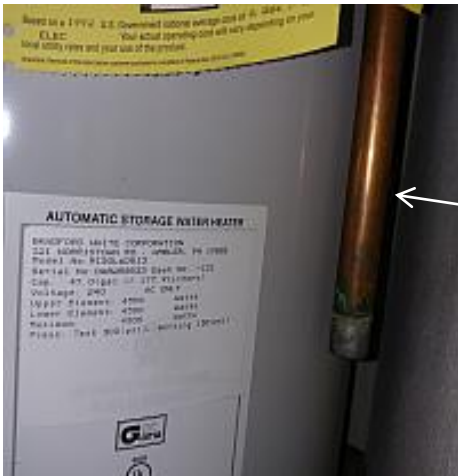
The temperature /pressure relief (TPR) valve extension is too short. It must extend to with 6 inches of the floor and terminate in a non-threaded end. Recommend Repair

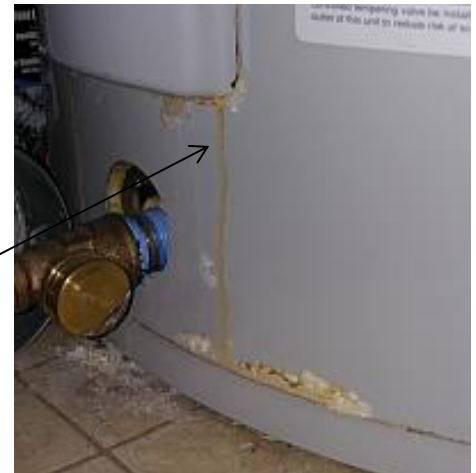
Indications of a leak at the input water line.  
 Indications of a leak at the lower heating element.  
 Recommend Repair.

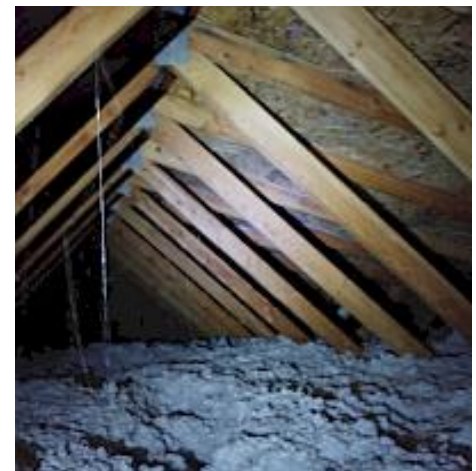
Possible mold growth observed near the kitchen exhaust fan ducting. The actual presence or absence of mold can only be verified by testing. Recommend removal.
