State of Montana Licensed Home Inspector  
HI0163

**Inspection Date: 12<sup>th</sup> of Never**

**Report Number: JJD00000000**

**Inspector: Michael Parker**

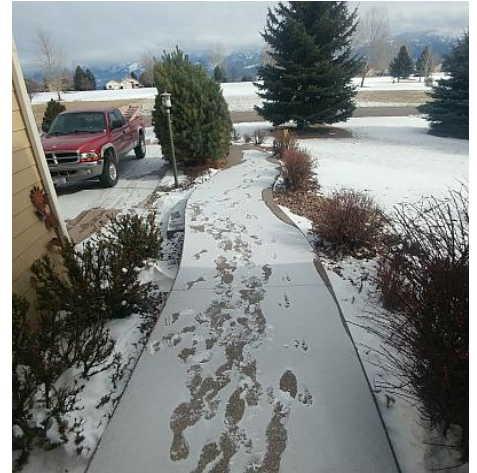
The service walks are partially snow covered and could not be completely visually inspected.

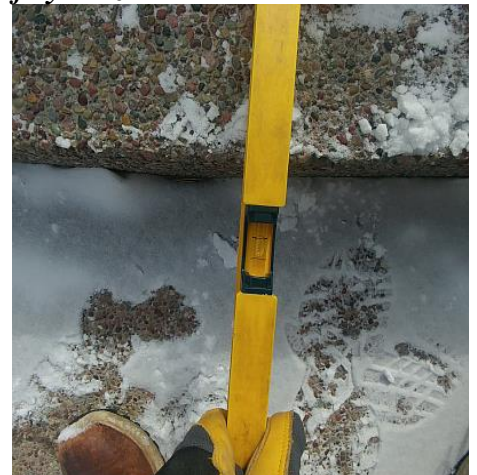
The steps are not properly pitched. Repair would likely not be

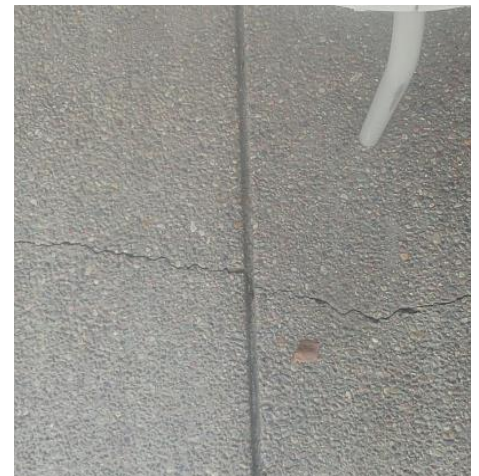
Large settling cracks observed. Recommend sealing to help prevent moisture intrusion.

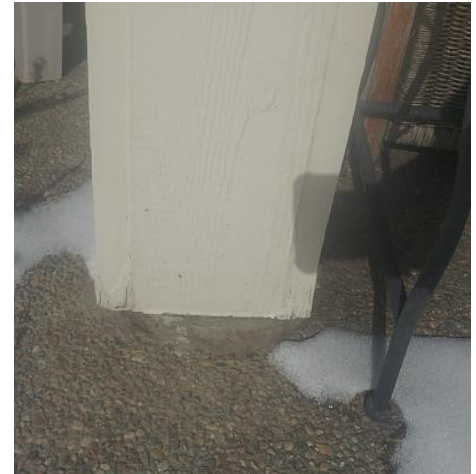
Wood to concrete contact. Untreated wood should never be allowed to be in contact with concrete (can cause deterioration). Deterioration detected at the time of the inspection. Recommend Repair.

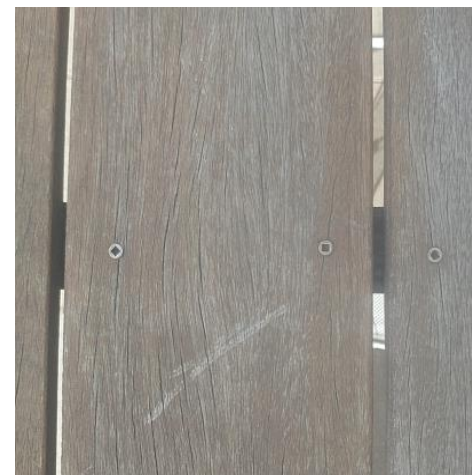
The floor is properly pitched away from the home. The floor is weathering. Recommend prepping and sealing (painting/staining). Recommend Repair.

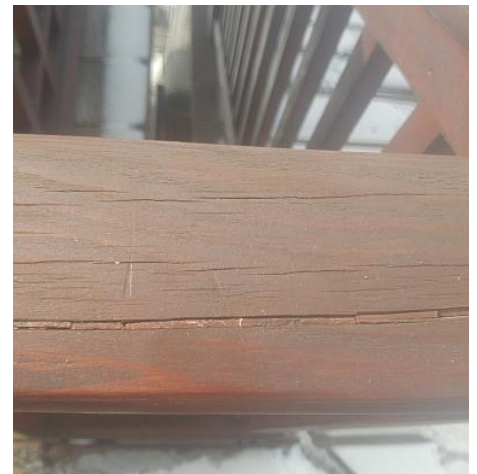
The railings are weathering. Recommend prepping and sealing (painting/staining). Recommend Repair.

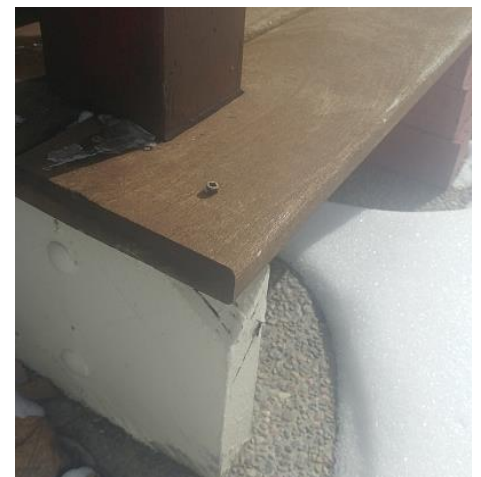
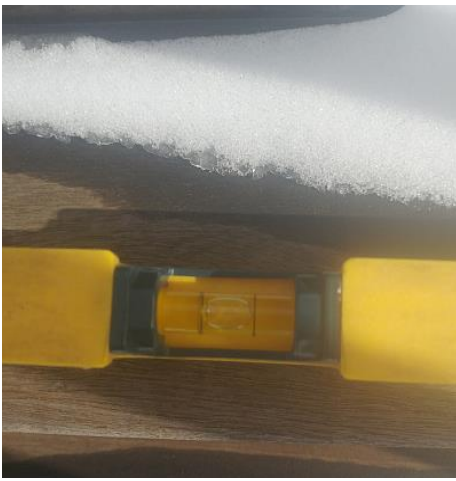
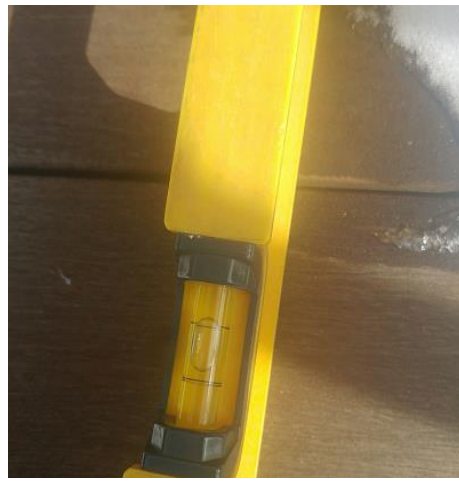
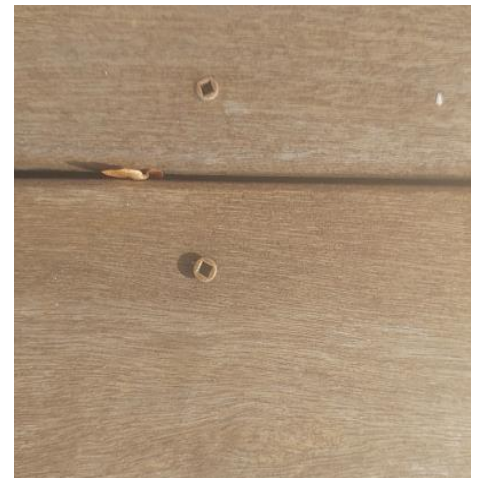
The center riser is cracked/broken. The bricks installed to support the steps are not permanently installed. Recommend Repair.

Wood to concrete contact. Untreated wood should never be allowed to be in contact with concrete (can cause deterioration).

Early indications of deterioration detected at the time of the inspection. Recommend Repair.

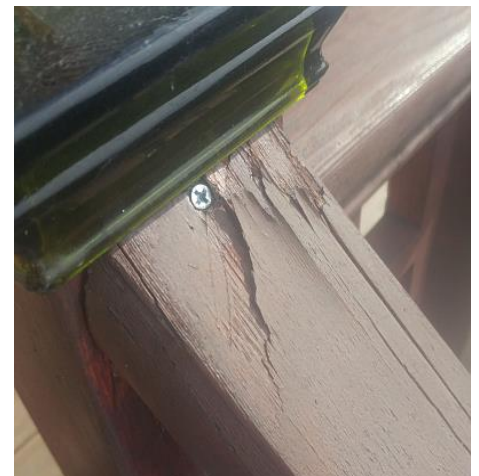
The railings are weathering, obvious repairs observed. Recommend prepping and sealing (painting/staining). Recommend Repair.

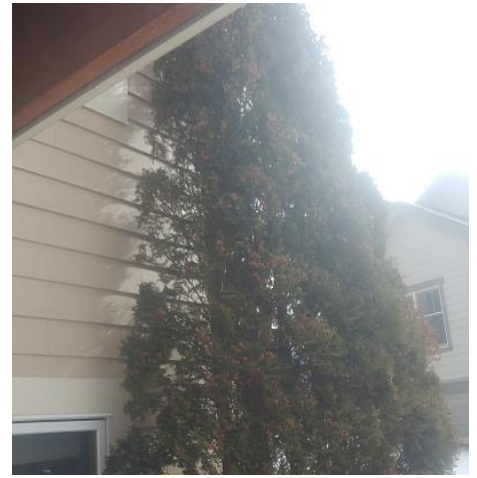
Vegetation in several areas is in direct contact with/overgrowing the home. Recommend Trimming.

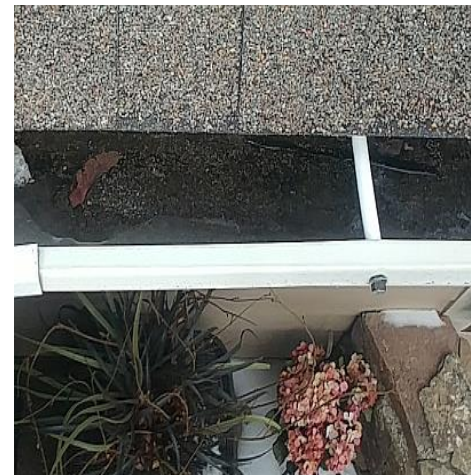
Missing granules observed. Minor damage observed (likely occurred during installation). The gutters are full of granules. This can be an indication that the roof cover is nearing the end of its operational life expectancy. Recommend evaluation by a licensed roofer. Recommend Repair.

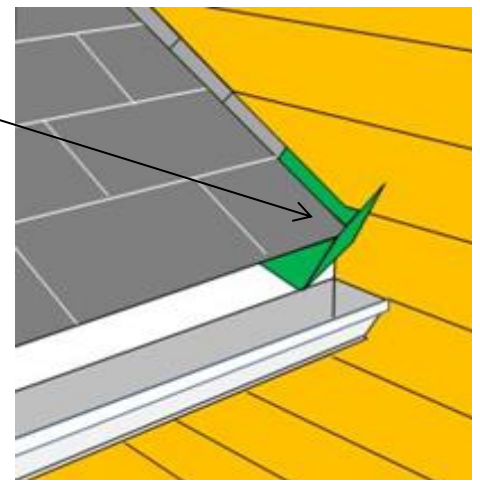
There is no kick out flashing installed. Kick out flashing is used where a lower roofline terminates against a vertical wall. The kick out is installed above the rain gutter or drip edge where the roof meets a vertical wall. It keeps rainwater out and diverts it away from the lower wall. This is an incorrect install. Recommend Repair.

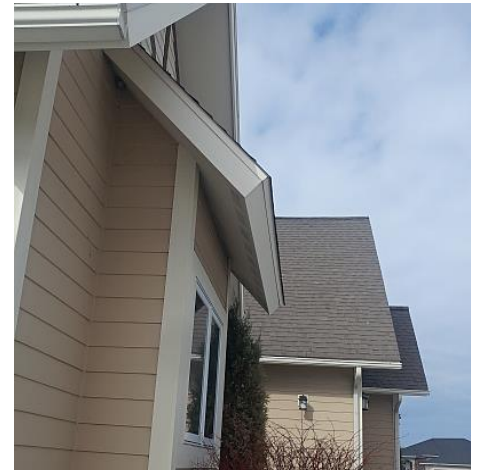
The gutters are dirty. Recommend Cleaning and seasonal cleaning thereafter.

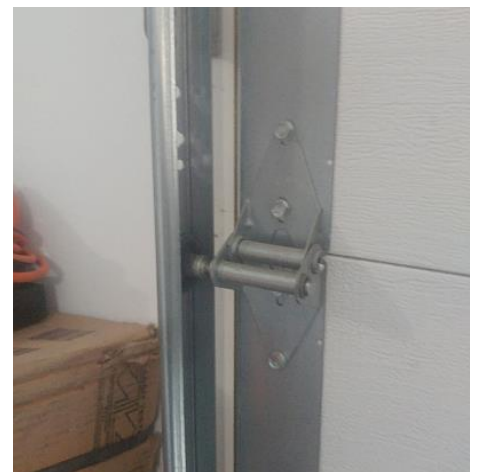
The exterior door trim is weathering. Damaged trim where indicated. Recommend Repair/Replacement.

Recommend lubricating all rollers and hinges and annually thereafter.

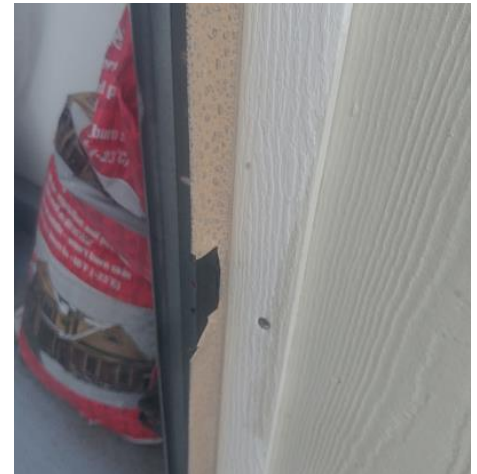
All of the side weather stripping is torn. Recommend Replacement.

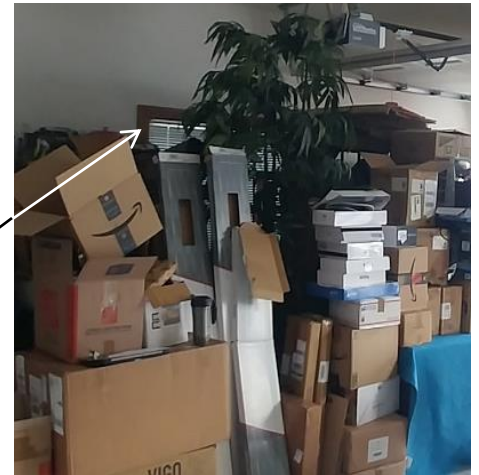
Mud dauber wasps are nesting in the inner portion of the window indicated. This could be an indication that the window is not properly sealed. The screen is not installed in this window. Recommend Repair/ Replacement.

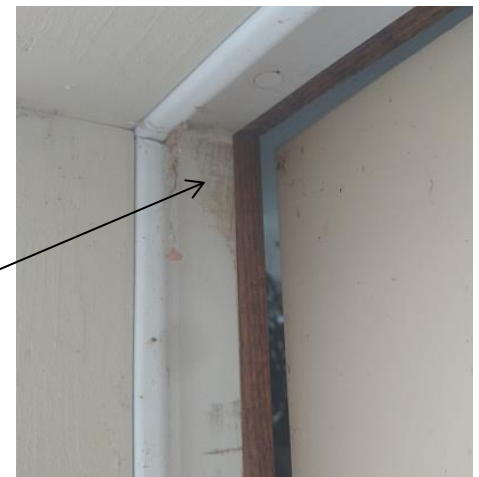
The exterior door frame is weathered. Recommend prepping and sealing (painting/staining). Recommend Repair

Door scrapes on the frame when opened/closed. Recommend Repair/Adjustment.

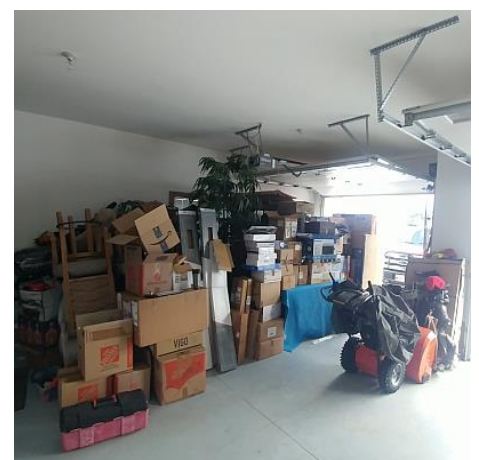
There is no visible GFCI in the garage. The inspector will not test a circuit for a GFCI unless the GFCI is visible. The reason being is that if access to the GFCI is say, obstructed by personal items, then the inspector will not be able to get to the GFCI to reset it. Based on the wiring in the home there is very likely a GFCI in the garage, but the inspector could not verify that.

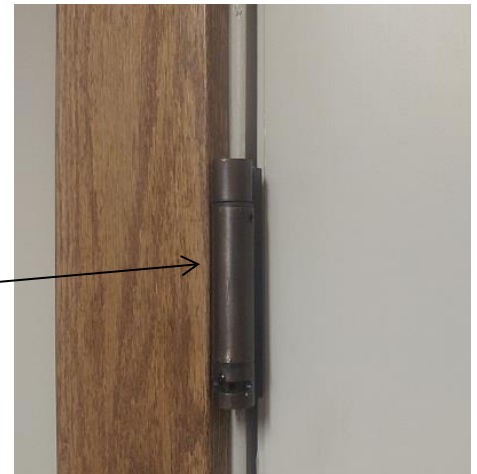
The door frame is slightly dinged. Recommend Repair.

The fire separation door should be self-closing. The self-closing hinges have been disabled. Recommend Repair.

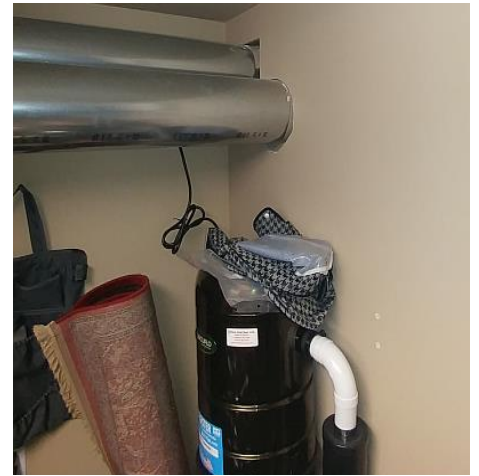
Flexible ducting penetrating the fire separation wall, the PVC ducting for the central vacuum penetrating the fire separation wall, and large gaps around the metal ductwork penetrating the fire separation wall are breaks in the fire separation wall and are potential Safety Hazards. Recommend Repair.

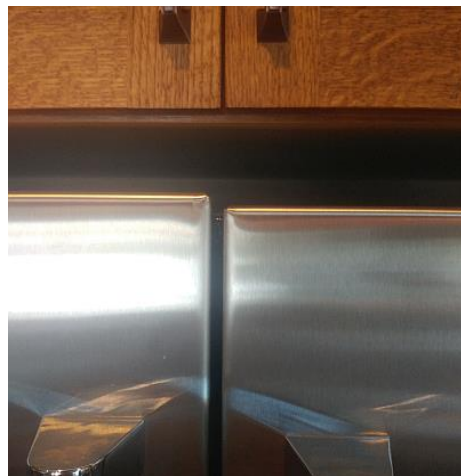
The refrigerator doors do not line up. The doors operate and appear to seal properly. Recommend Repair/Adjustment.

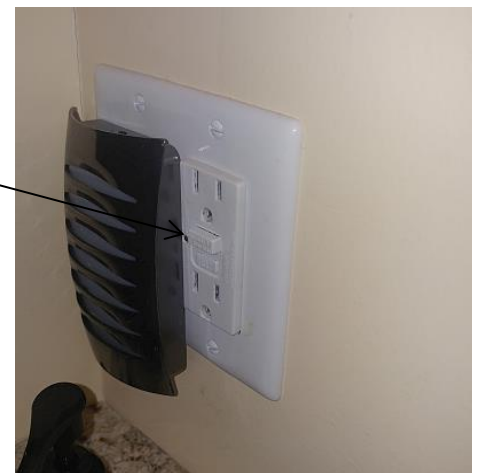
When the exhaust fan was turned on the GFCI would trip. This could be an indication of a problem with the bathroom electric system. This is a Major Concern. Recommend Repair.

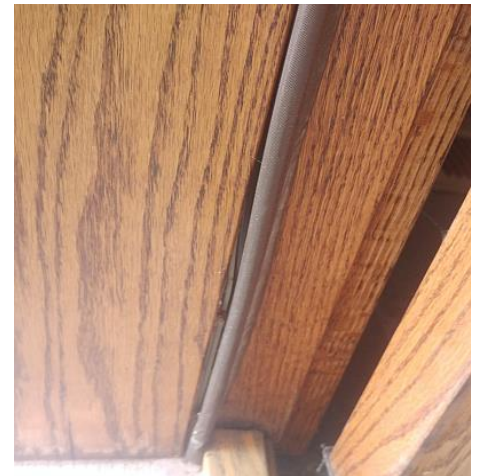
The weather stripping is loose. Recommend Repair.

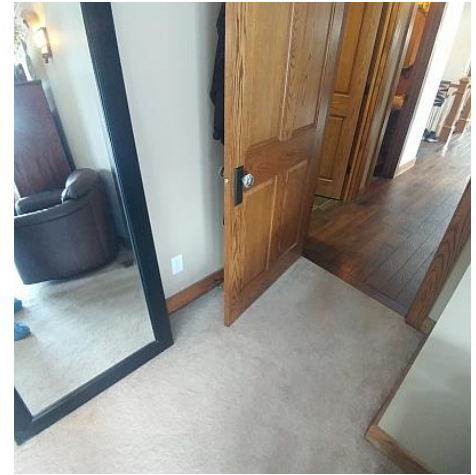
Door scrapes on the floor cover when opened/closed. Recommend Repair/Adjustment.

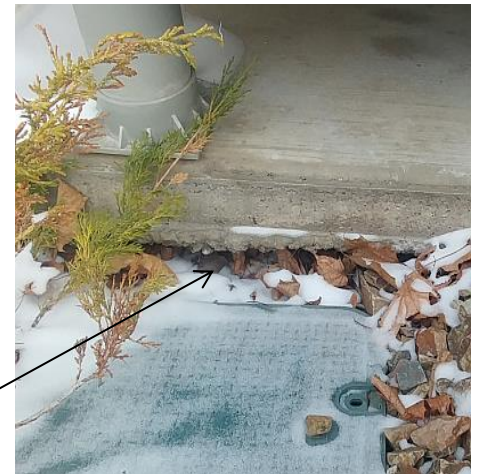
The condensing unit is within 24 inches of vegetation. Debris from vegetation can clog the condensing unit evaporator coils, making the unit less efficient and possibly shortening the life expectancy of the compressor. Recommend Repair.
