State of Montana Licensed Home Inspector
HI0163

Inspection Date: 12th of Never
Prepared For: Jane and John Doe

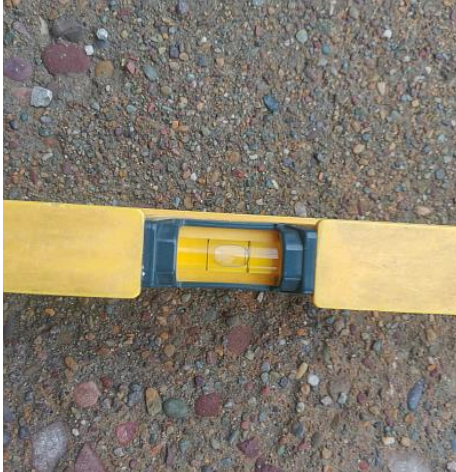
The service walks are pitched toward the building. Recommend Repair.

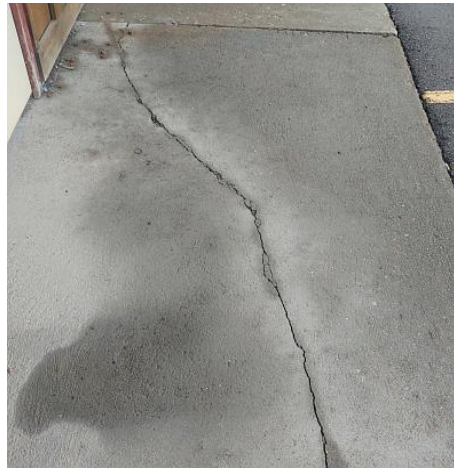
Large settling cracks on service walks. Recommend sealing to help prevent moisture intrusion.

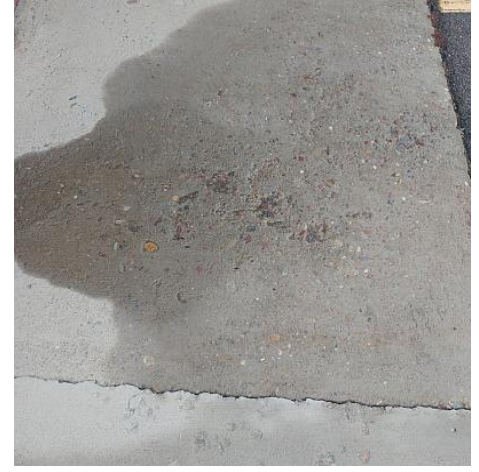
Scaling (loss of surface aggregate) observed. Repair would be cosmetic.

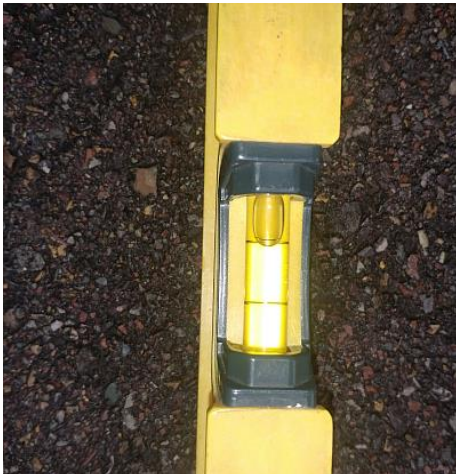
The driveway is properly pitched away from the building.

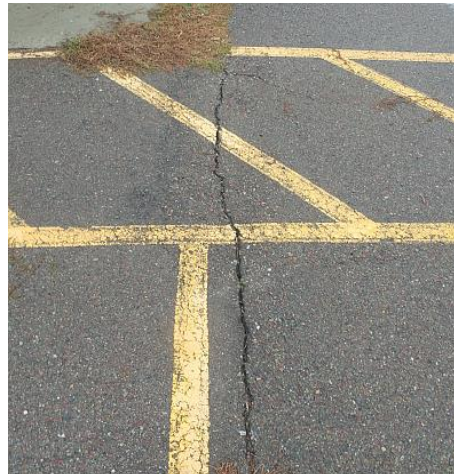
Large settling cracks on the driveway. Recommend sealing to help prevent moisture intrusion.

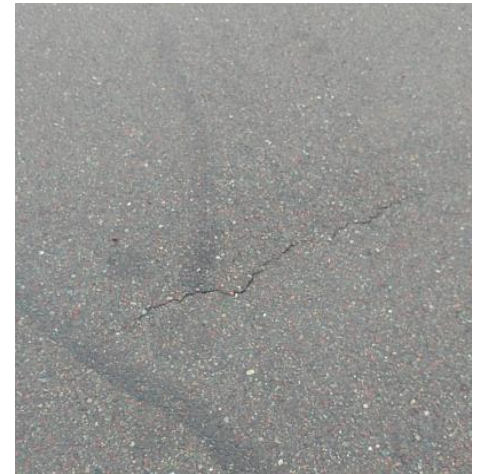
Typical cracks on driveway. No indication of recent movement, no trip hazard.

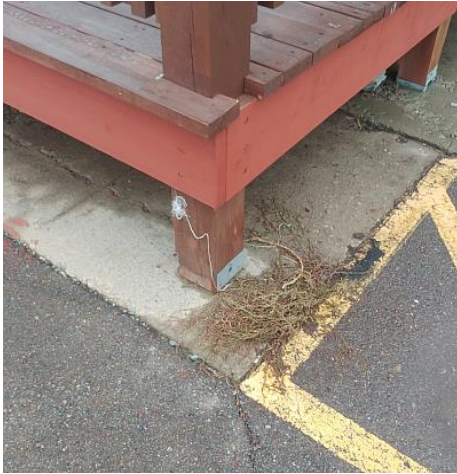
The footings and piers are in Satisfactory Condition.

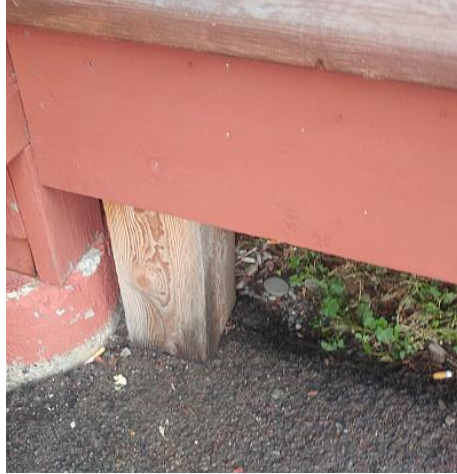
Wood to asphalt contact. Untreated wood should never be allowed to be in contact with asphalt (can cause deterioration). No deterioration detected at the time of the inspection. Recommend Monitoring.

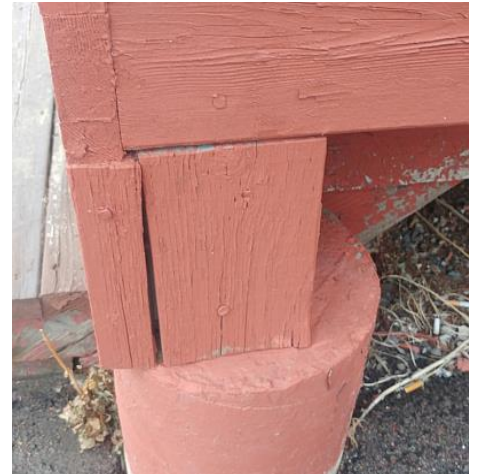
Weathered piers have been properly painted.

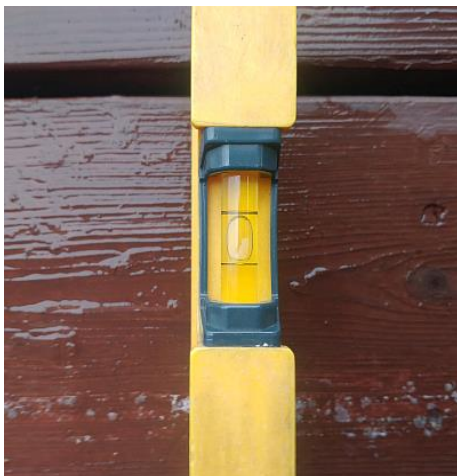
The floor is properly pitched away from the home.

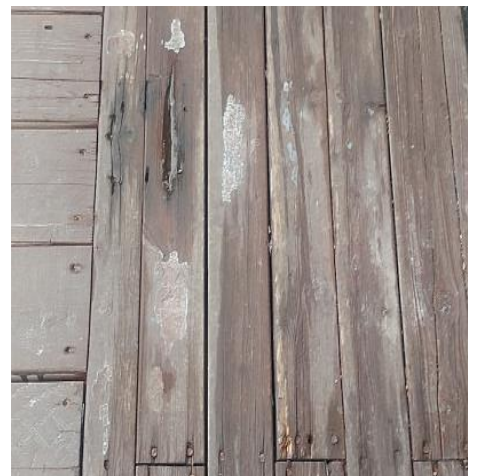
Improper attachment to house *Railing loose* *Railing/Balusters recommended*

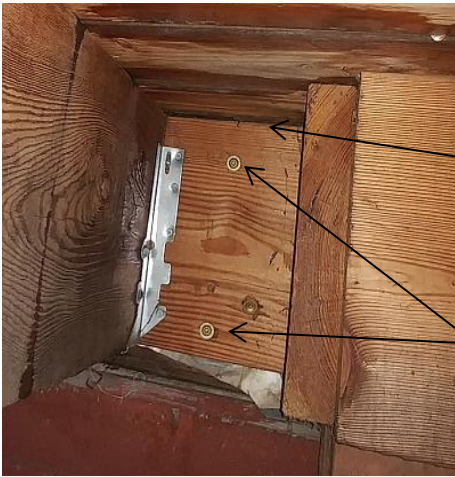
The floor is not flashed. Flashing helps prevent moisture intrusion at the deck/home junction. If the floor is ever replaced recommend flashing be added.

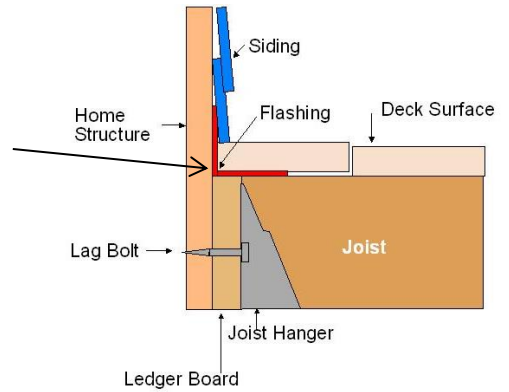
Proper attachment between the ledger board and home structure observed.

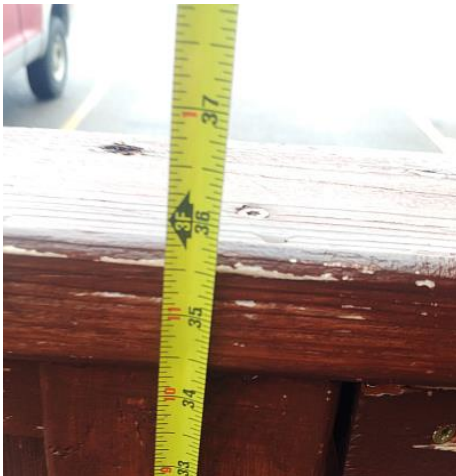
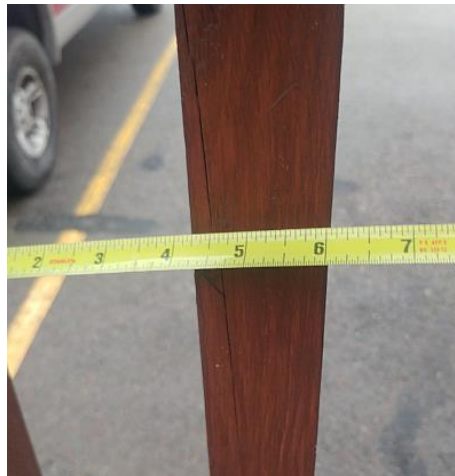
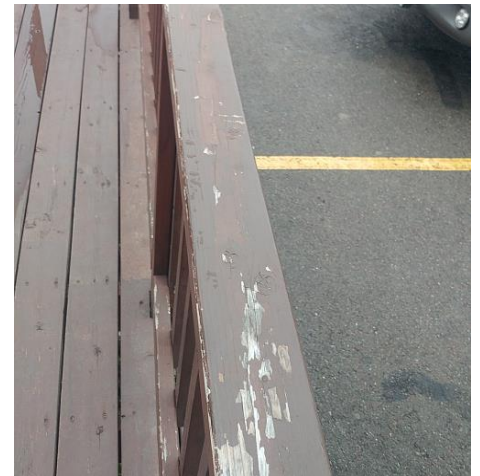
The railing is the proper height. Balusters are properly spaced.

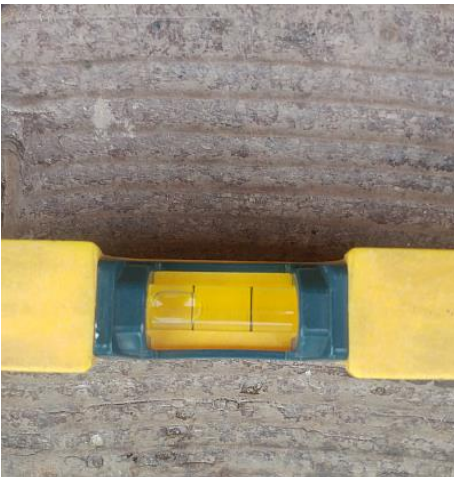
The steps are not properly pitched.
Recommend Repair.

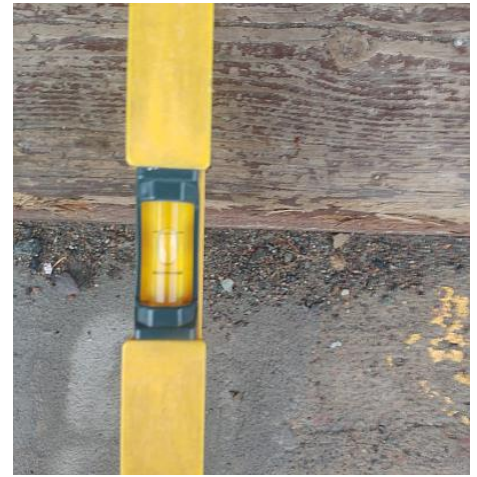
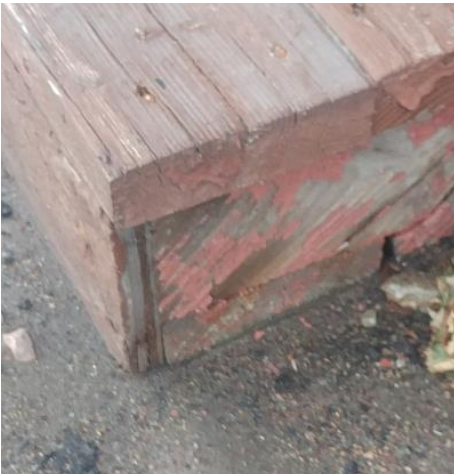
Wood to asphalt contact.
Untreated wood should never be allowed to be in contact with asphalt (can cause deterioration).

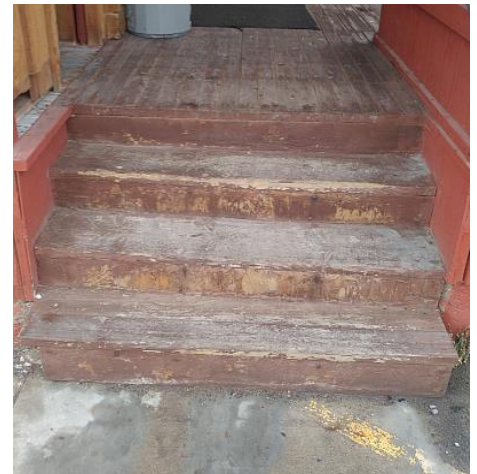
The steps are weathering.
Recommend prepping and sealing (painting/staining). Recommend Repair.

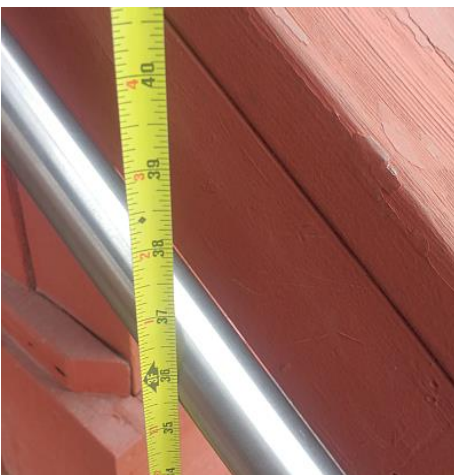
The handrail is the proper height.

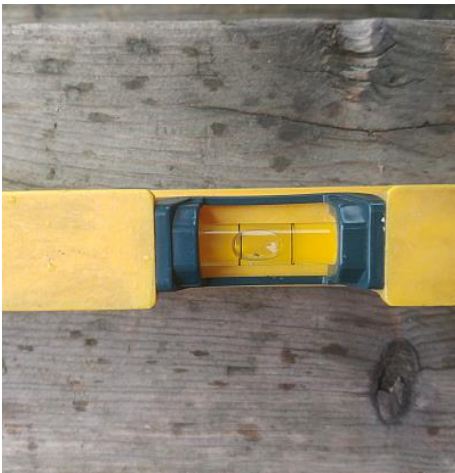
The steps are properly pitched.

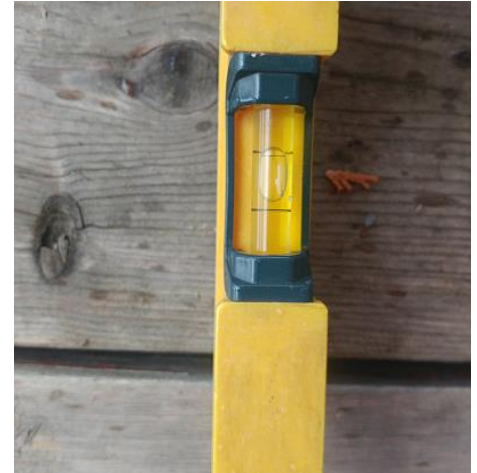
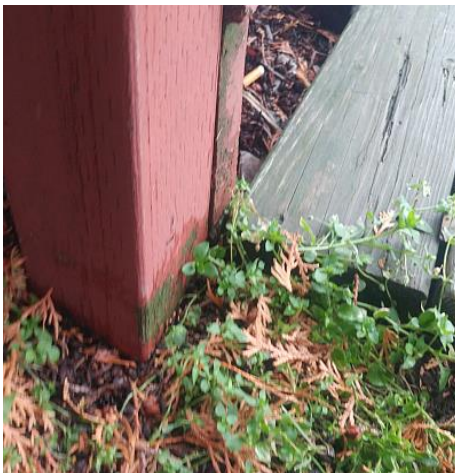
Wood to earth contact. Untreated wood should never be allowed to be in contact with earth (can cause deterioration).

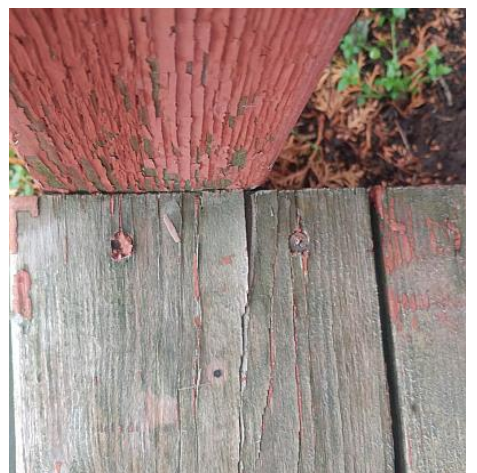
The steps are weathering. Early indications of deterioration observed. Recommend Repair.

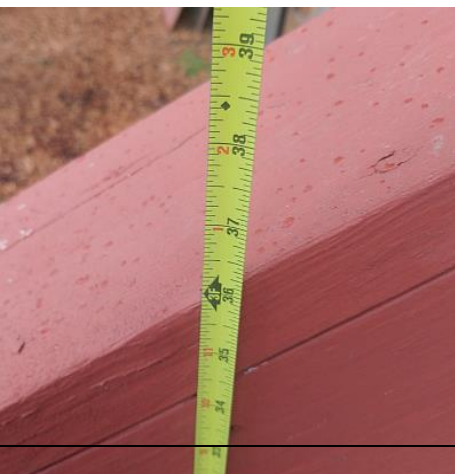
The railing is the proper height.

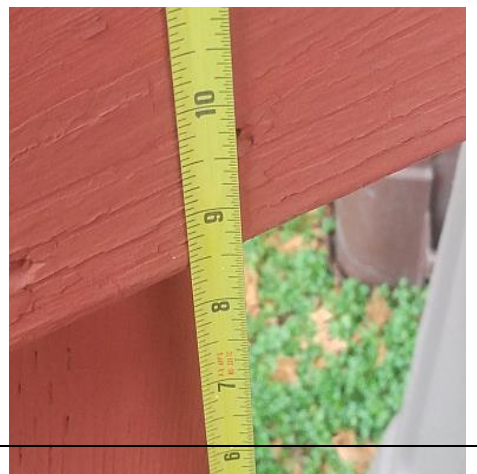
The balusters are improperly spaced. Recommend Repair.

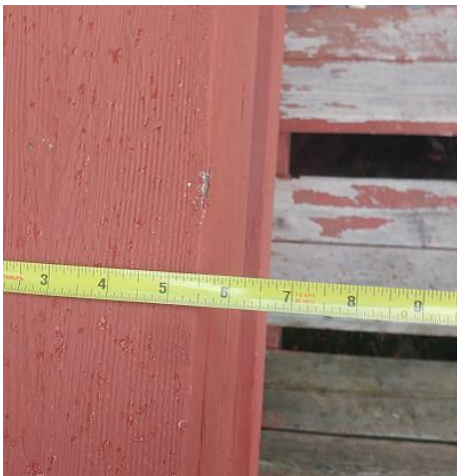
The grip surface is not proper. Illustrated are a few (but not the only) types of proper grip surfaces. Recommend Replacement.

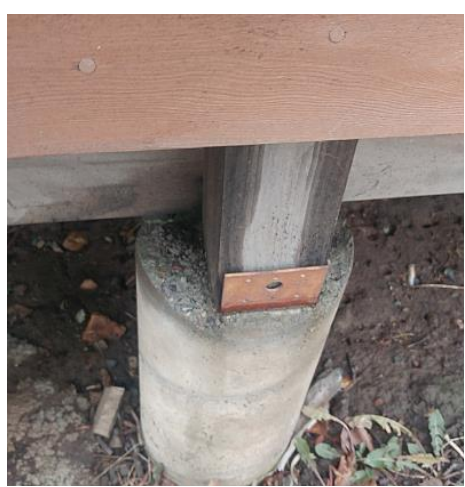
The footings and piers are in Satisfactory Condition. Positive attachment observed between all structural components.

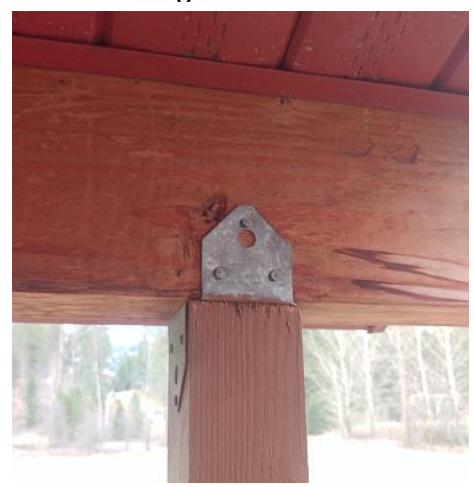
- Floor:** Satisfactory Marginal Poor
- Material:** Wood Metal Composite Concrete
- Finish:** Treated Painted/Stained Other

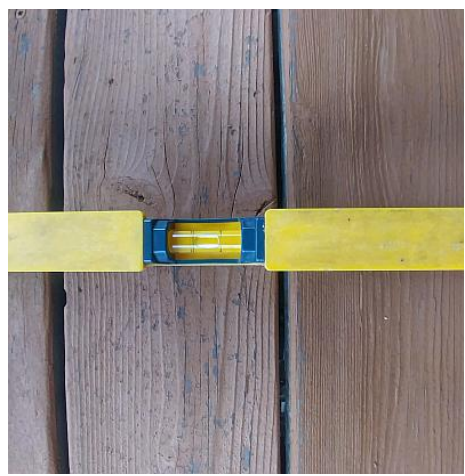
The floor is properly pitched away from the building. The floor is weathering. Recommend prepping and sealing (painting/staining). Recommend Repair.

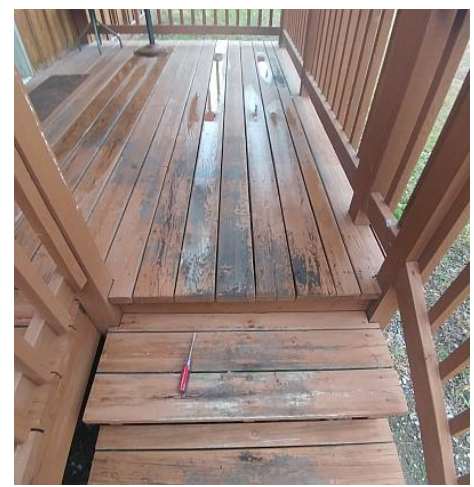
Improper attachment to house **Railing loose** **Railing/Balusters recommended**

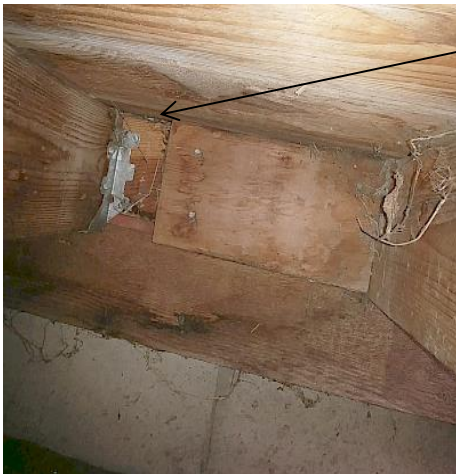
The floor is not flashed. Flashing helps prevent moisture intrusion at the deck/home junction. If the floor is ever replaced recommend flashing be added.

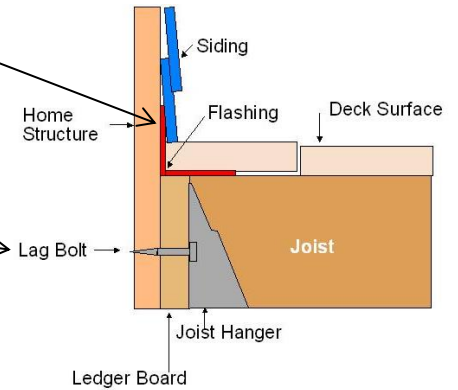
The ledger board is not properly attached to the home structure. Lag bolts are one (but not the only) means of positively attaching the ledger board to the home structure. Recommend Repair.

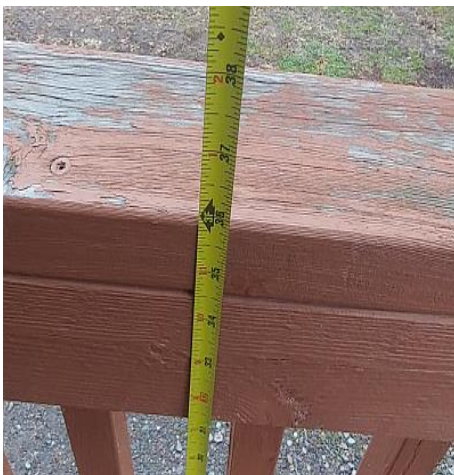
The railing is the proper height. Balusters are properly spaced.

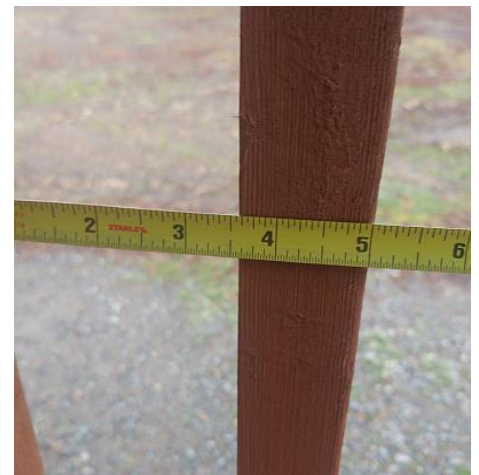
Decks/balconies are by nature vulnerable to moisture intrusion due to the fact that they are continuously exposed to the elements and there are multiple seams and joints where moisture can penetrate. Decks/balconies always require monitoring and maintenance. Moisture intrusion is often unseen and unpredictable and in most cases cannot be verified visually.

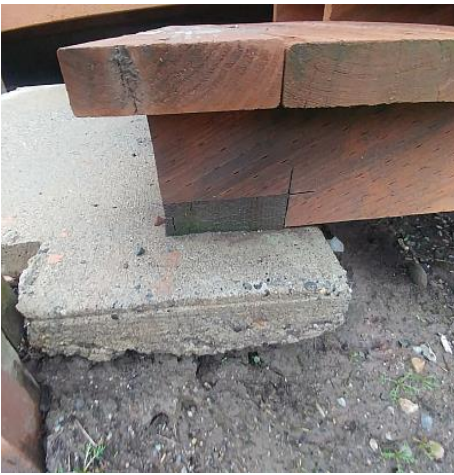
Proper treated wood used for contact with concrete. Material has eroded from under the concrete pad the steps are resting on. Recommend Repair (backfill).

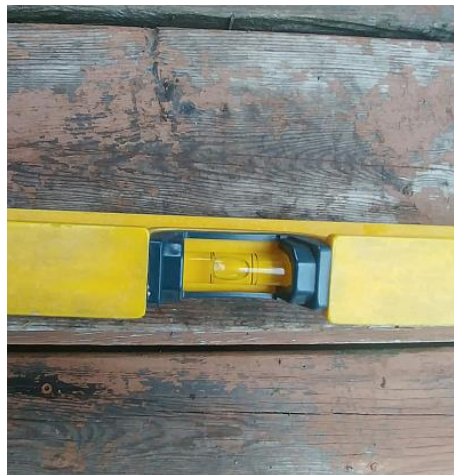
The steps are properly pitched.

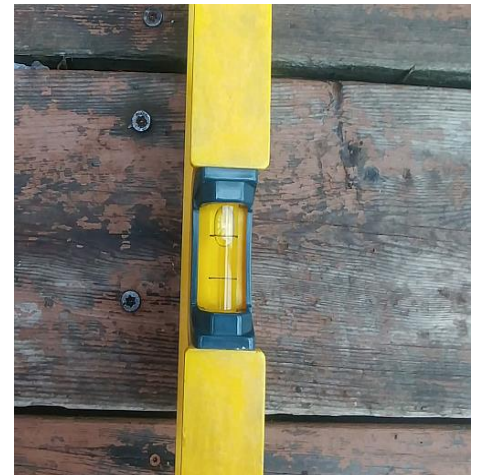
The steps are weathering. Recommend prepping and sealing (painting/staining). Recommend Repair.

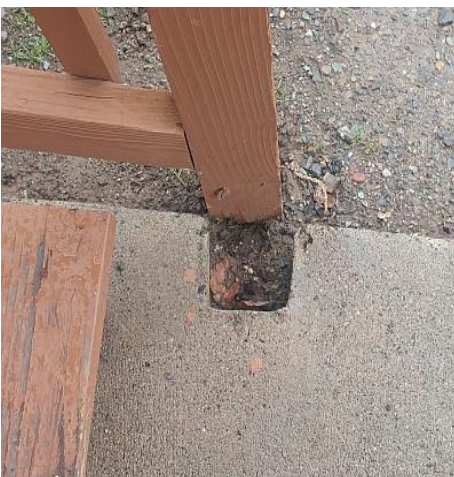
The rail post has deteriorated and is loose. The loose railing is a potential Safety Hazard. Recommend Repair/Replacement.

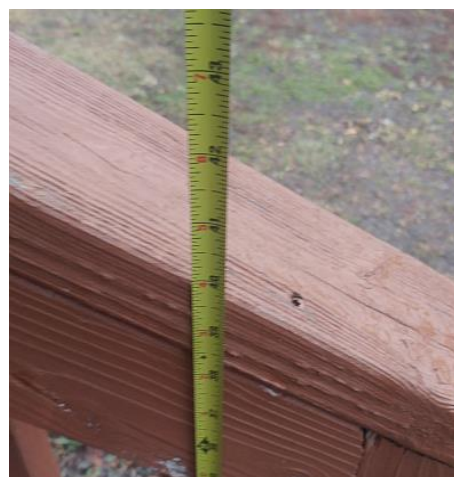
The railing is the proper height. Balusters are properly spaced.

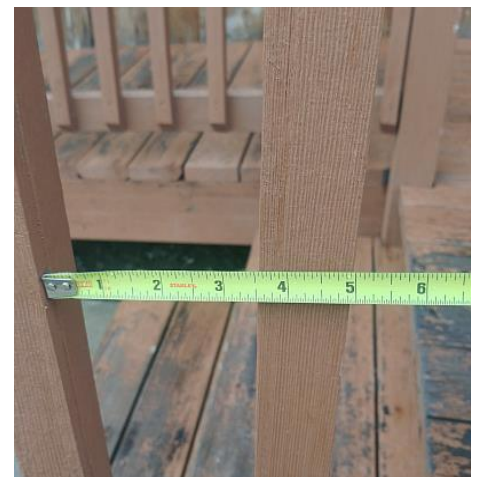
The railings are weathering. Recommend prepping and sealing (painting/staining). Recommend Repair.

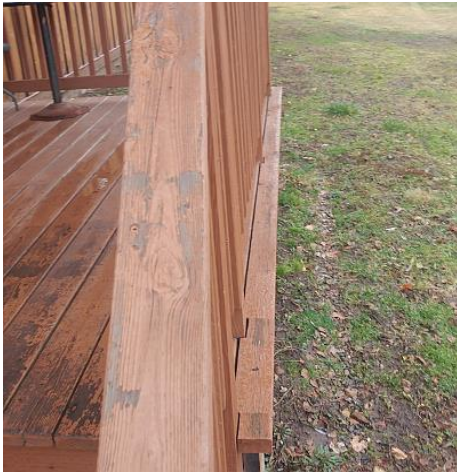
The grip surface is not proper. Illustrated are a few (but not the only) types of proper grip surfaces. Recommend Replacement.

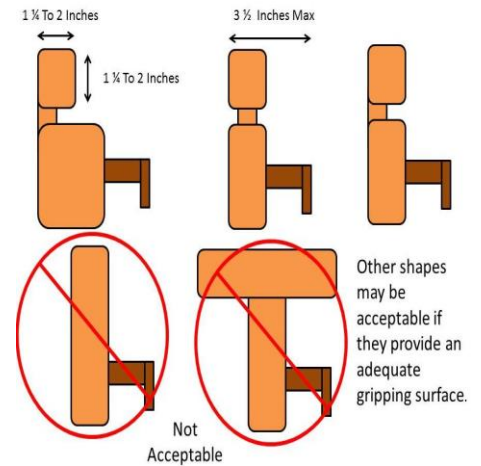
- RAMP** None **Condition:** Satisfactory Marginal Poor
Material: Concrete Wood Other *Railing/Balusters recommended*
 Cracked *Settled* *Rotted/Damaged* *Uneven risers* *Safety Hazard*

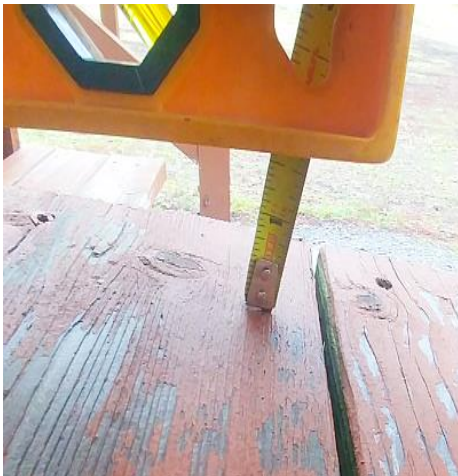
The slope of the ramp is in compliance with the Americans with disabilities act (ADA).

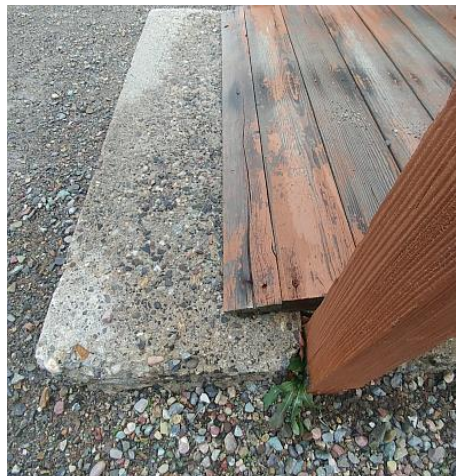
Wood to concrete contact. Untreated wood should never be allowed to be in contact with earth/concrete (can cause deterioration).

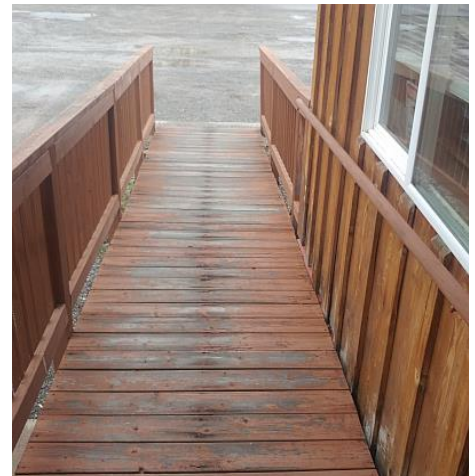
No deterioration detected at the time of the inspection. Recommend Monitoring.

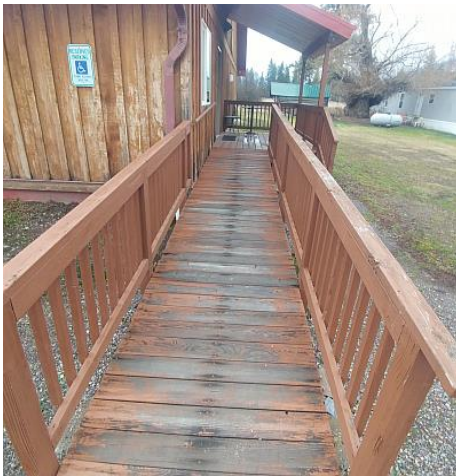
The railing is the proper height. Balusters are properly spaced.

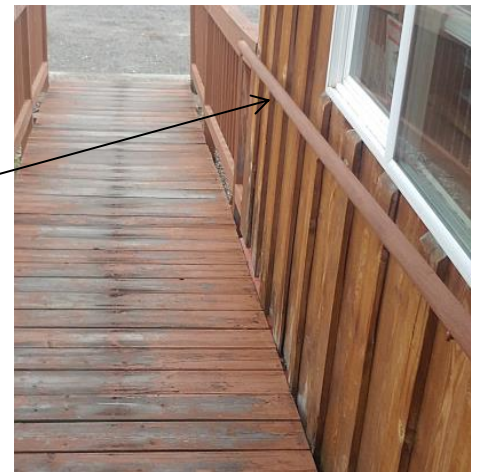
Recommend Replacement.

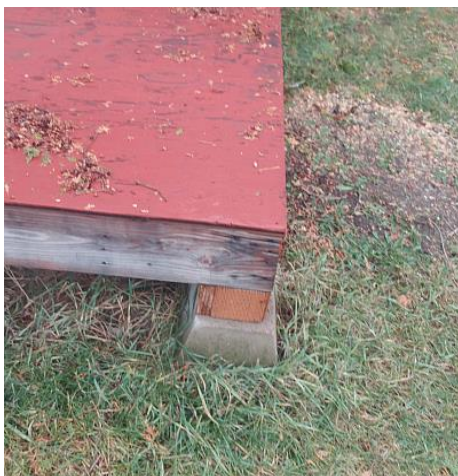
The footings and piers are in Satisfactory Condition. Proper treated wood used for contact with concrete.

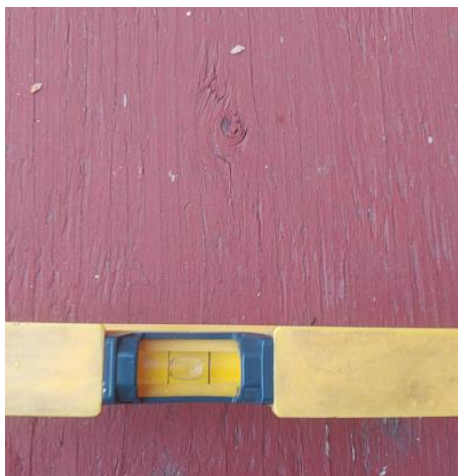
The floor is properly pitched away from the building.

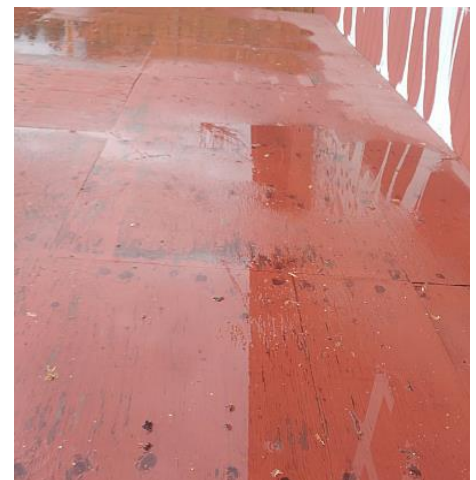
Improper attachment to house **Railing loose** **Railing/Balusters recommended**

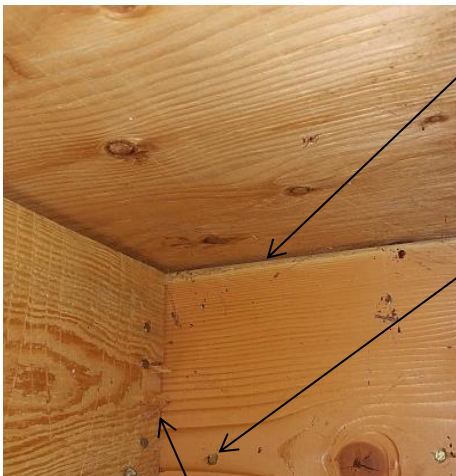
The floor is not flashed. Flashing helps prevent moisture intrusion at the deck/home junction. If the floor is ever replaced recommend flashing be added.

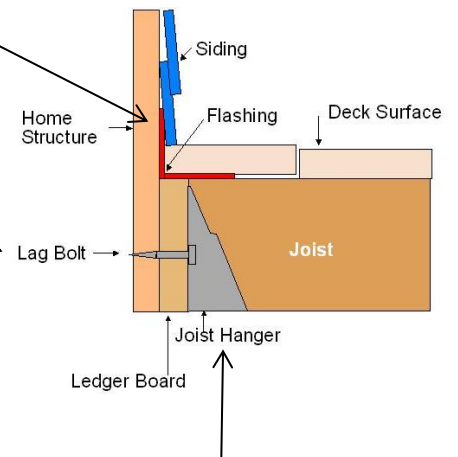
There are no joist hangers installed. Joist hangers ensure positive attachment between the joists and ledger board. Recommend Repair/Replacement.

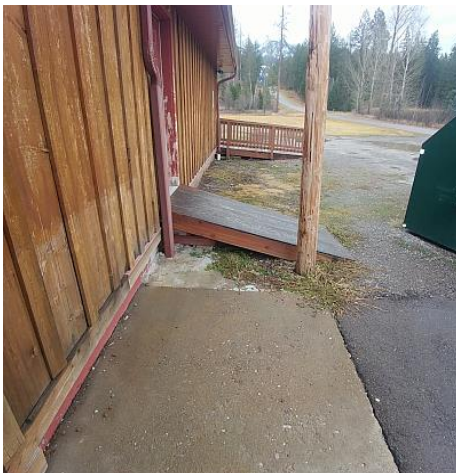
The loading ramp, for the purpose it was built for, is in Satisfactory Condition.

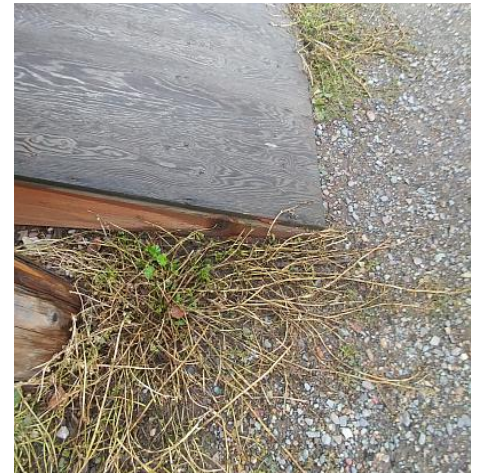
The ramp is weathering. Recommend prepping and sealing (painting/staining). Recommend Repair.

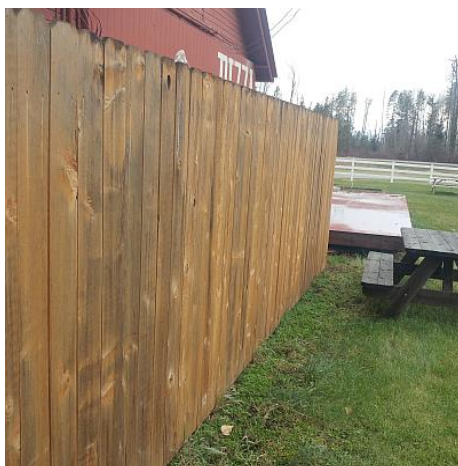
The fences are in Satisfactory Condition.

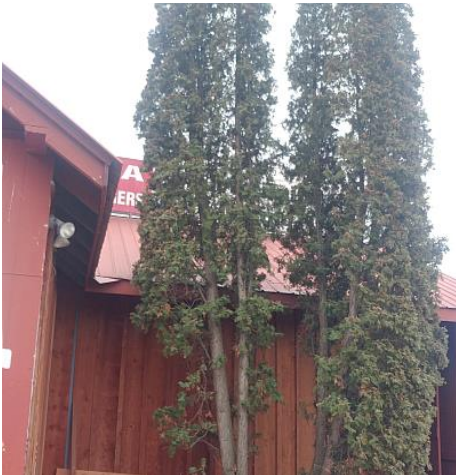
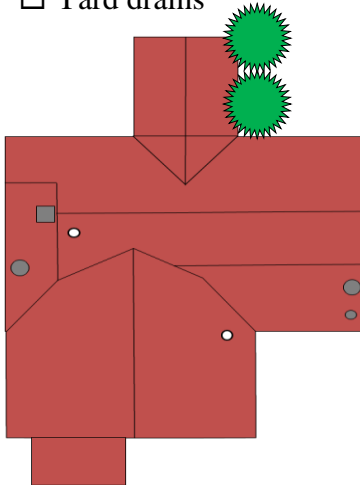
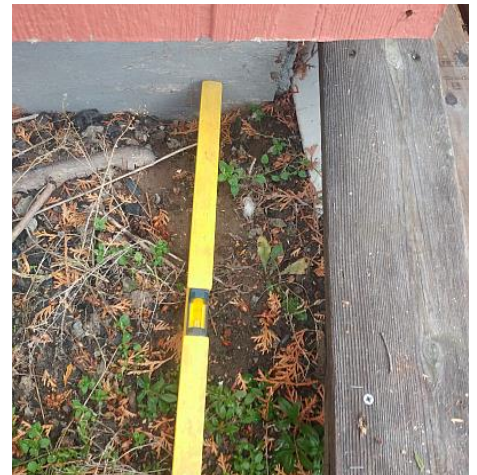
Vegetation where indicated is in direct contact with/overgrowing the home. Recommend Trimming.

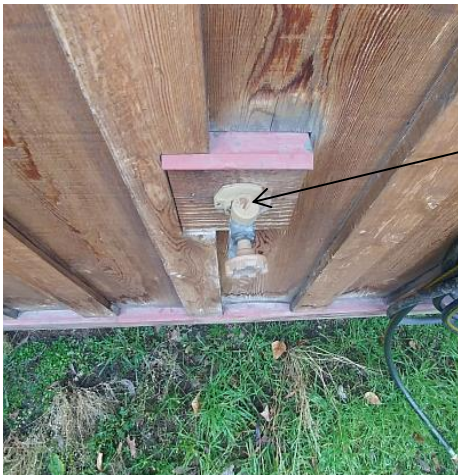
Proper anti-siphon valve installed on all external faucets (bibs).

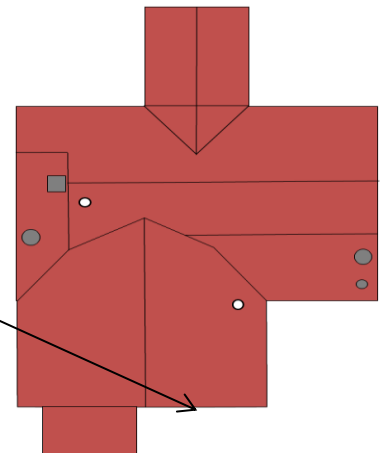
Conditions reported above reflect visible portion only

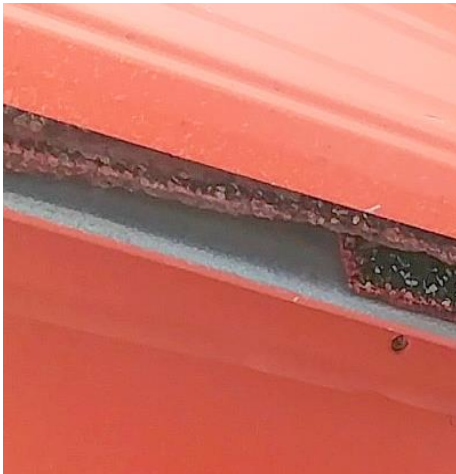
The metal roof cover has been installed directly over asphalt shingles. When this is done a membrane (30 pound roofing felt is common) is laid over the asphalt shingles before the metal roof is installed. This helps protect the metal roof from the abrasive granules on the asphalt shingles. There is no membrane visible. Recommend Replacement.

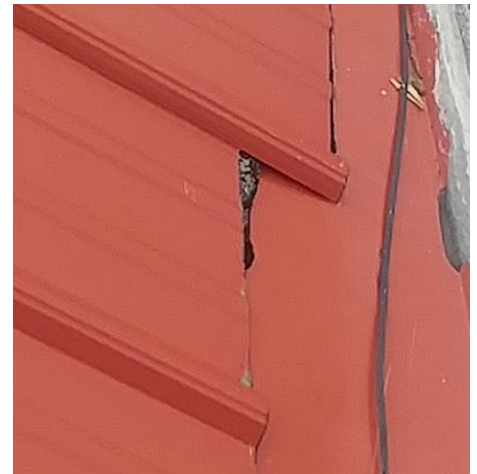
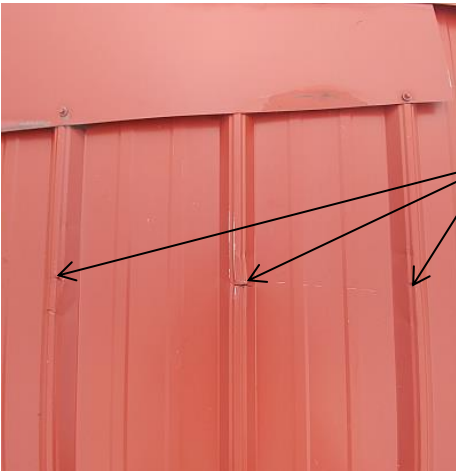
The roof cover is bent/cracked in numerous areas where indicated. Recommend Repair/Replacement.

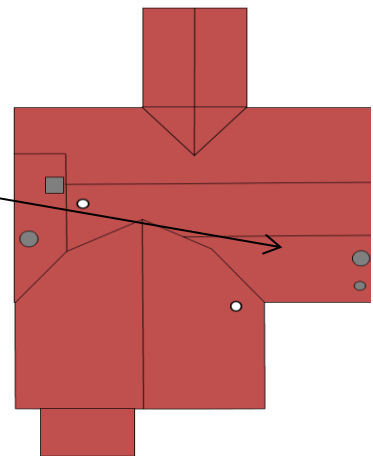
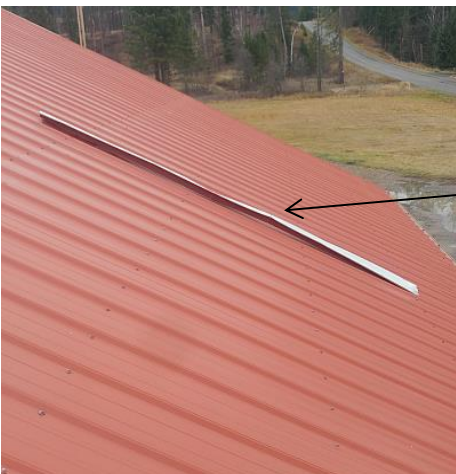
Loose/damaged snow brake observed where indicated. Recommend Repair/Replacement.

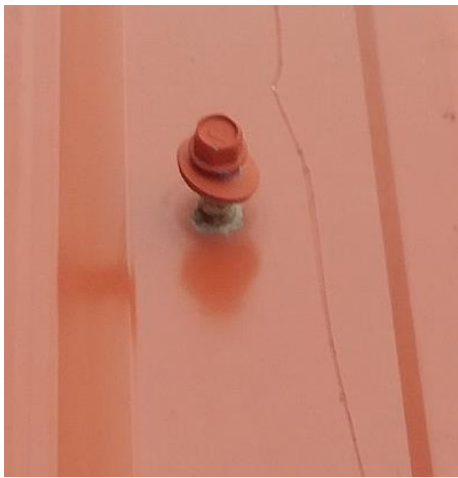
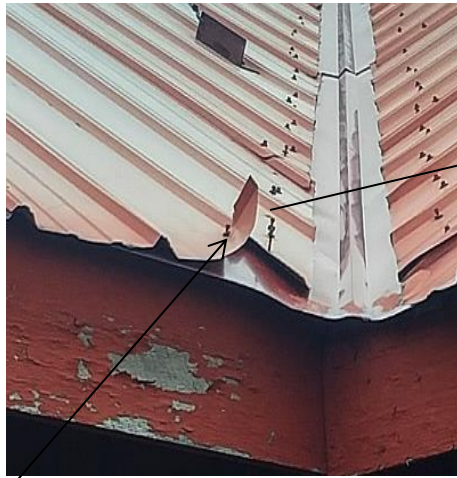
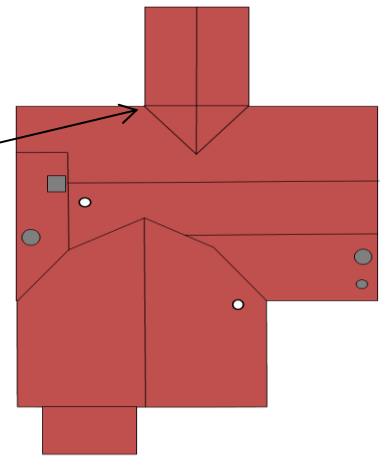
Numerous loose screws observed. Damaged roof cover observed where indicated. Some rusting observed on the lower edges. Recommend Repair/ Replacement.

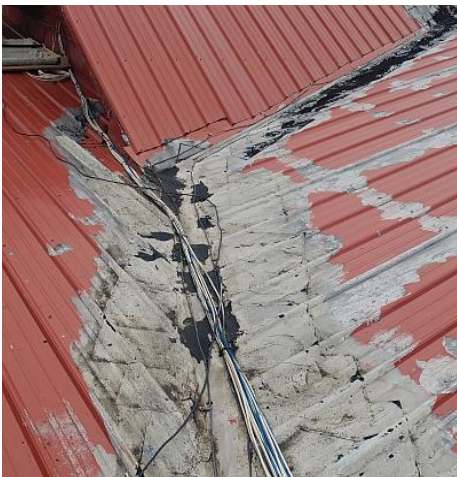
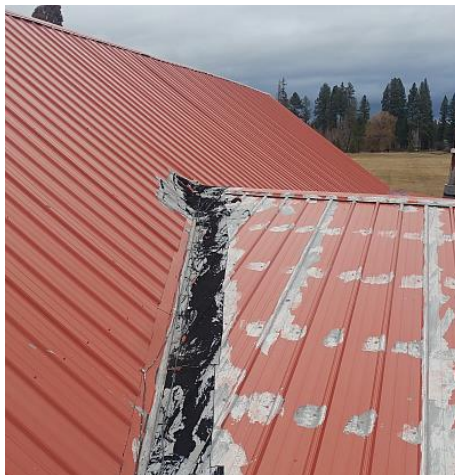
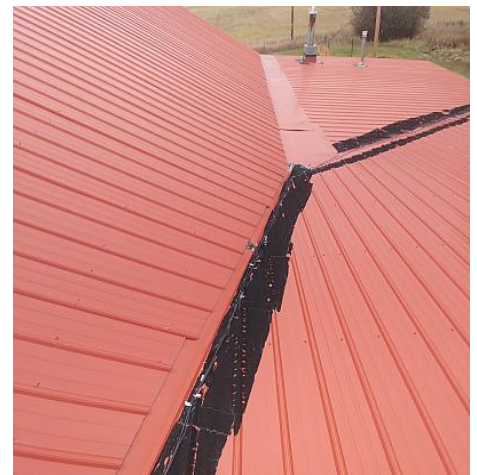
There is a lot of sealant on various areas of the roof. Typically a properly installed metal roof system does not need surface sealant to keep it from leaking.

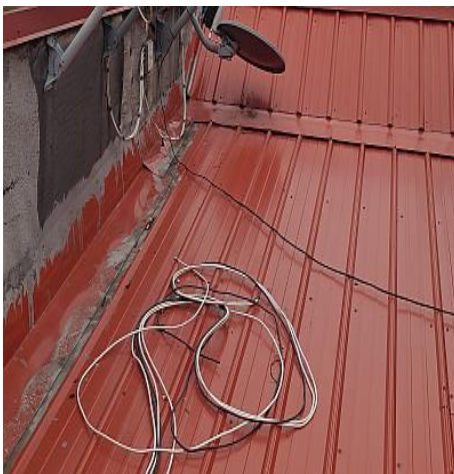
The roof pitch in some areas is very shallow. The pitch in the area indicated is close to 1:12. Typically metal roofs are not installed on roofs with a pitch of 1:12 or less in areas where heavy snowfall is likely as the snow can accumulate on the roof. There are some snow melters installed in this area.

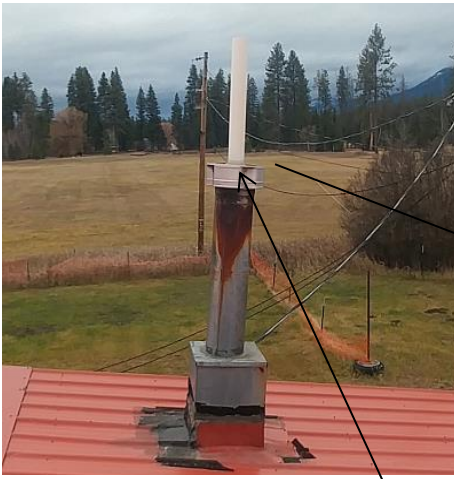
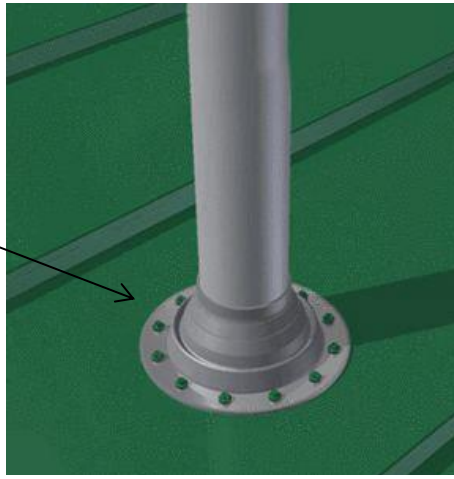
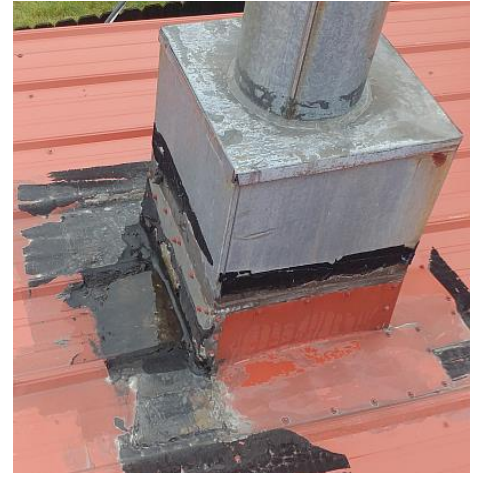
The PVC exhaust for the furnace is being run through an old metal flue. While the PVC exhaust is heavily sealed where it goes through the old spark arrestor, a proper weather boot is recommended. The old metal flue is rusting. Recommend Repair.

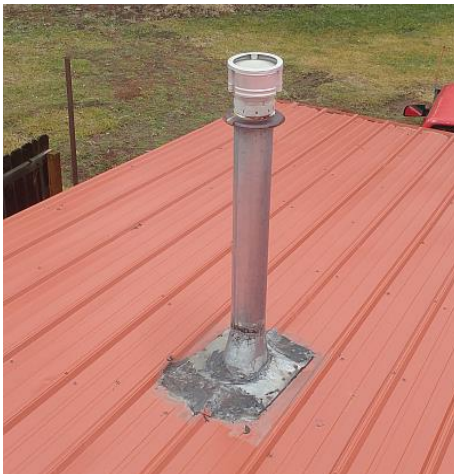
This is the wrong type of weather boot for this type of roof cover. Illustrated is one (but not the only) type of weather boot for use on this type of roof cover. Recommend Replacement.

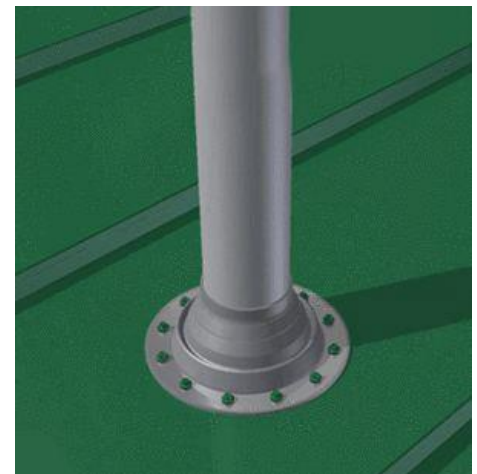
This is the flue for the gas water heater.

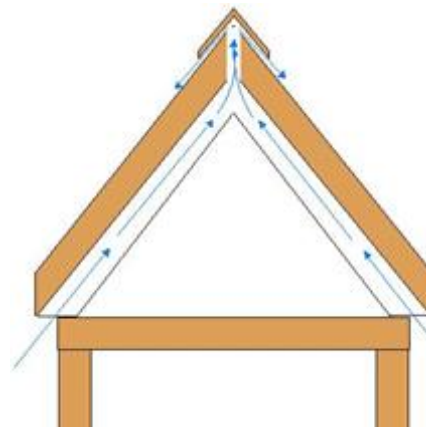
FLASHING None **Condition:** Satisfactory Marginal Poor Not visible
Material: Galvanized/Alum Asphalt Rubber Copper Other Not Visible
 Rusted Separated from chimney/roof Recommend Sealing Other

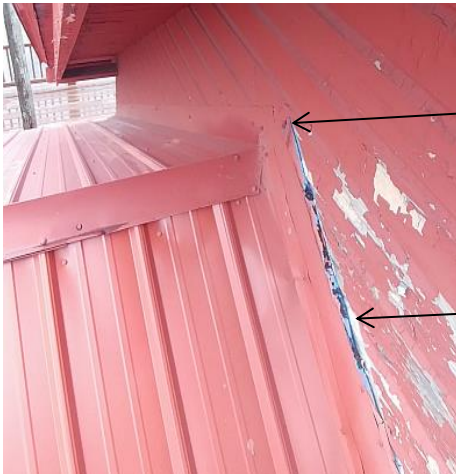
The side wall flashing is not properly installed in areas. The flashing should go under, not on top of, the siding. While the top of the flashing is heavily sealed there are gaps at the wall/flashing junction. Recommend Repair.

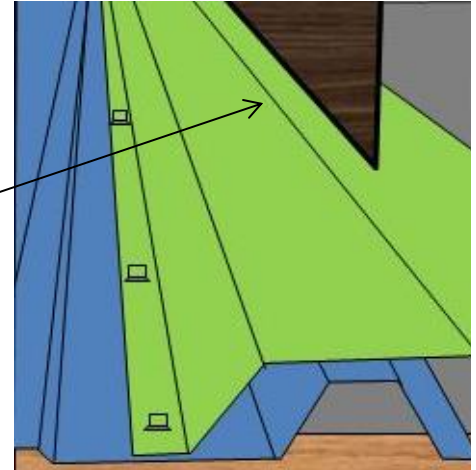
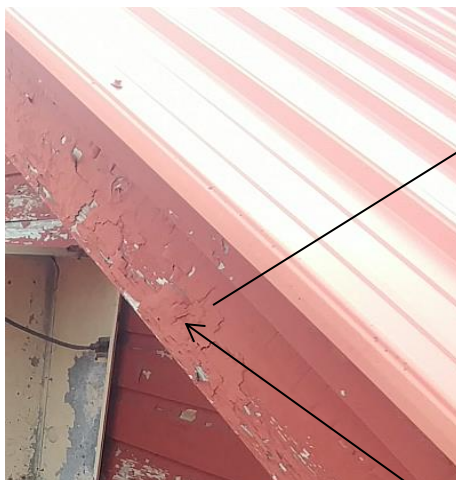
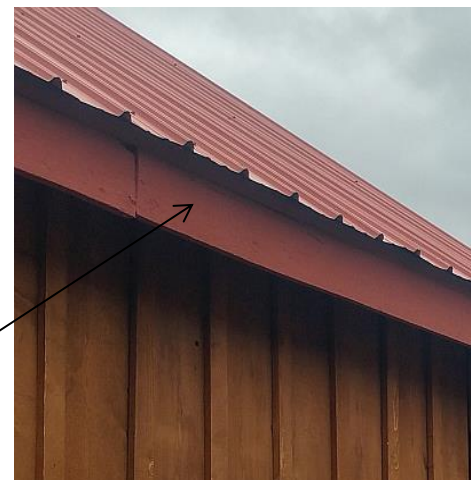
The eave and gable flashing is not completely installed. This flashing helps secure the roof edges and helps prevent moisture intrusion. Recommend Replacement.

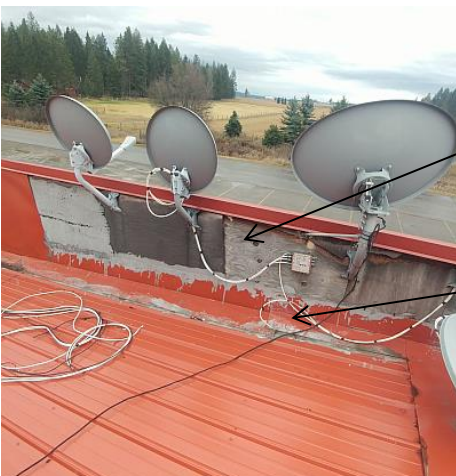
There is a parapet wall where indicated. The roof side of the wall is not completely flashed, exposing the sheathing. Loose flashing observed. Recommend Repair.

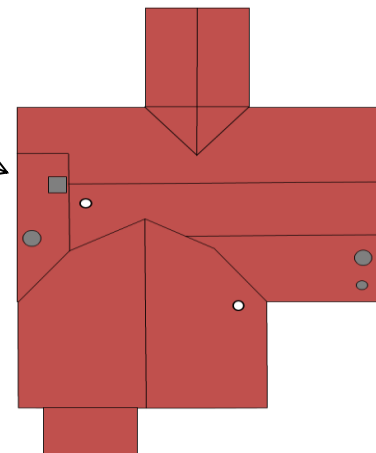
VALLEYS None **Condition:** Satisfactory Marginal Poor Not visible
Material: Galvanized/Alum Asphalt Rubber Copper Other Not Visible

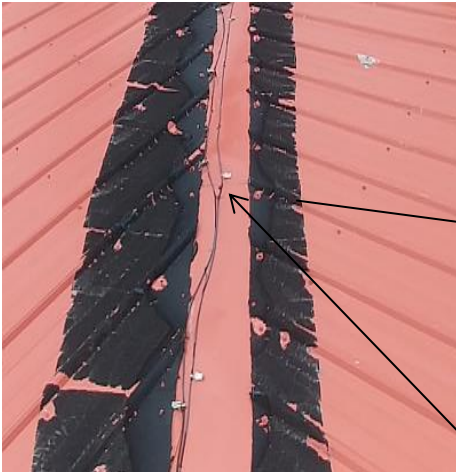
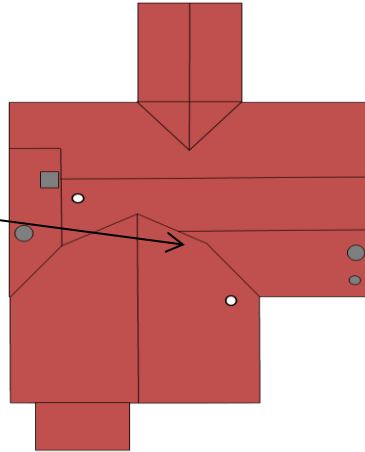
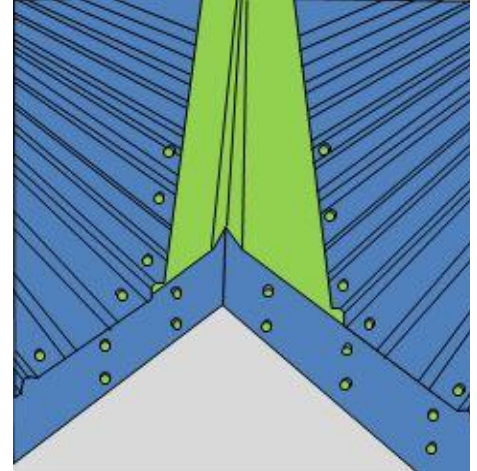
Pre formed valleys are not being used where indicated. Pre formed valleys have a diverted that helps prevent water from rushing under the panels on the opposite side and help channel water smoothly off the roof.

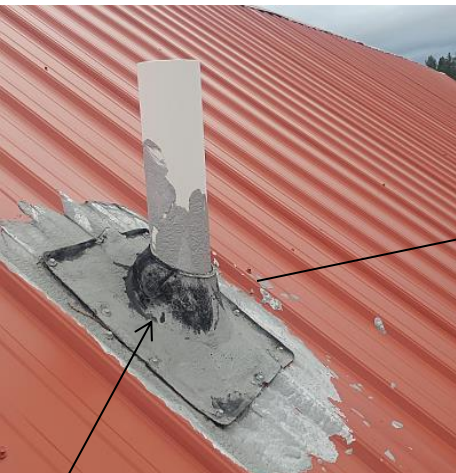
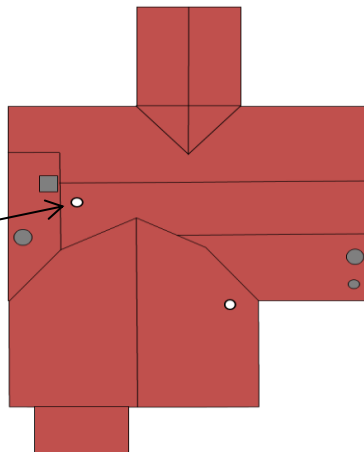
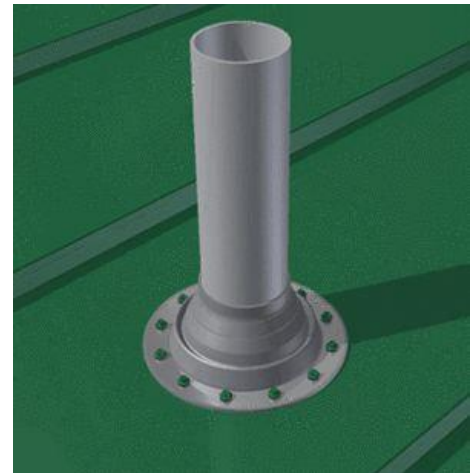
For the plumbing vent indicated, this is the wrong type of weather boot for this type of roof cover. Illustrated is one (but not the only) type of weather boot for use on this type of roof cover. Recommend Replacement.

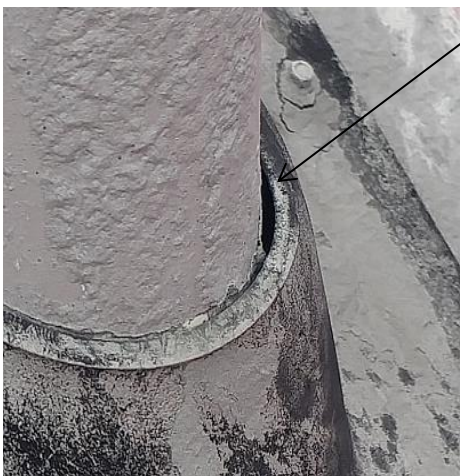
The weather boot on the plumbing vent above is gapped. This is a Major Concern. Recommend Repair. The plumbing vent has been heavily sealed.

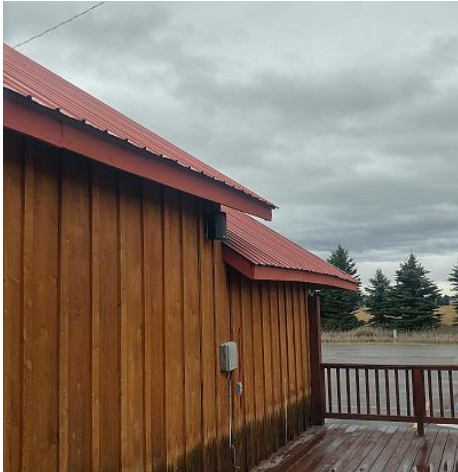
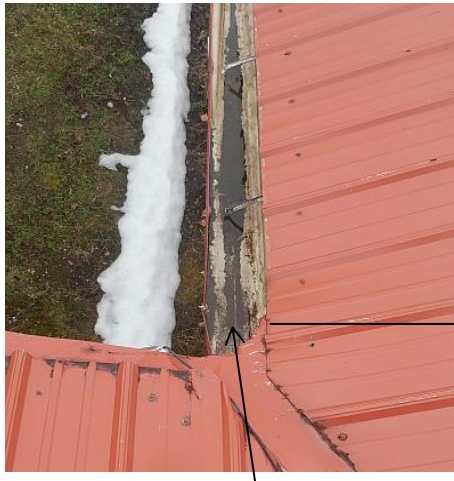
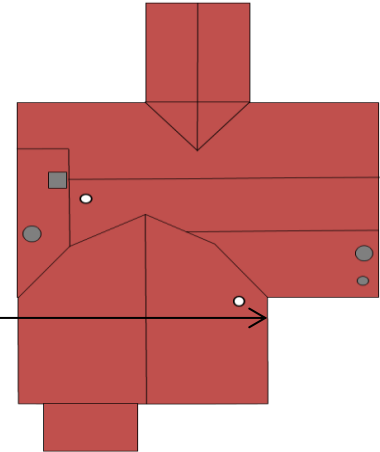
The gutters are not completely installed. Recommend gutters help divert runoff away from the foundation and help keep backsplash away from the homes siding. Recommend Replacement.
