State of Montana Licensed Home Inspector
HI0163

Inspection Date: 12th of Never
Prepared For: Jane and John Doe

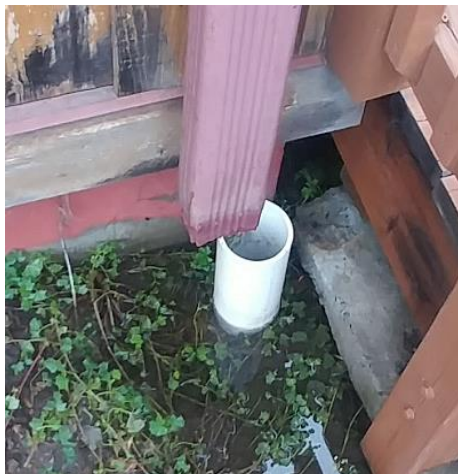
The downspouts are short of the ground drains in several areas. Recommend Repair.

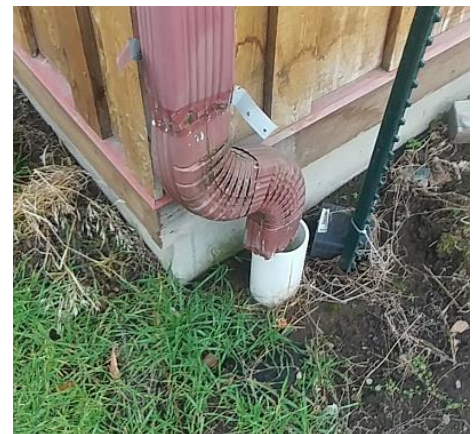
BUILDING(S) EXTERIOR WALL CONSTRUCTION

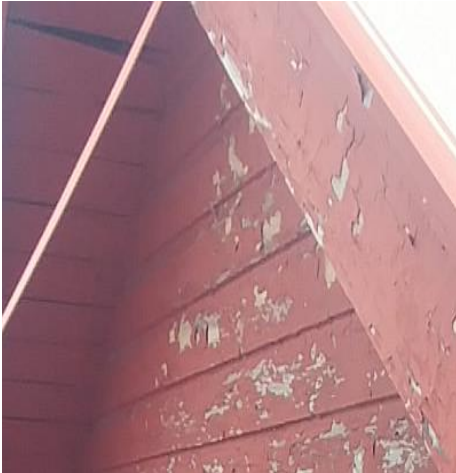
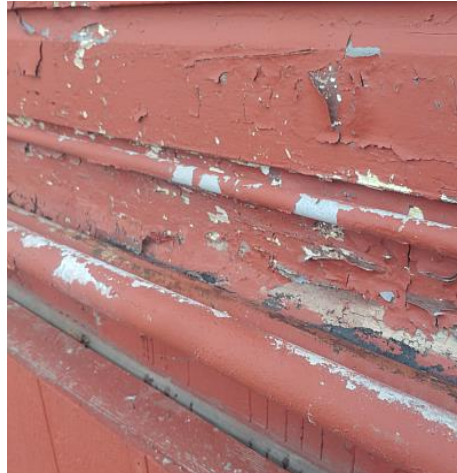
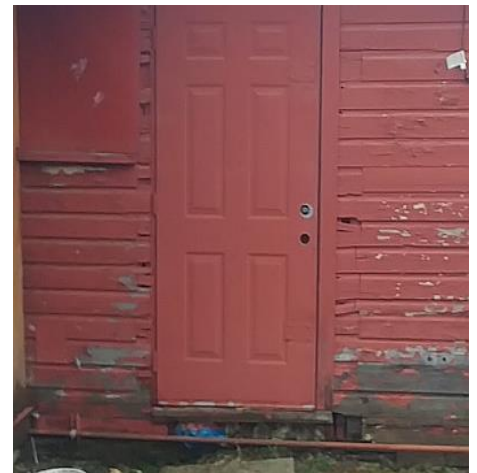
The siding is heavily weathered in areas. Loose/missing siding observed. Some deteriorated siding observed. Recommend Repair/Replacement.

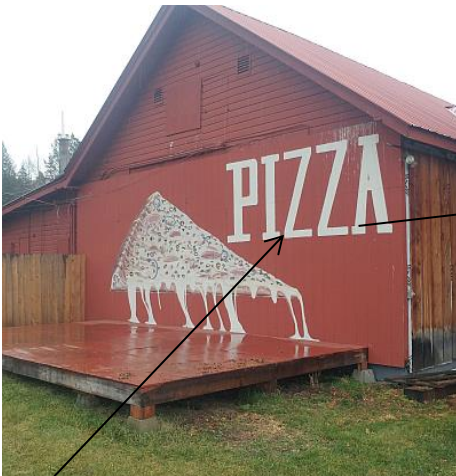
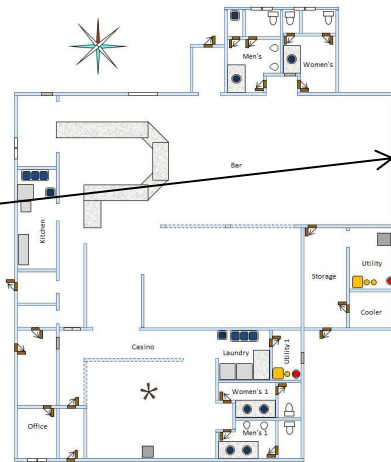
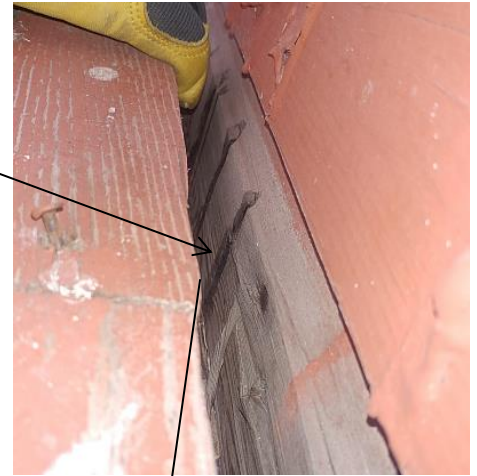
A faux wall has been added where indicated, on top of the load bearing wall. There is a gap at the top between the faux wall and the load bearing wall. The gap is not sealed (fiberglass insulation is not a proper moisture seal). Moisture, debris, and 'critters' can get into this area. The visible siding on the load bearing wall is weathered, possible deterioration observed. Recommend Repair/Replacement.

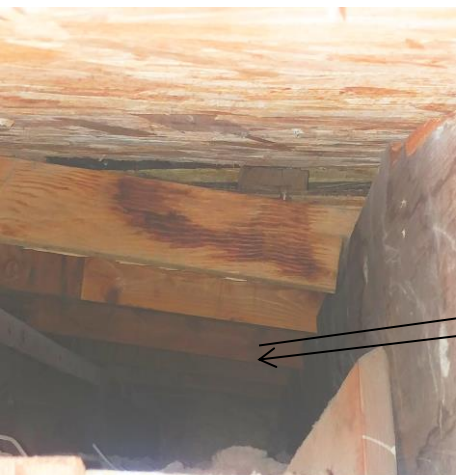
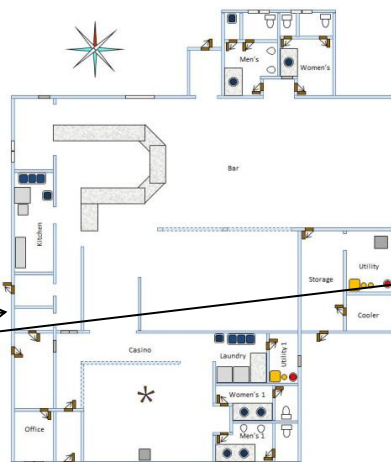
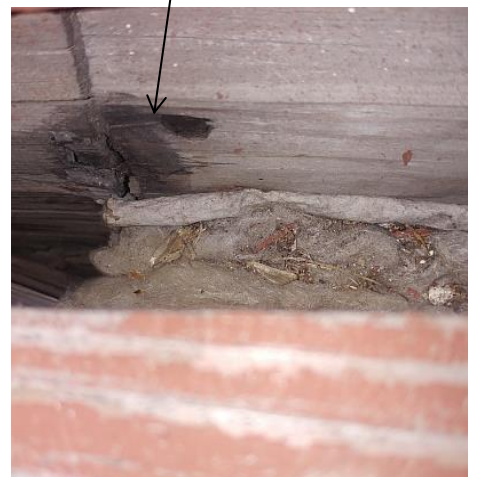
The siding is missing where indicated, giving direct access from the exterior to part of the attic structure. Moisture, debris, and 'critters' can get into this area. Recommend Repair.

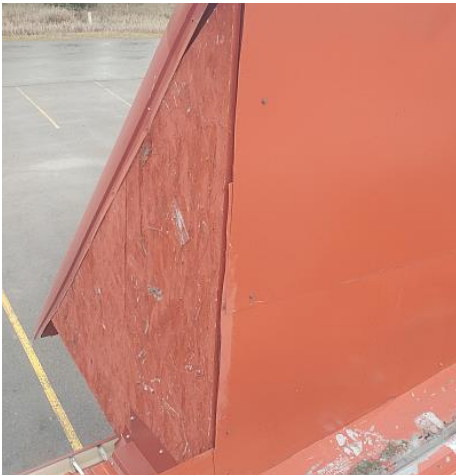
OSB is being used as part of the roof parapet. Typically this material is not designed to be exposed to the elements, even when painted. The OSB is gapped. Recommend Repair/Replacement.

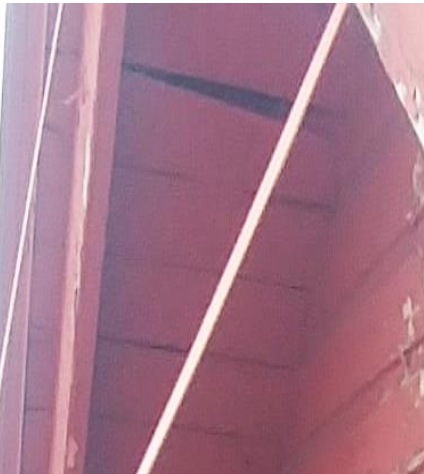
The soffit is loose/gapped in several areas. Recommend Repair.

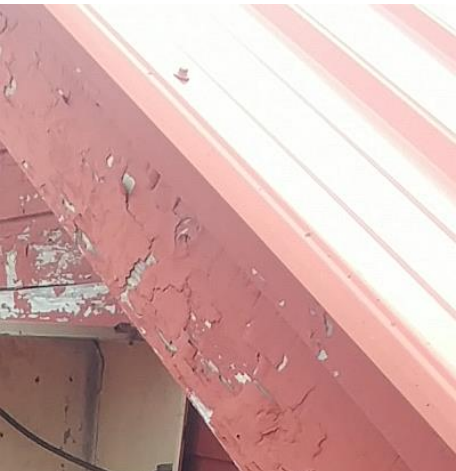
The fascia is heavily weathered in several areas. Recommend prepping and sealing (painting/staining). Recommend Repair.

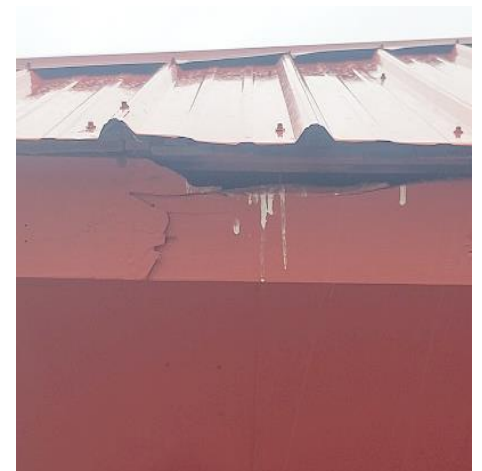
TRIM Condition: Satisfactory Marginal Poor
 Material: Wood Fiberboard Metal/Vinyl Fiber Cement Stucco
 Recommend repair/painting *Damaged wood* Other

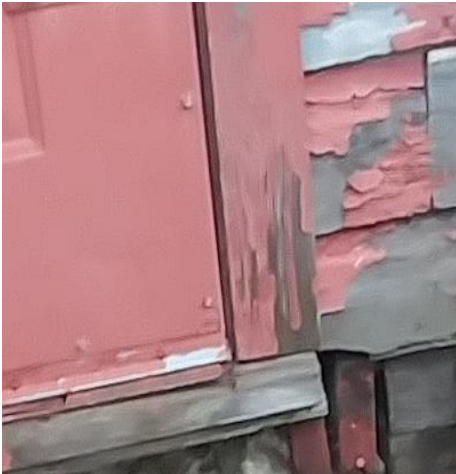
The trim is heavily weathered in several areas. Recommend prepping and sealing (painting/staining). Recommend Repair.

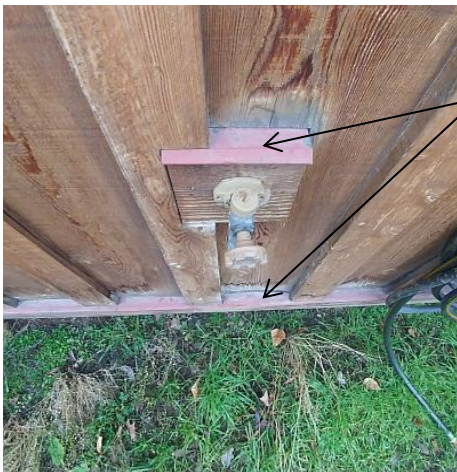
Flashing is installed primarily at the siding transitions. Flashing is a thin continuous piece of material that is installed to prevent moisture intrusion. Flashing is installed in a manner that directs water down and away from the structure. It is typically installed above windows, doors and at siding transitions.

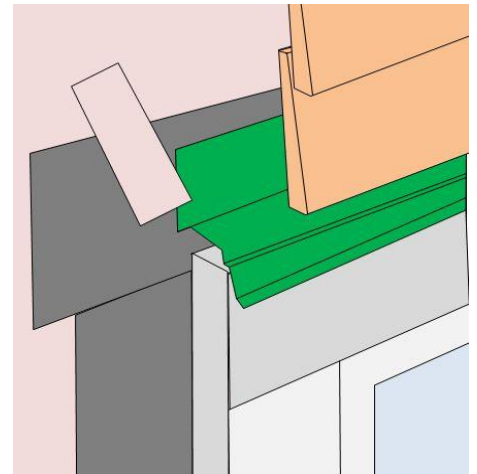
CAULKING Condition: Satisfactory Marginal Poor
 Recommend around windows/doors/masonry ledges/corners/utility penetrations
 Recommend repair/painting

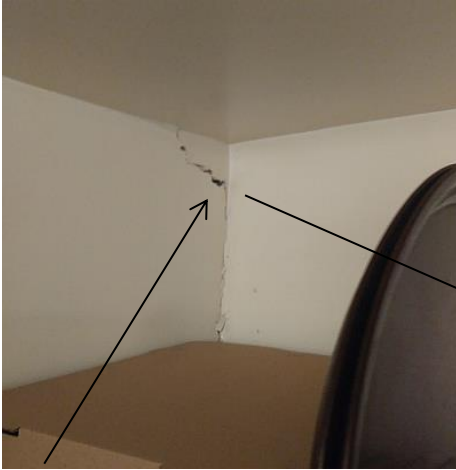
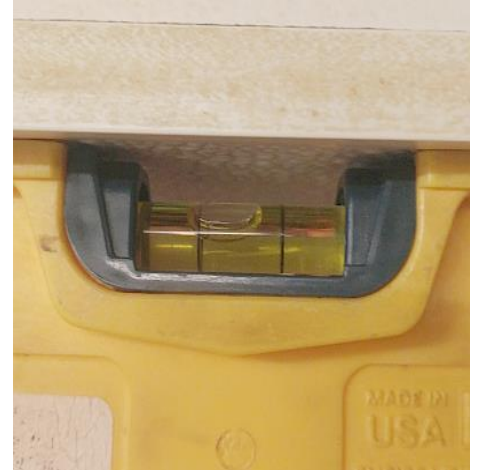
There is a large settling crack on the wall where indicated. The ceiling is not level. Recommend Evaluation/Repair by a licensed contractor.

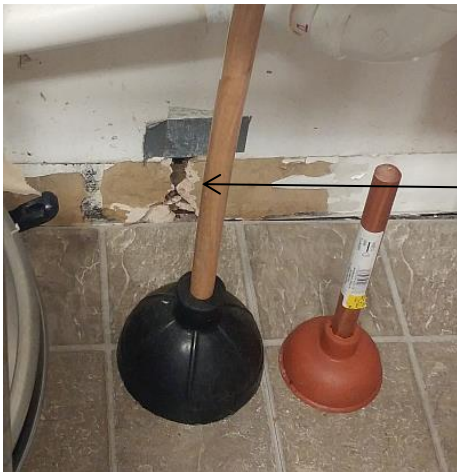
Drywall holed where indicated. Recommend Repair.

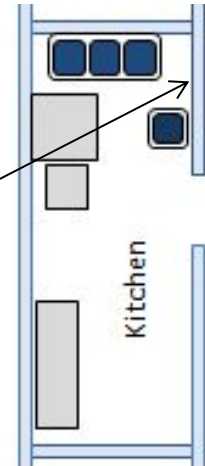
FLOOR **Condition:** Satisfactory Marginal Poor Sloping Squeaks

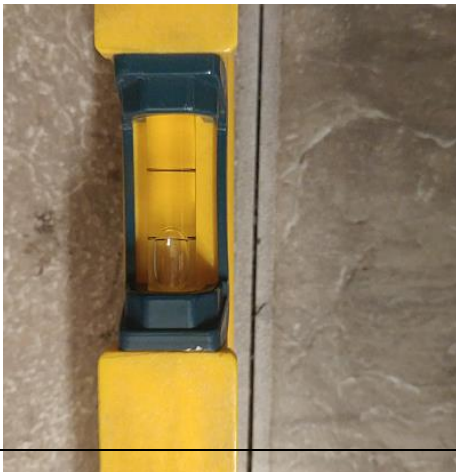
The floor is swayed/bowed in several areas. Recommend Repair.

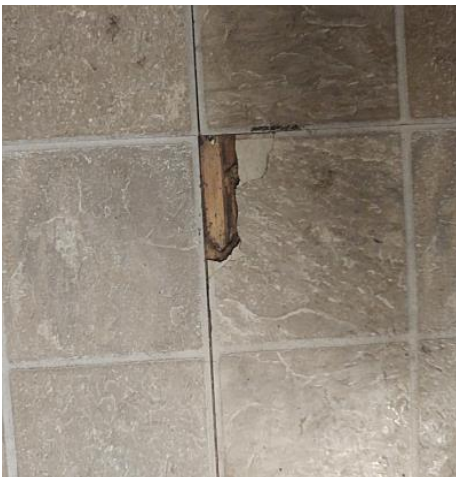
The floor cover is gapped/holed in several areas. Recommend Repair/ Replacement.

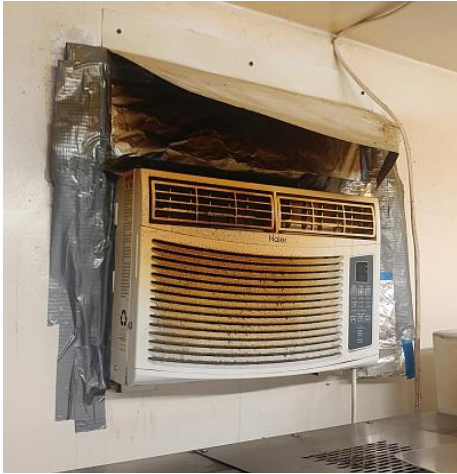
The window has been removed to accommodate a portable air conditioner. When viewed from the exterior there are large gaps between the unit and building structure. Recommend Repair.

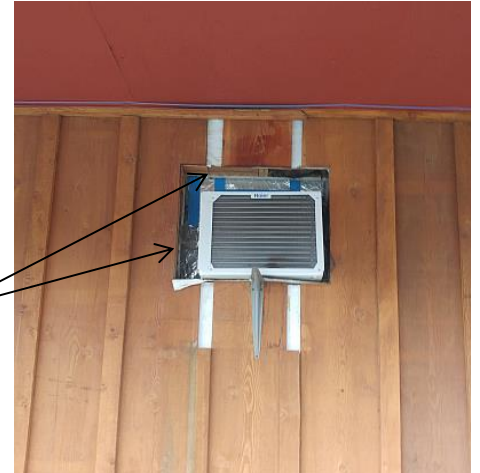
HEATING / COOLING SOURCE Yes No

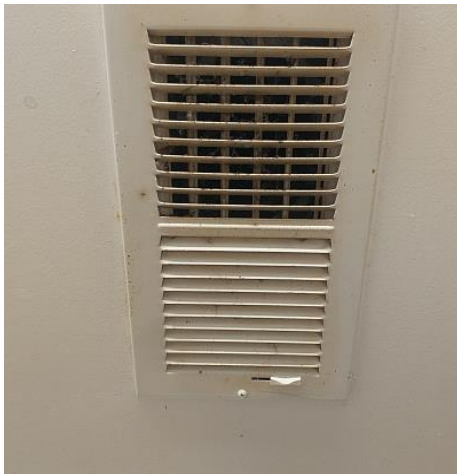
The ceiling register cover is dirty. Recommend Cleaning.

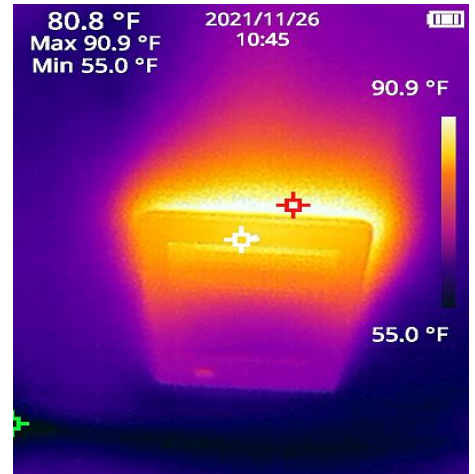
The window air conditioner was not plugged in at the time of the inspection.

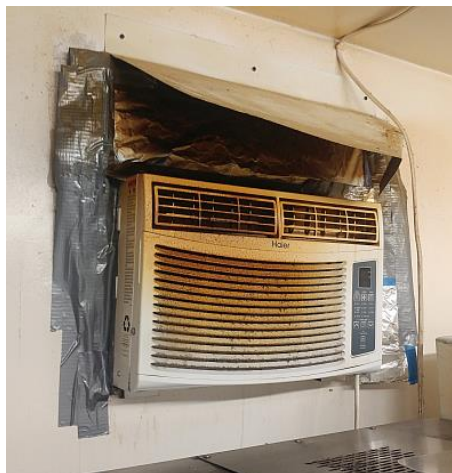
The inspector plugged the unit in. The unit does not appear to be operating/ Recommend Repair/ Replacement.

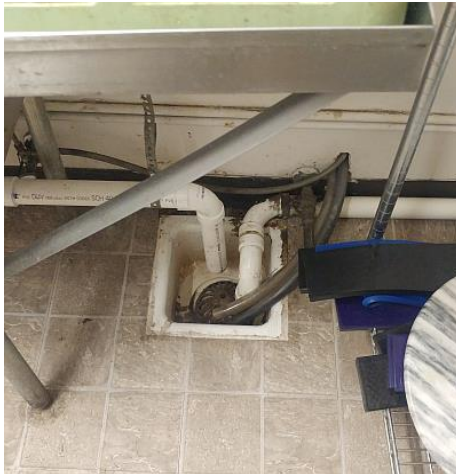
All sinks drain to a proper floor trap.

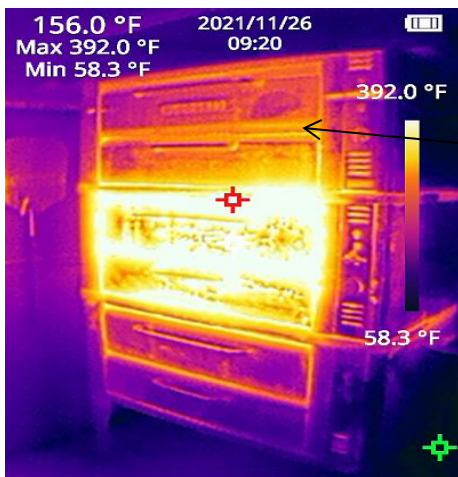
The upper pizza oven is not operating. Parts are missing. Recommend Repair.

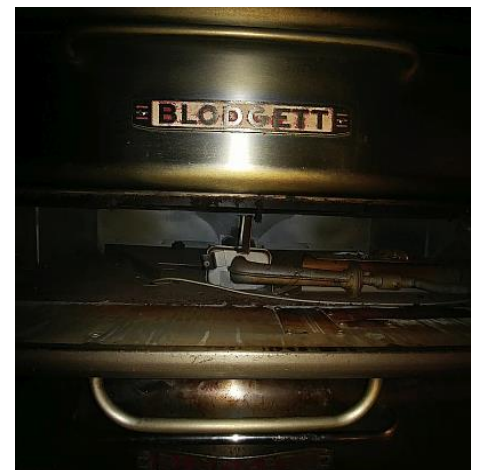
The lower two pizza ovens are operating.

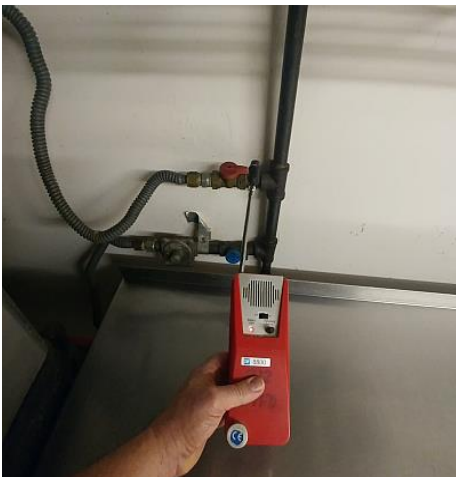
No gas or CO leaks detected.
Testers TIF 8800/DCO 1001.

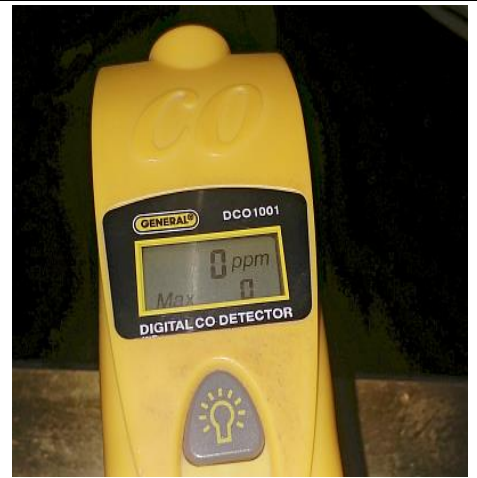
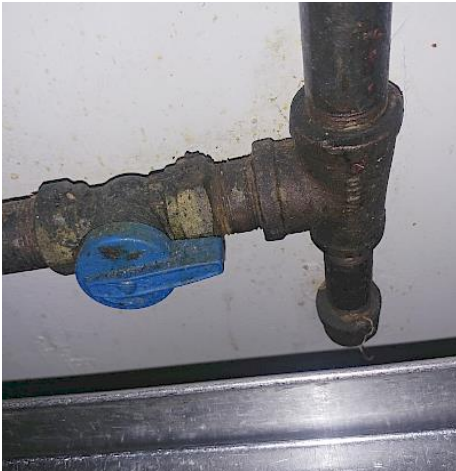
Proper sediment trap installed.
The sediment trap helps prevent contaminants from entering the appliance burner section.

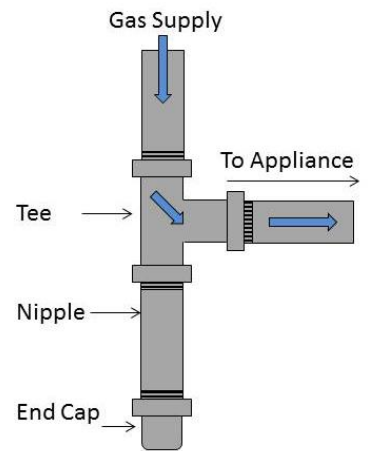
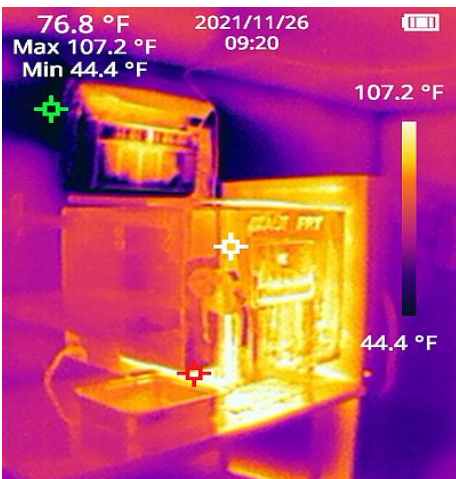
The electric oven is operating.

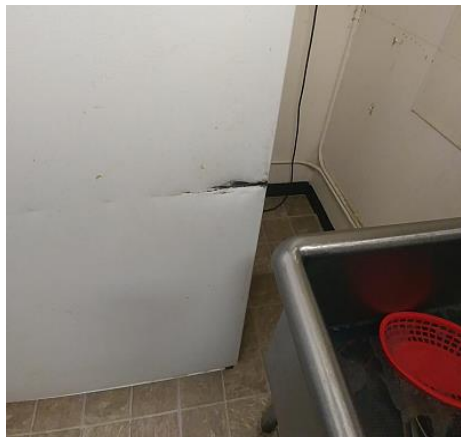
The door for the upright refrigerator is dinged. Recommend Repair.
Both refrigeration units are operating.

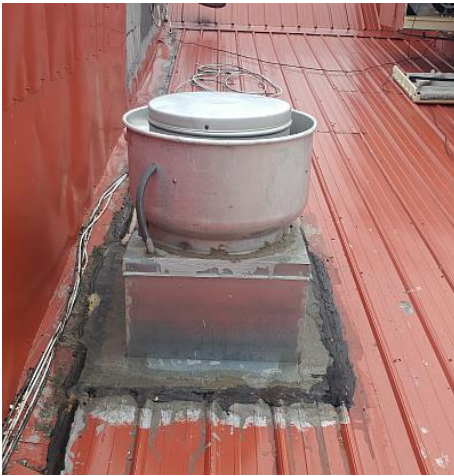
The roof mounted exhaust fan is operating.

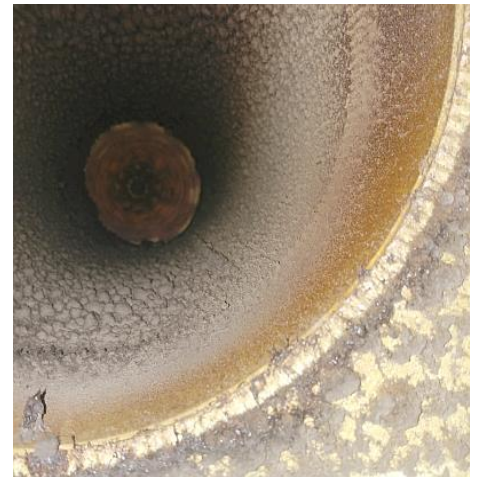
The flue is very dirty. Recommend Cleaning.

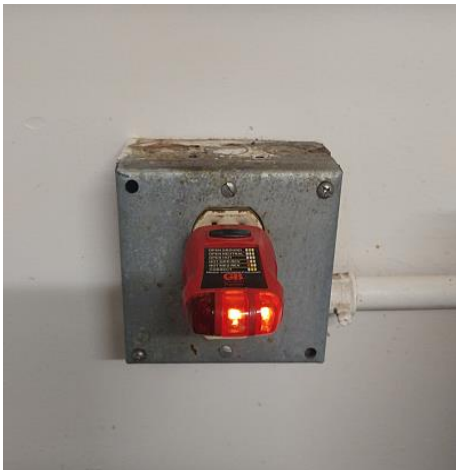
The kitchen outlets are not GFCI. Current standards call for all kitchen outlets (except for the refrigerator) to be GFCI. This is a potential Safety Hazard. Recommend Repair/ Replacement.

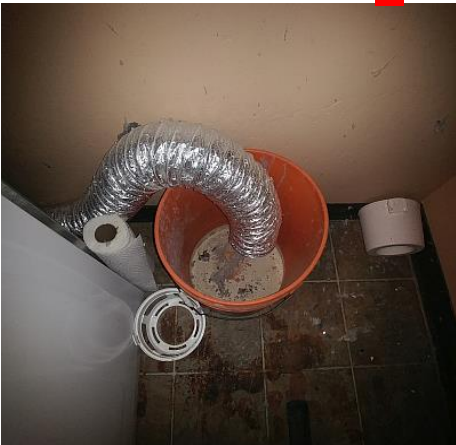
The dryer duct is not vented to the exterior. Venting warm/moist air into the building could promote mold/microbial growth and could possibly damage the structure. Dryer lint is very flammable. The improperly terminated duct is a potential Safety Hazard. Recommend Repair.

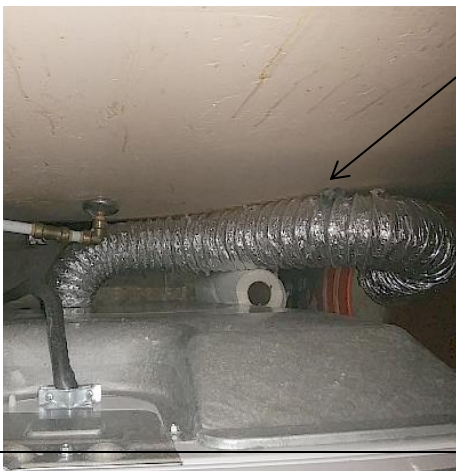
Wire bound vinyl or plastic ducting is being used to connect the dryer to the dryer duct. This ducting can melt and will not contain a fire within the dryer.

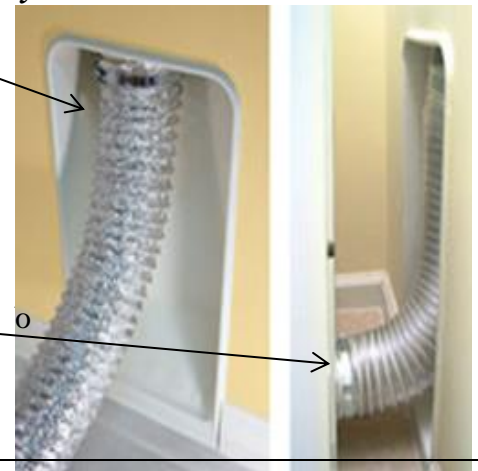
COUNTERTOPS Satisfactory Marginal Poor *Recommend repair/caulking*

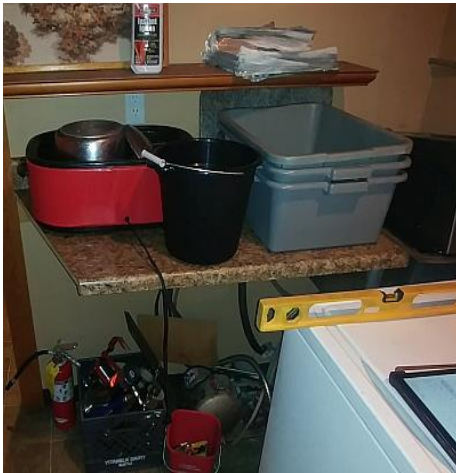
The formica countertop is slightly loose. Recommend Repair.

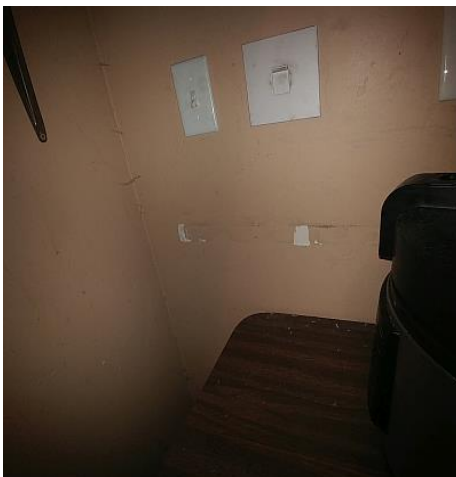
Minor dings observed on the walls. Recommend Repair.

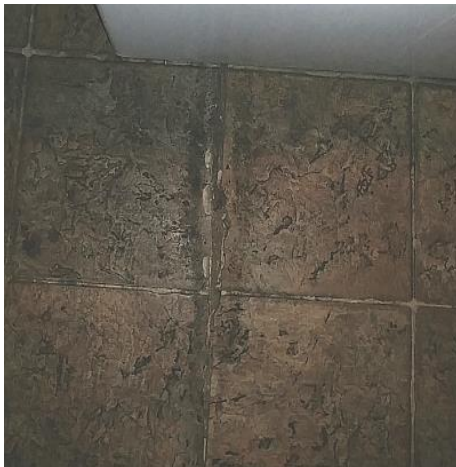
The floor cover is loose/gapped in areas. Recommend Repair.

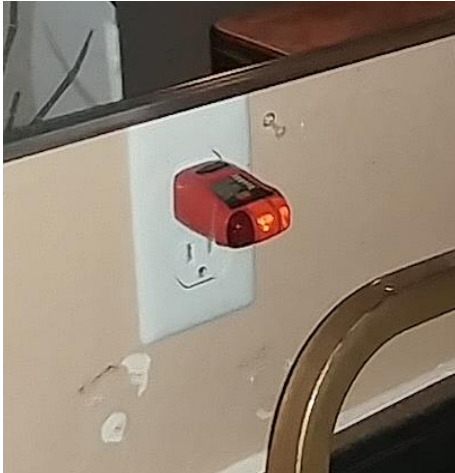
All outlets tested are Proper GFCI.

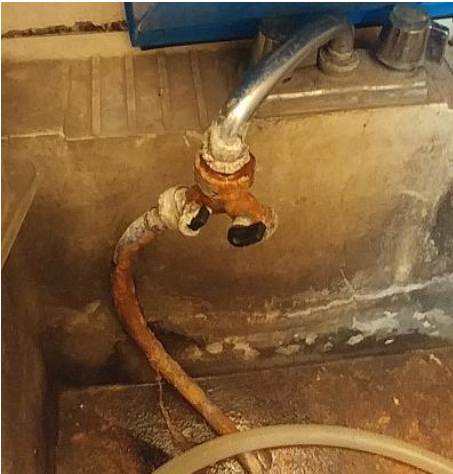
The utility sink faucet is leaking. The drain is leaking. Recommend Repair.

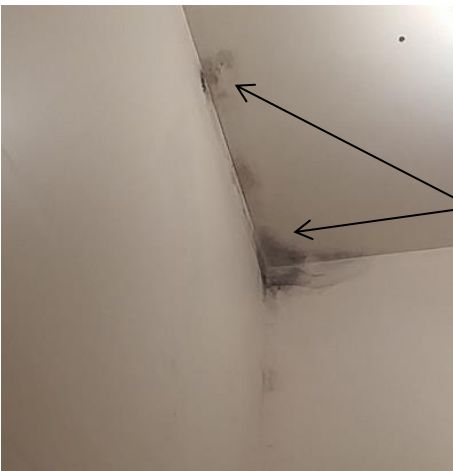
Indications of mold growth observed where indicated. The actual presence or absence of mold can only be verified by testing. Recommend Removal.

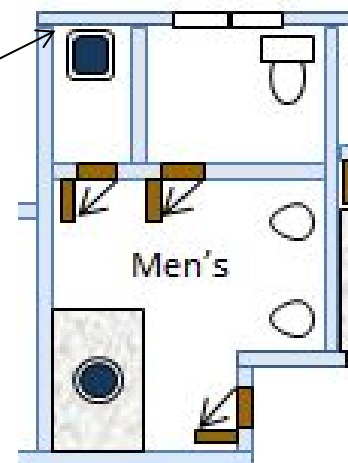
COUNTERTOPS Satisfactory Marginal Poor *Recommend repair/caulking*

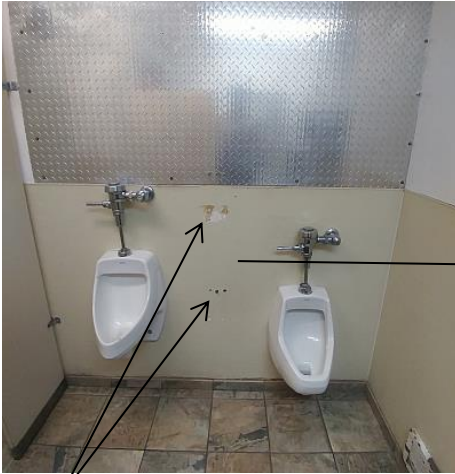
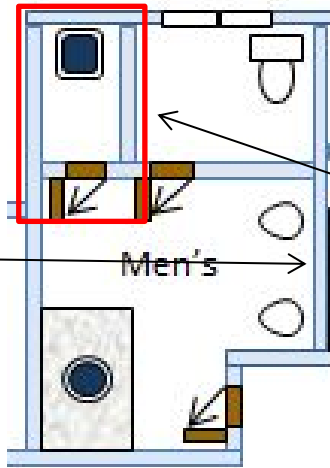
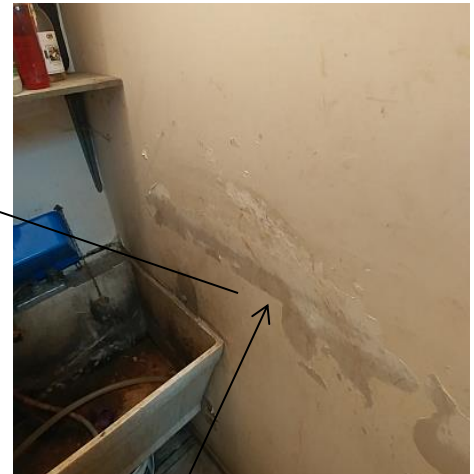
Dinged walls where indicated (appears to be from a removed divider). Recommend Repair.

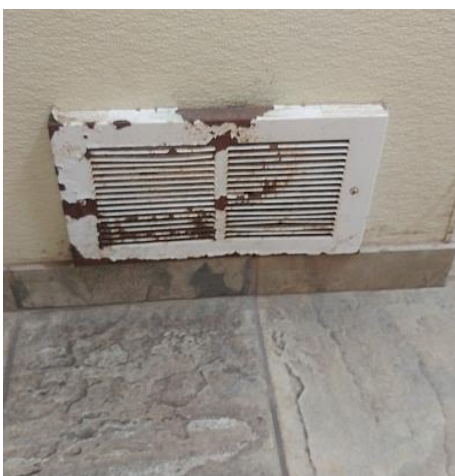
The in wall electric heater is not operating. The cover is rusted. There is no visible thermostat for the heater. Recommend Repair/Replacement.

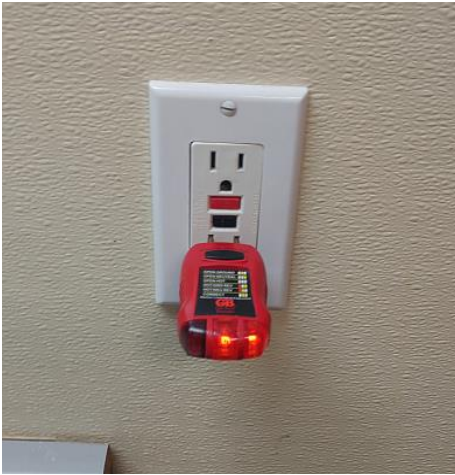
Proper GFCI outlet installed.

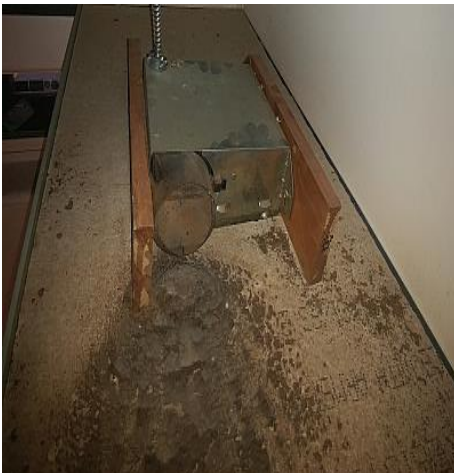
The exhaust fan vents into the ceiling. Bathroom exhaust fans should vent cleanly to the exterior. Venting warm moist air directly into the ceiling can promote mold/ microbial growth and possibly cause structural damage to the home. There is a lot of dust/possible mold at the exhaust port. Illustrated is one (but not the only) method of venting a bathroom exhaust fan cleanly to the exterior.

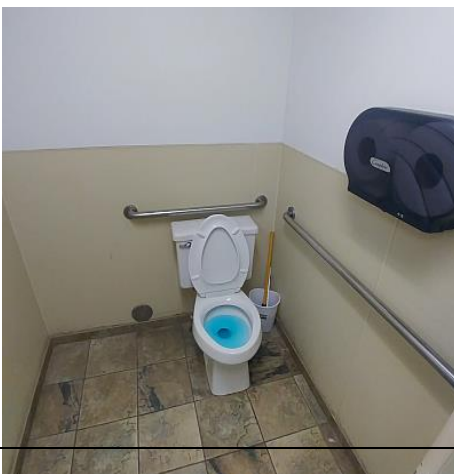
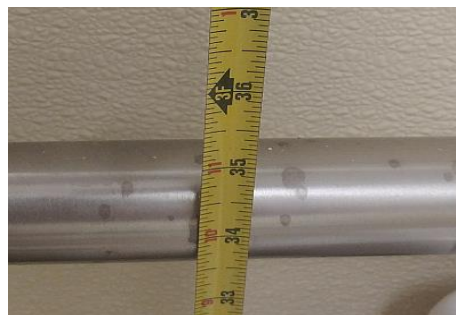
For ADA compliance, the railings are placed properly and are the proper height(34 to 38 inches).

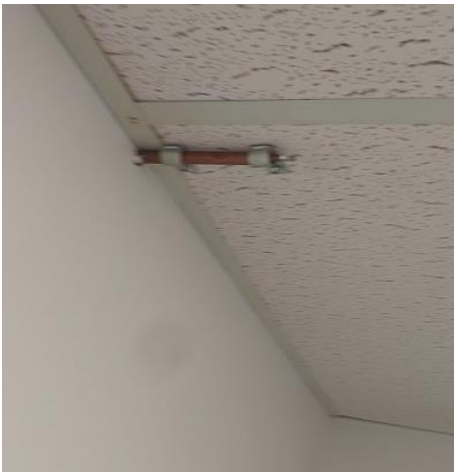
There is, what appears to be, a temperature sensor connected to an unmarked multi position switch in this bathroom. Purpose unknown.

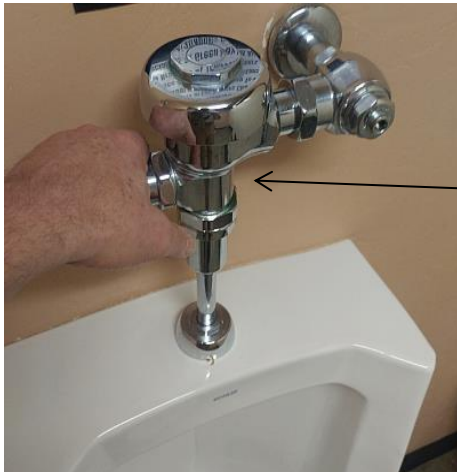
The handle assembly for the urinal indicated is loose. Recommend Repair/Adjustment.

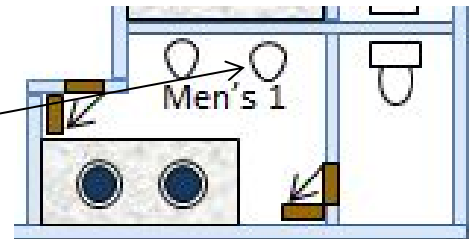
EVIDENCE OF MOLD/MICROBIAL GROWTH Yes No

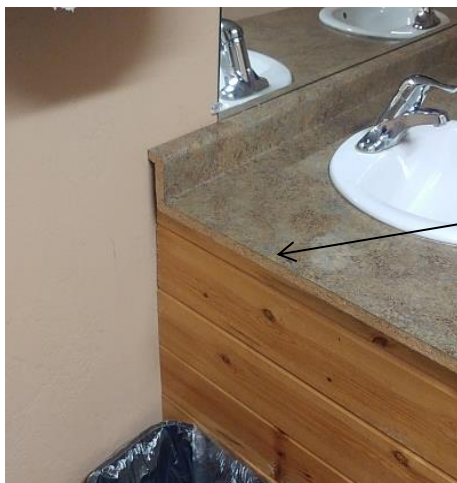
The end countertop trim is missing. Recommend Replacement.

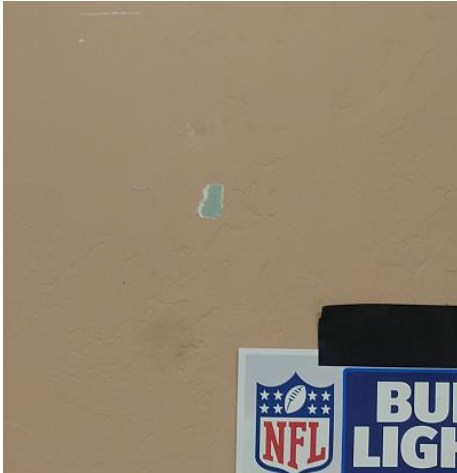
Minor dings observed on the walls. Recommend

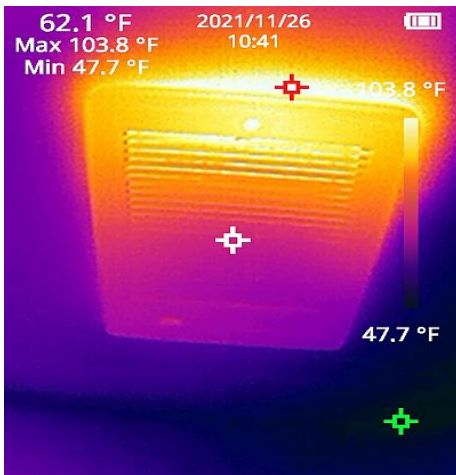
The in wall electric heater is operating. The heater is dirty. Recommend Cleaning.

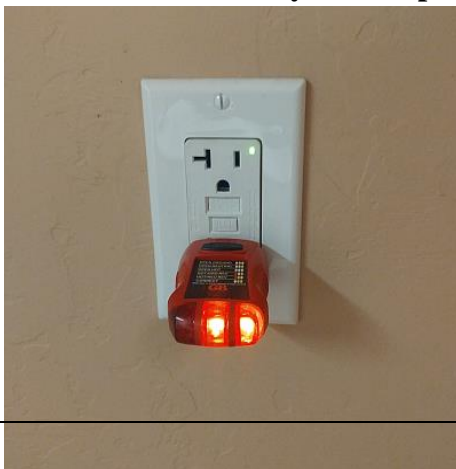
All outlets are proper GFCI.

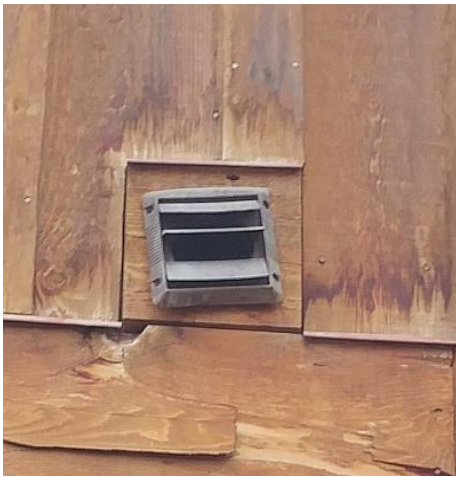
The exhaust fan shares a common duct with the Woman's 1 bathroom.. Bathroom exhaust ducts should always have dedicated (not shared) ductwork. Recommend Repair.

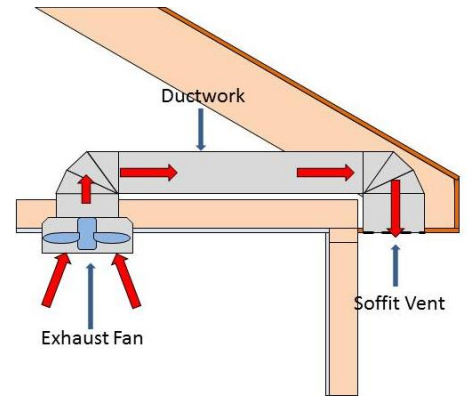
The termination backdraft damper is loose. Recommend Repair.

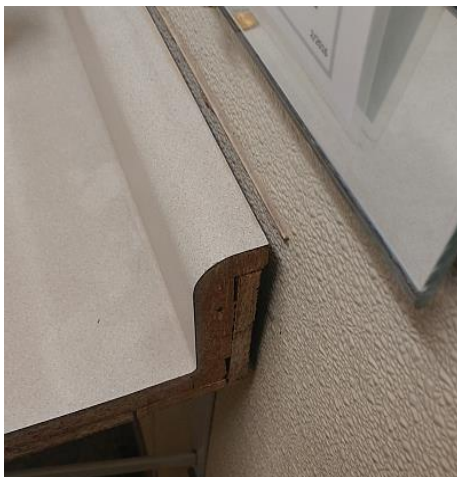
The countertop has pulled away from the wall. The end trim is missing. Recommend Repair/Replacement.

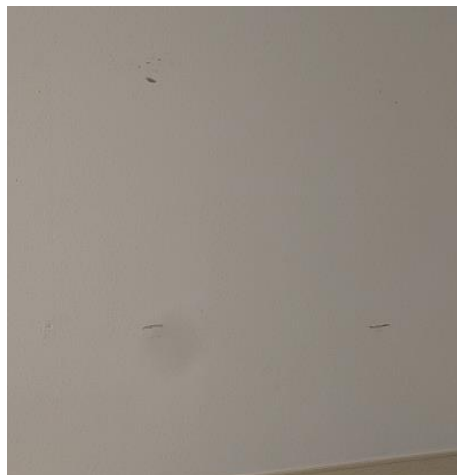
The walls are slightly dinged. Recommend Repair.

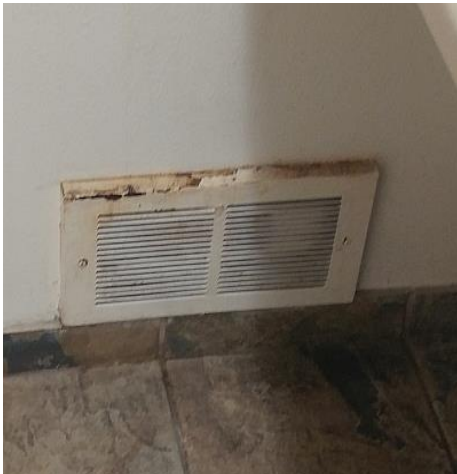
The in wall electric heater is not operating. The cover is rusted. There is no visible thermostat for the heater. Recommend Repair/Replacement.

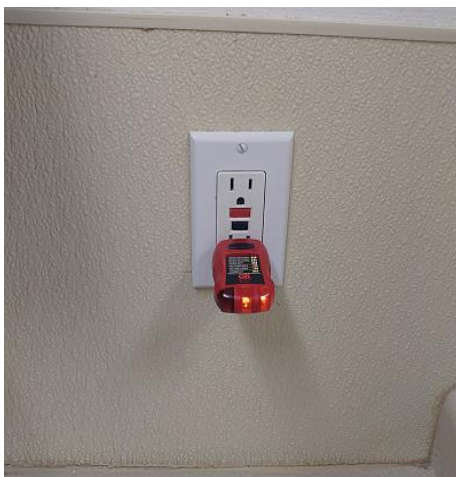
All outlets are proper GFCI.

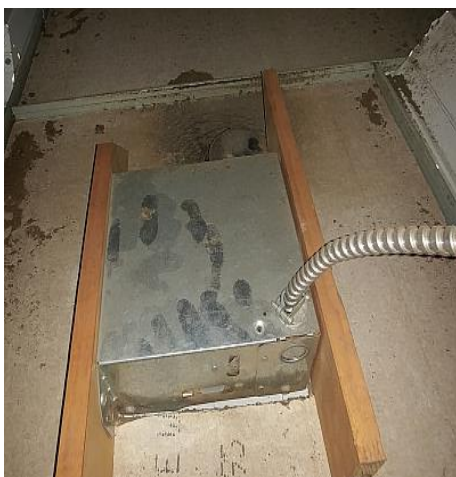
The exhaust fan vents into the ceiling. Bathroom exhaust fans should vent cleanly to the exterior. Venting warm moist air directly into the ceiling can promote mold/microbial growth and possibly cause structural damage to the home. There is a lot of dust/possible mold at the exhaust port. Illustrated is one (but not the only) method of venting a bathroom exhaust fan cleanly to the exterior. Recommend Repair.

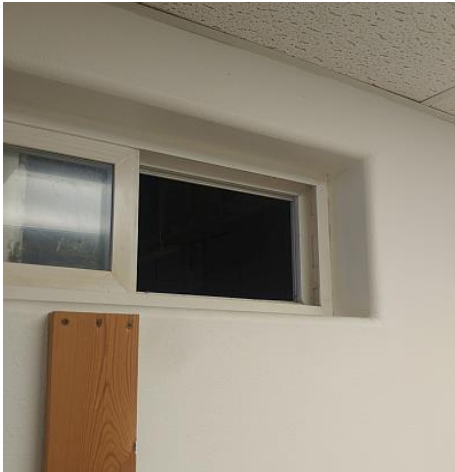
The screen is not installed. Recommend Replacement.

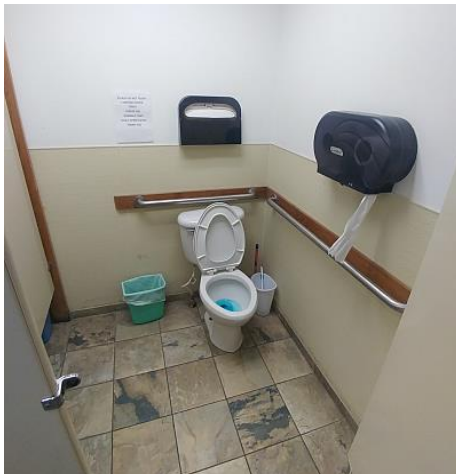
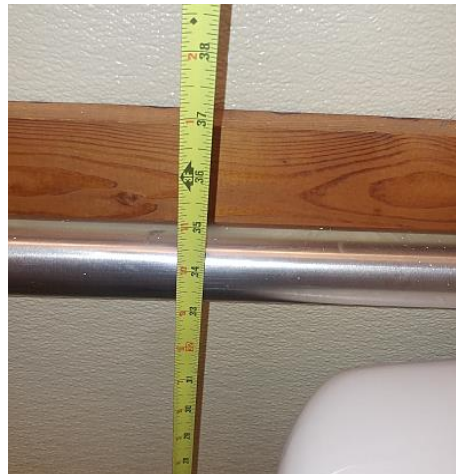
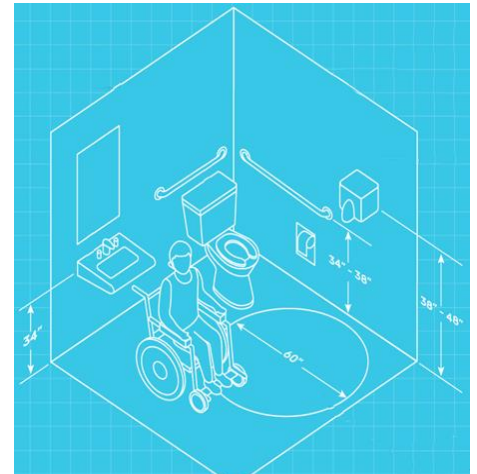
For ADA compliance, the railings are placed properly and are the proper height(34 to 38 inches).

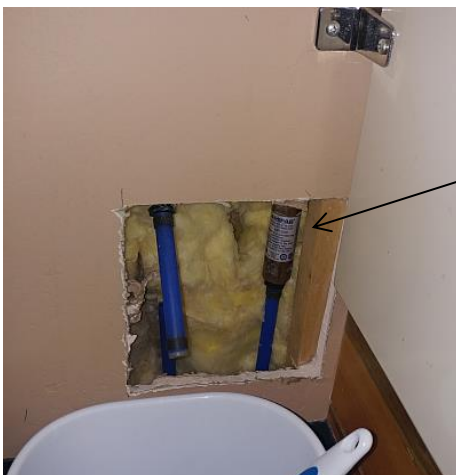
There is a hole cut in the wall where indicated (access for repair?). The wall is holed where indicated. Minor dings observed. Recommend Repair.

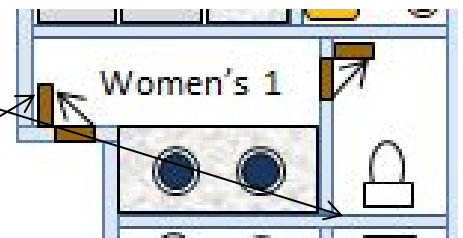
FLOOR **Condition:** Satisfactory Marginal Poor Sloping Squeaks
Material: Tile Linoleum Carpet Wood Composite Other

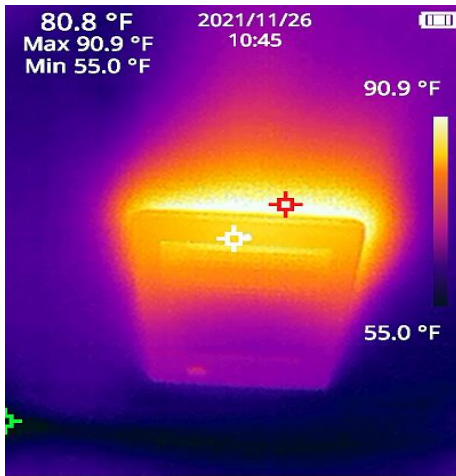
The in wall electric heater is operating. The heater is dirty. Recommend Cleaning.

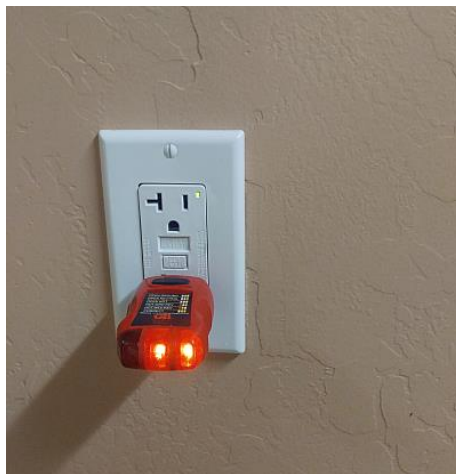
Proper GFCI installed.

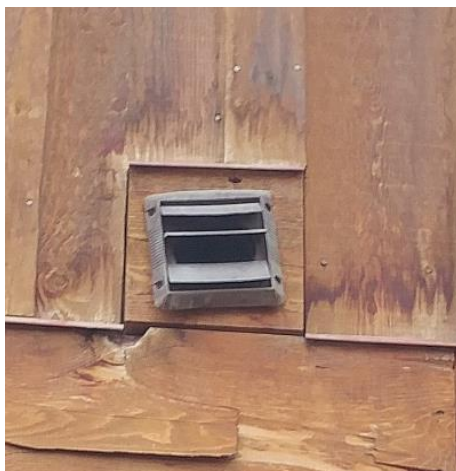
The exhaust fan shares a common duct with the Man's 1 bathroom.. Bathroom exhaust ducts should always have dedicated (not shared) ductwork. Recommend Repair.

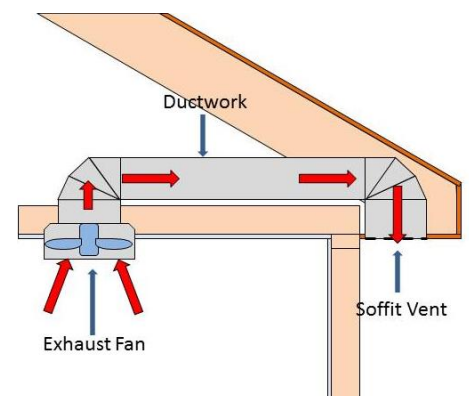
The termination backdraft damper is loose. Recommend Repair.

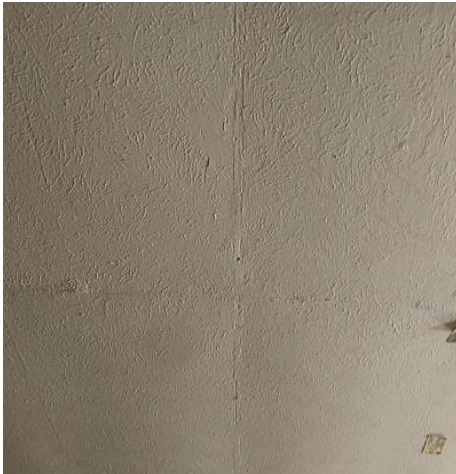
Visible/loose dry wall seams/holes observed on the ceiling. Recommend Repair.

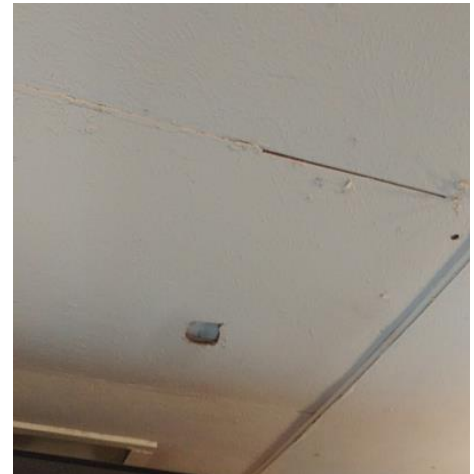
FLOOR Condition: Satisfactory Marginal Poor Sloping Squeaks

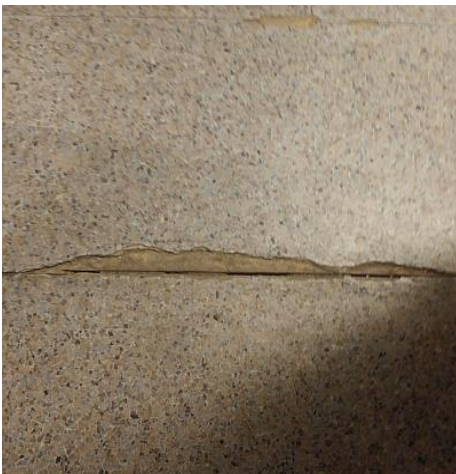
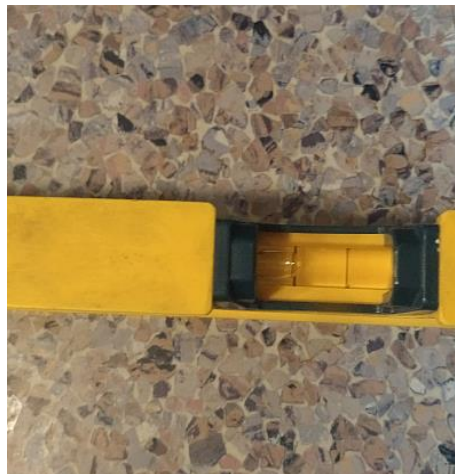
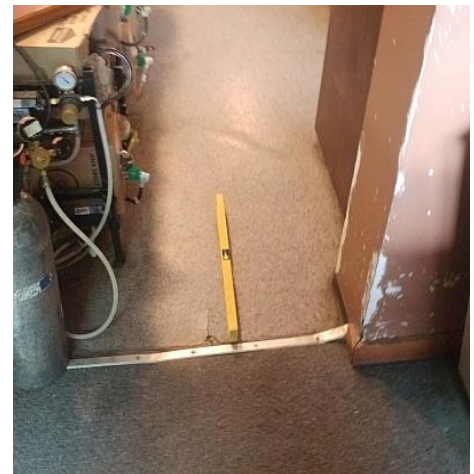
The floor cover is worn/missing in several areas. The floor is sloped in several areas. Recommend Repair.

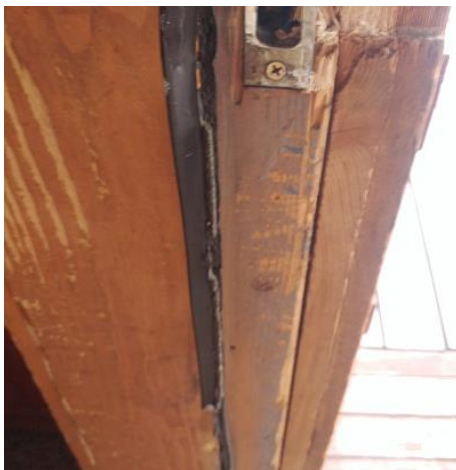
The weather stripping is torn/holed. Recommend Repair/Replacement.

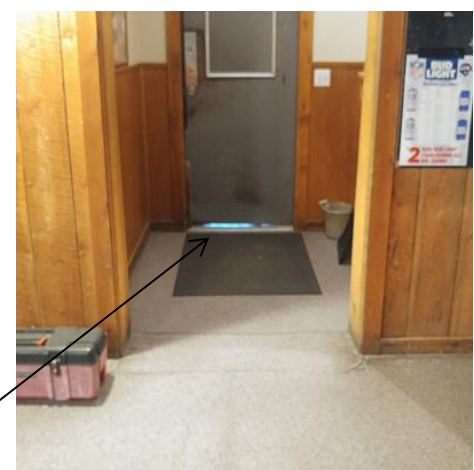
Threshold weather stripping is torn/holed. There is a visible gap at the threshold. Recommend Repair/Replacement.

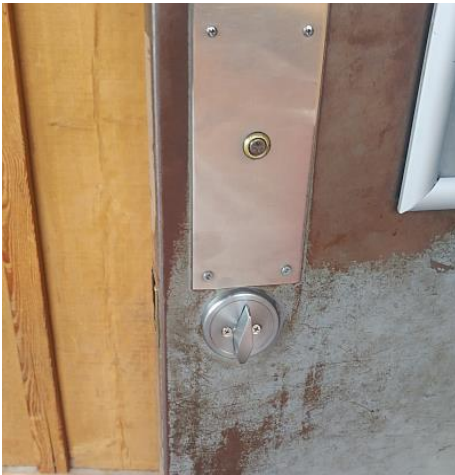
The door is weathered.
Recommend Repair

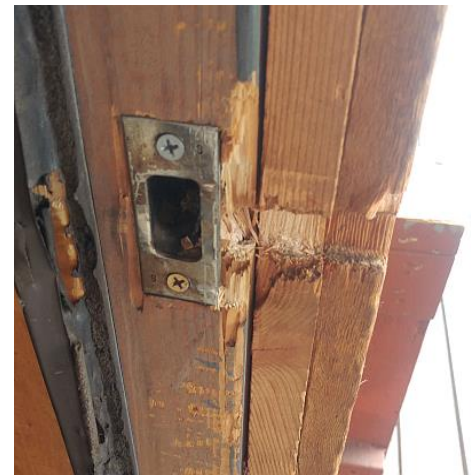
INTERIOR DOOR Yes No

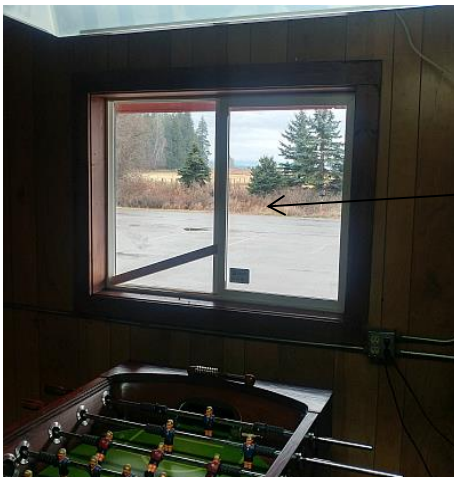
The screen is not installed in the window indicated. Recommend Replacement.

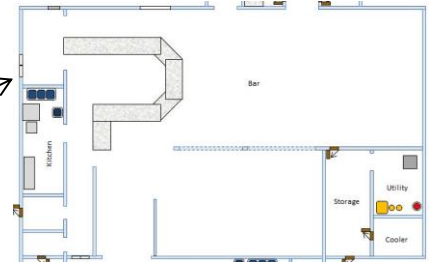
HEATING / COOLING SOURCE Yes No

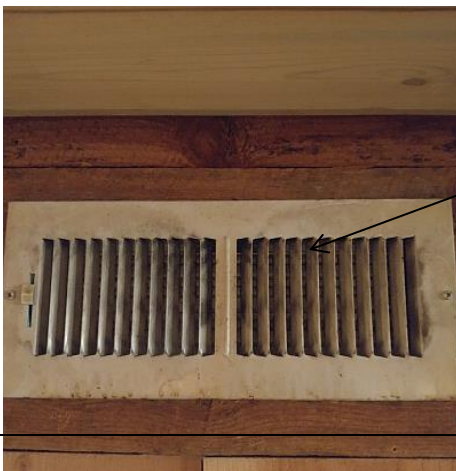
The wall registers where indicated are very dirty. Recommend Cleaning.

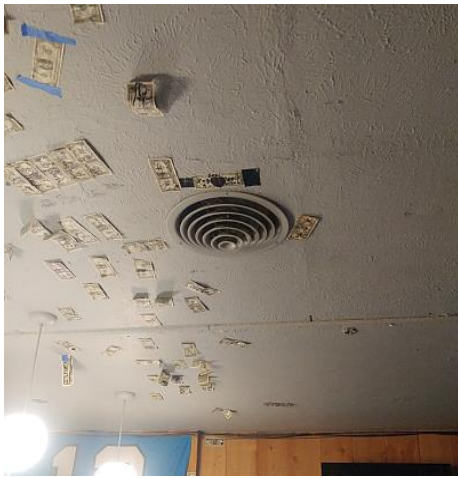
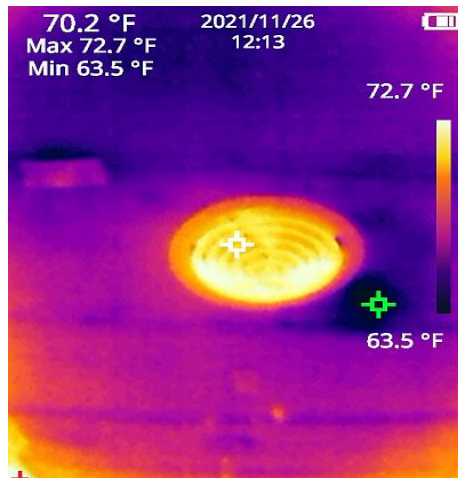
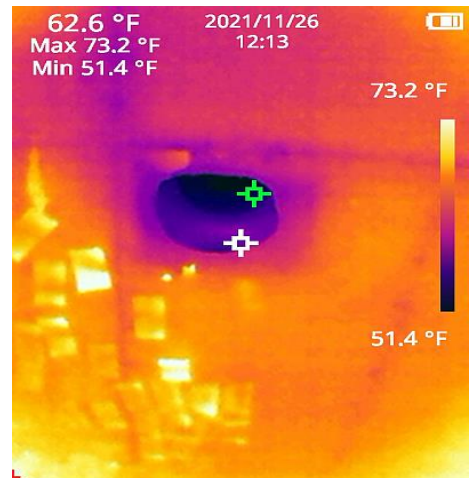
Only the ceiling registers with covers are heat/cooling sources. The other uncovered openings are likely for the inoperative evaporative cooler (see Cooling, Page 84).
