State of Montana Licensed Home Inspector
HI0163

Inspection Date: 12th of Never
Prepared For: Jane and John Doe

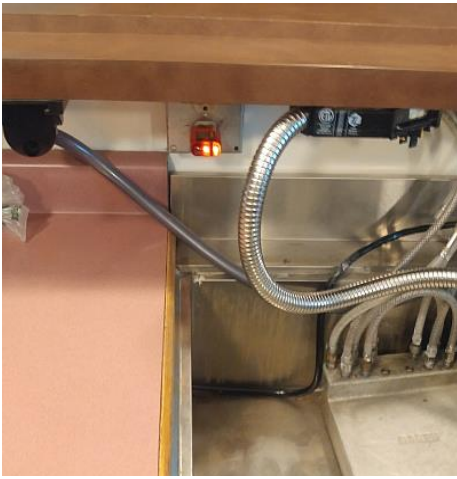
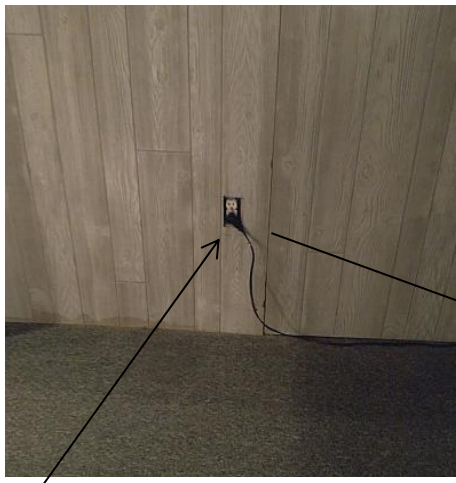
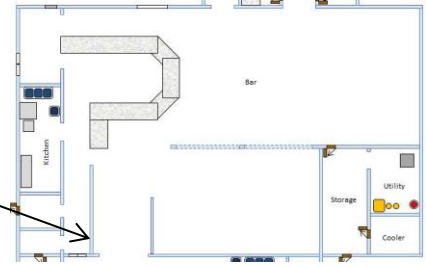
The bar outlets within 6 feet of water (sinks) are not GFCI. Current standards call for all kitchen outlets (except for the refrigerator) to be GFCI. This is a potential Safety Hazard. Recommend Repair/ Replacement.

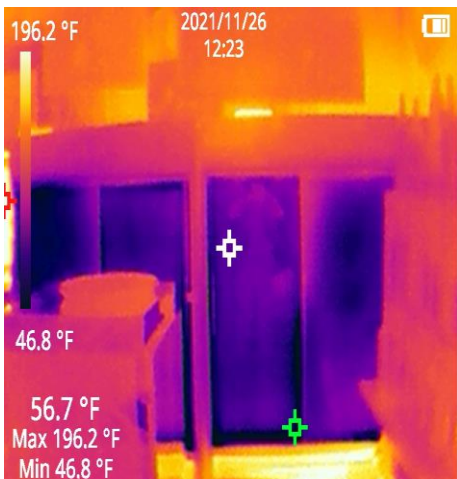
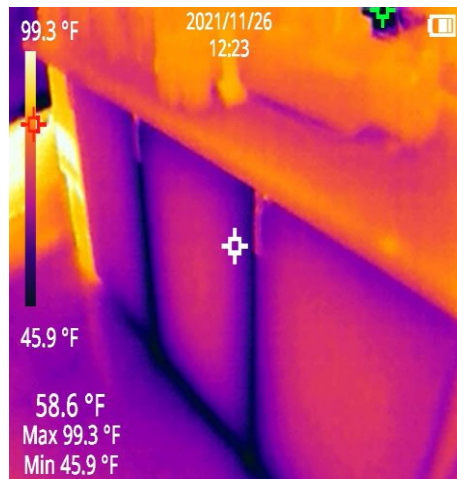
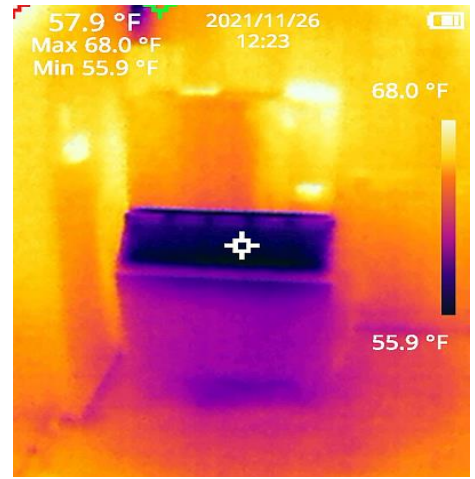
All of the cooling units are operating.

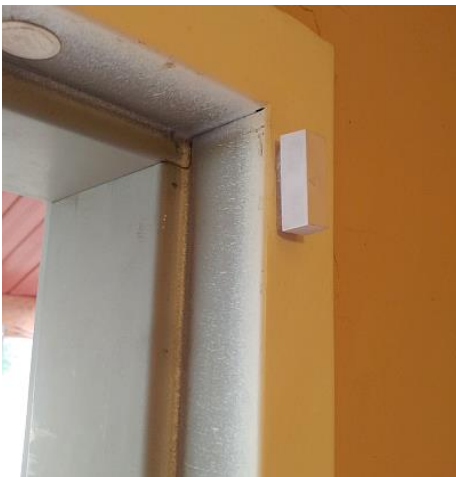
The weather stripping is missing.
Recommend Replacement.

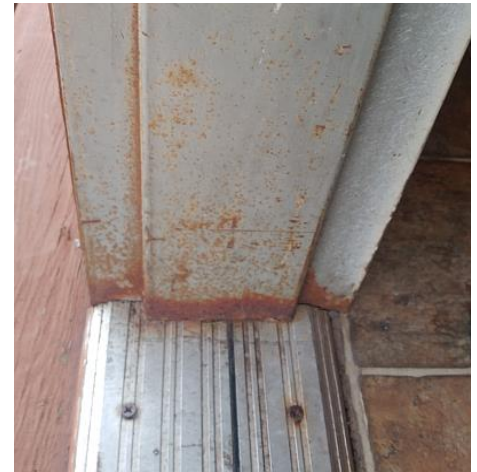
INTERIOR DOOR Yes No Satisfactory Marginal Poor
Locks/Latches Operable: Yes No Missing

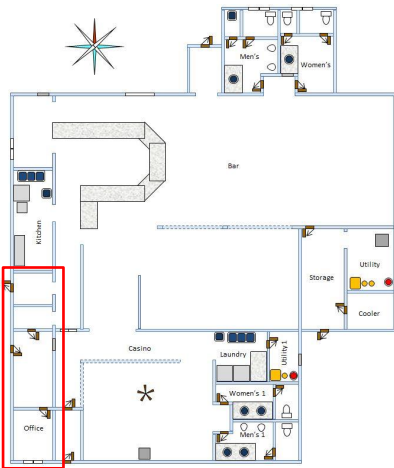
The highlighted area is the Office.

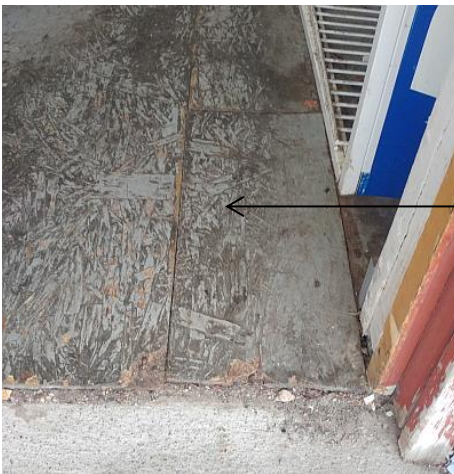
OSB has been installed on the floor where indicated.

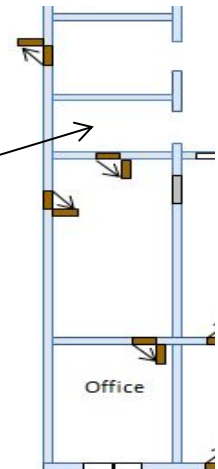
EXTERIOR DOOR None Condition: Satisfactory Marginal Poor

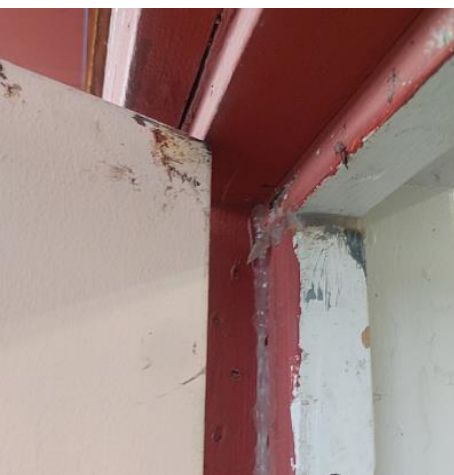
The weather stripping is missing. Recommend Replacement.

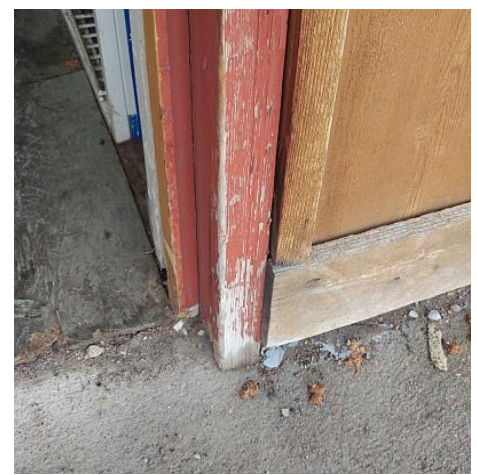
The exterior door frame is weathered. Recommend prepping and sealing (painting/staining). Recommend Repair

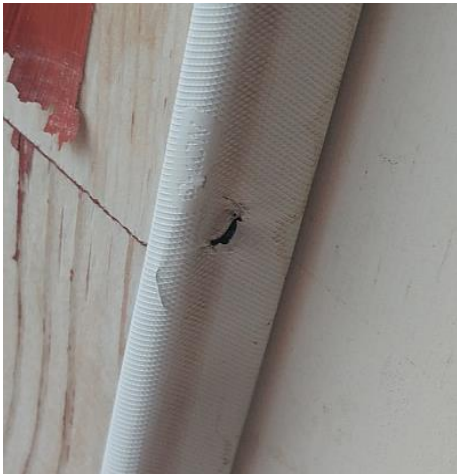
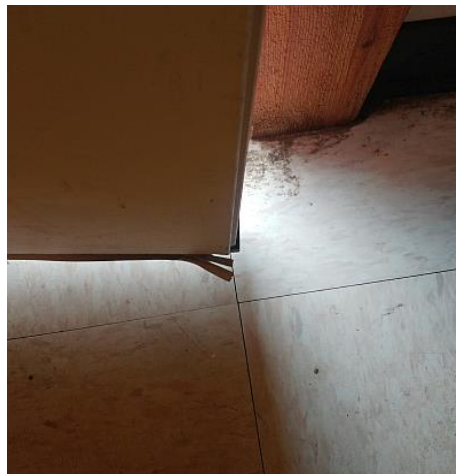
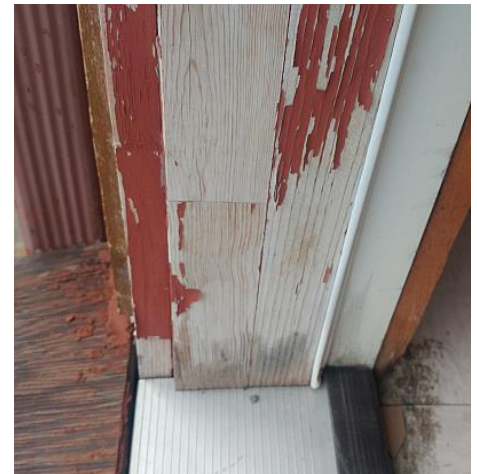
The weather stripping is torn/holed. Recommend Repair/ Replacement.

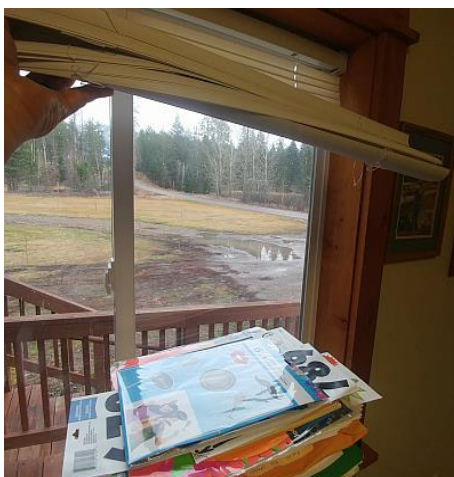
The window screen is not installed. Recommend Replacement.

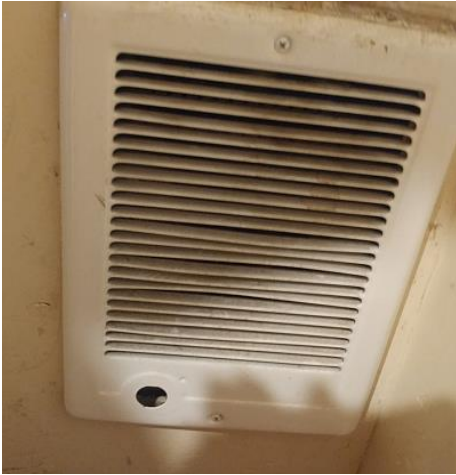
The control knob is missing. The inspector could not get the heater to operate. Recommend repair. The heater is dirty. Recommend Cleaning.

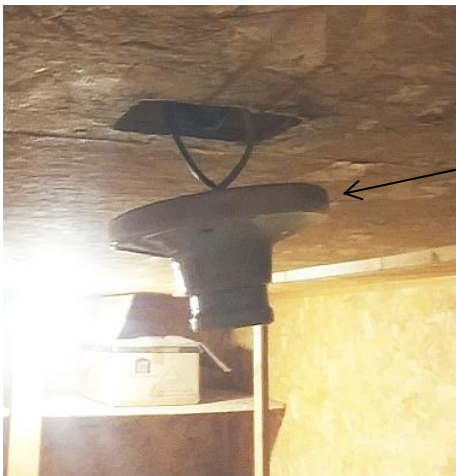
The ceiling light fixture where indicated is loose. Recommend Repair.

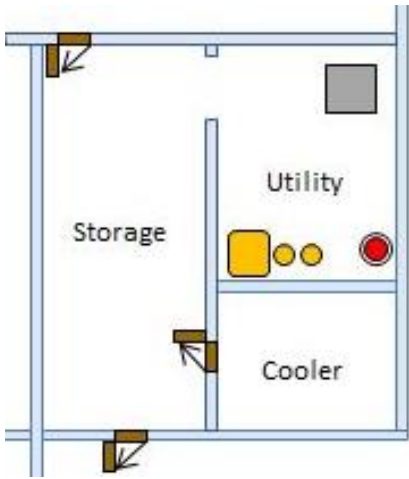
Storage/Utility/Cooler

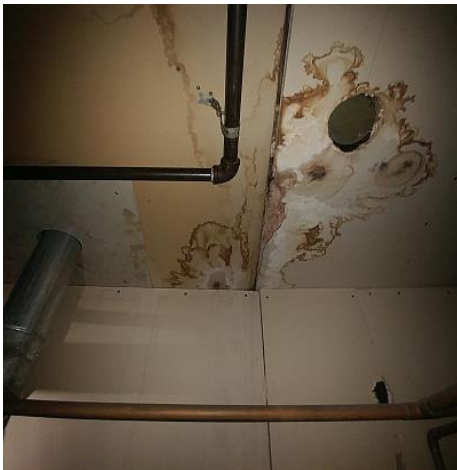
Heavy moisture staining observed on the ceiling of the utility room. Although testing with a moisture meter showed the area to be dry, the stains came from somewhere. Recommend Repair.

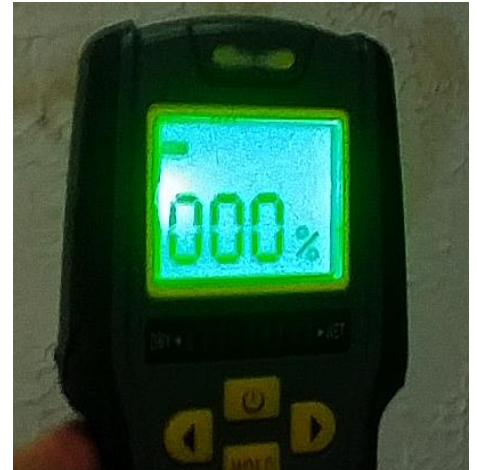
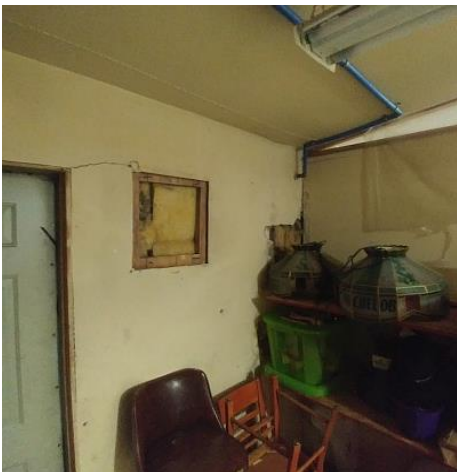
The walls are holed/cracked in multiple areas. Recommend Repair.

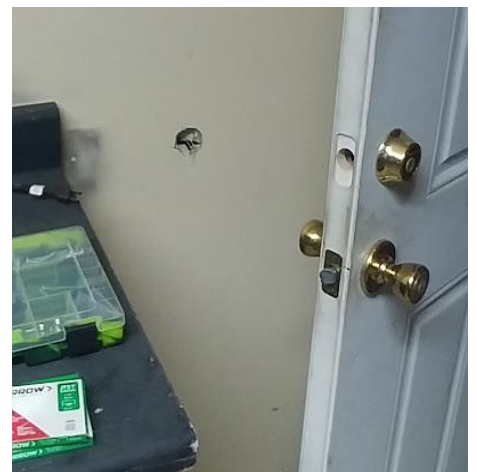
FLOOR Condition: Satisfactory Marginal Poor Sloping Squeaks
Material: Tile Linoleum Carpet Wood Composite Other Concrete

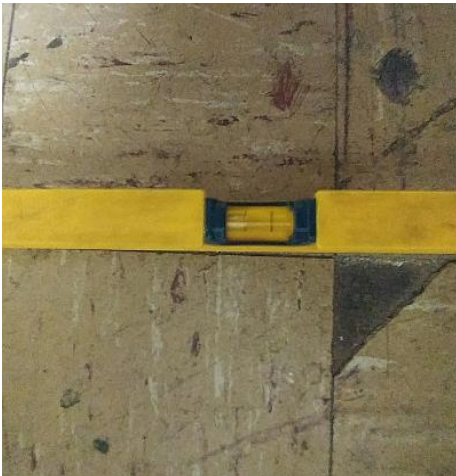
The floors are sloped. Large settling cracks observed. Recommend Repair.

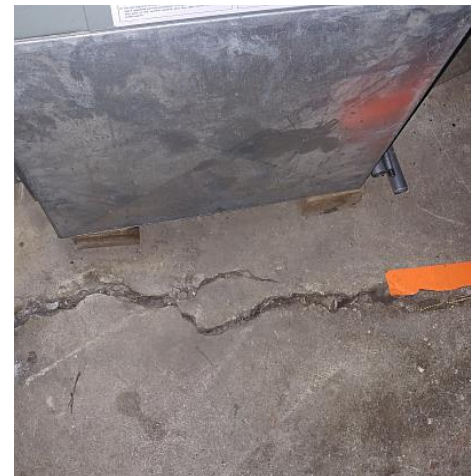
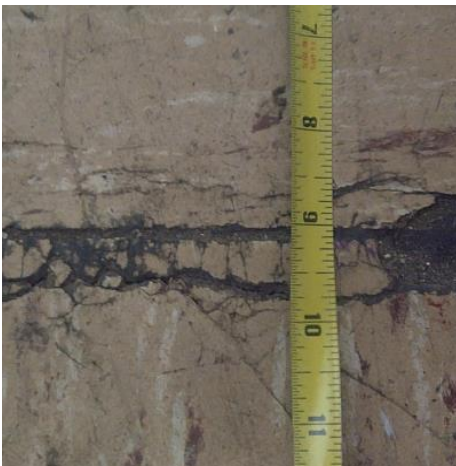
The floor tiles are chipped/damaged. Recommend Replacement. These tiles are 9 x 9 in size. Tiles of is this size manufactured before 1990 may contain asbestos.

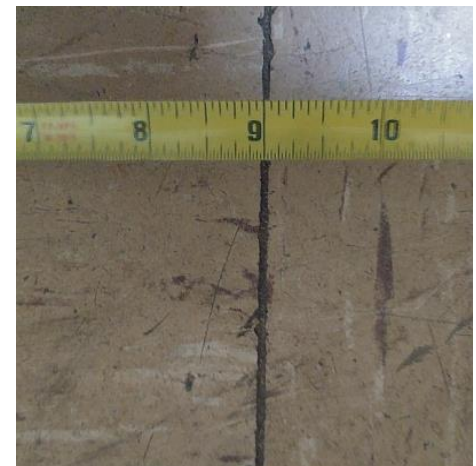
Inspector's Note: Asbestos in vinyl products becomes dangerous when fibers are released and become airborne. Normally, if the material is in good condition, it does not pose a threat. The

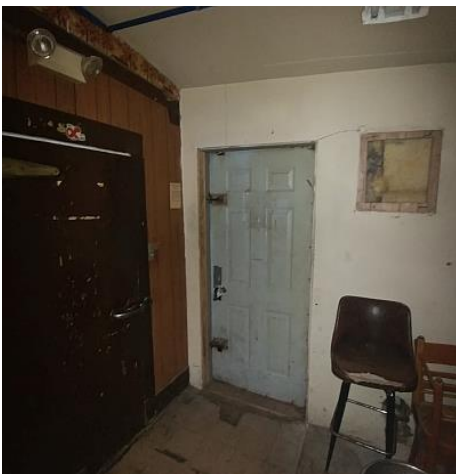
The door appears to be sealed shut and could not be operated.

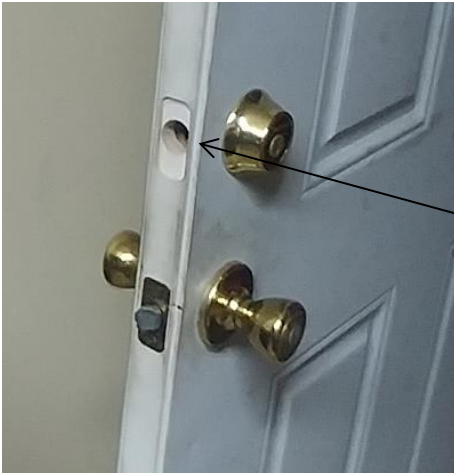
The dead bolt lock bolt is missing. Recommend Replacement.

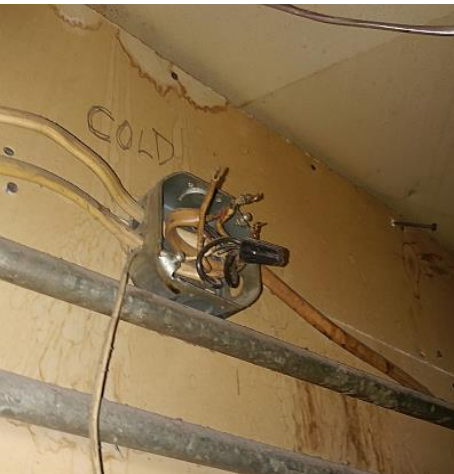
Open junction box/improperly spliced wiring observed in the utility room. This is a potential Safety Hazard. Recommend Repair.

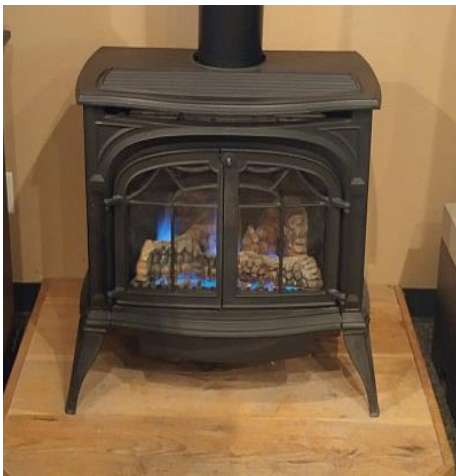
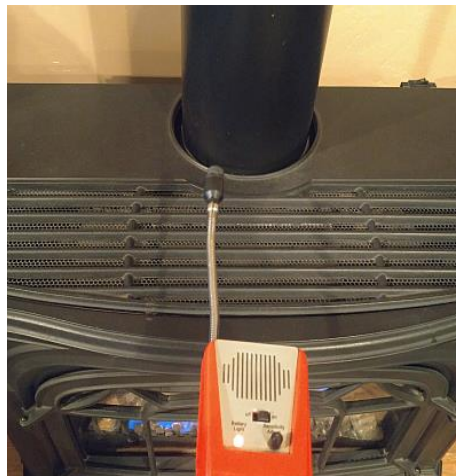
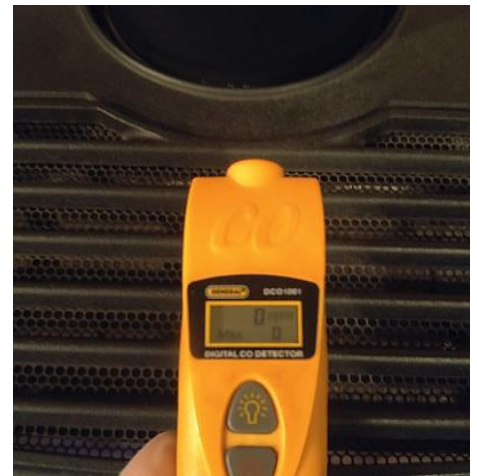
The fireplace is in Satisfactory Condition. No gas or CO leaks detected (testers TIF 8800/DCO 1001).

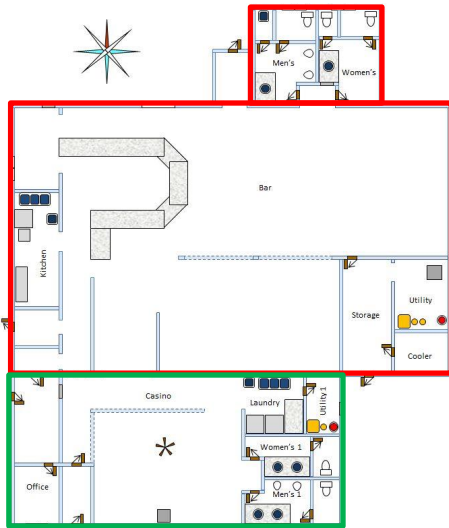
The building has been added on to. There are two separate attics.

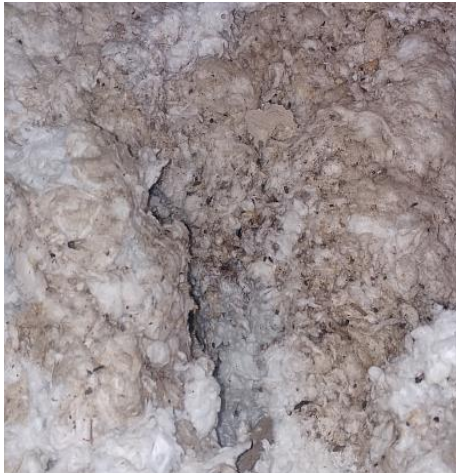
Eight inches of blown in insulation equates to an R (Resistance) value of 20. R 39 is recommended for attics in this region.

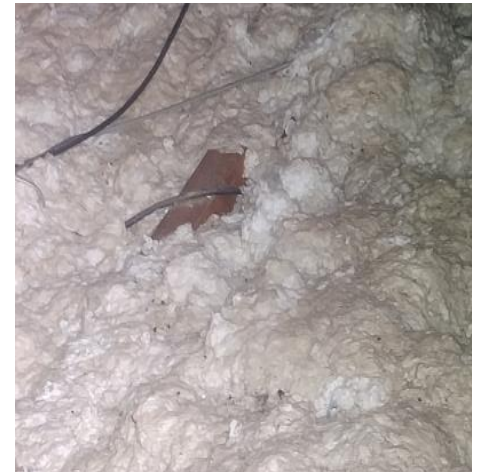
Ventilation: Ventilation appears adequate Recommend additional ventilation

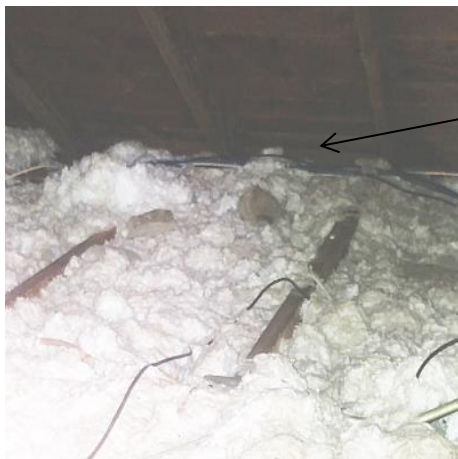
There are no baffles at the eaves. Baffles help keep insulation out of the soffits, allowing air from the soffit vents to freely enter the attic space. If soffit vents are ever installed baffles are recommend.

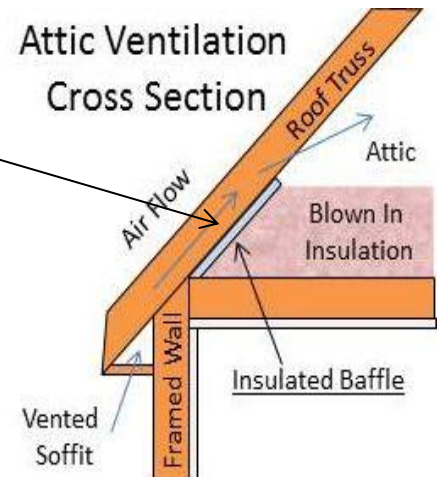
Fans Exhausted To: N/A Attic: Yes No Outside: Yes No Not visible

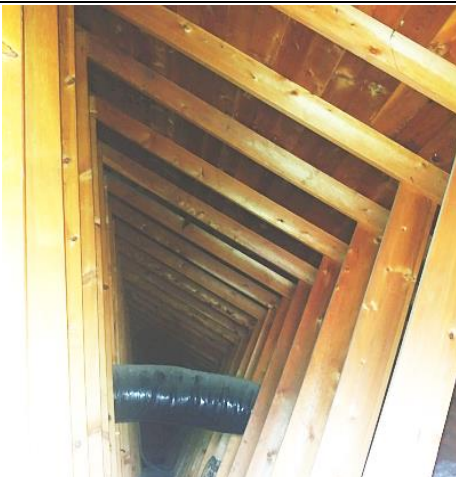
The attic structure is in Satisfactory Condition.

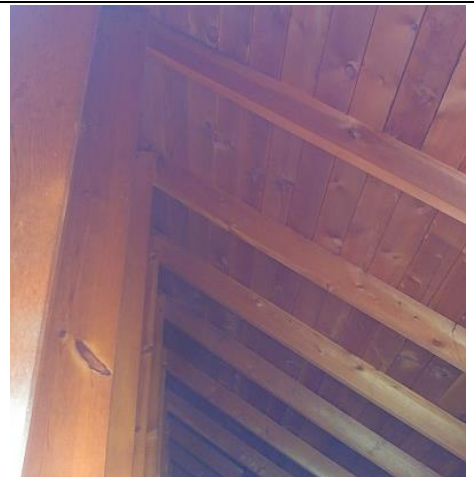
Indications of Mold / Microbial Growth: Yes No

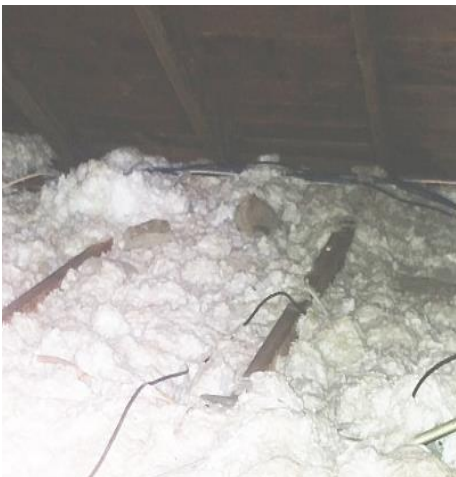
Improperly secured electric wires (every 4 1/2 feet, 1 foot from a service box) observed. Recommend Repair.

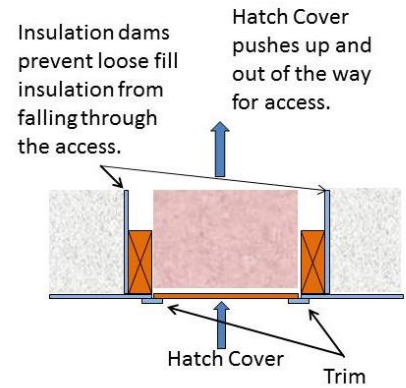
- Flooring:** Complete Partial None
- Insulation:** Type: Batts Loose Average inches: 13 Approx. R-rating: 32.5
- Damaged Displaced Missing Compressed
- Installed In:** Rafters Walls Between ceiling joists Not visible
- Recommend additional insulation**

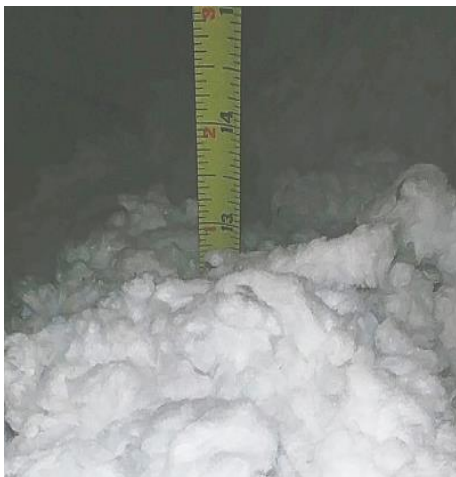
Thirteen inches of blown in insulation equates to an R (Resistance) value of 32.5. R 39 is recommended for attics in this region.

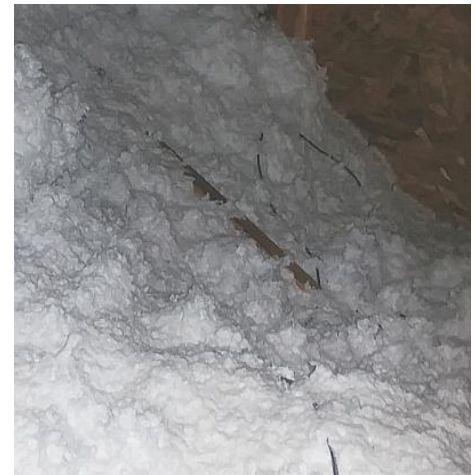
- Ventilation:** Ventilation appears adequate Recommend additional ventilation
- Recommend Baffles @ Eaves**

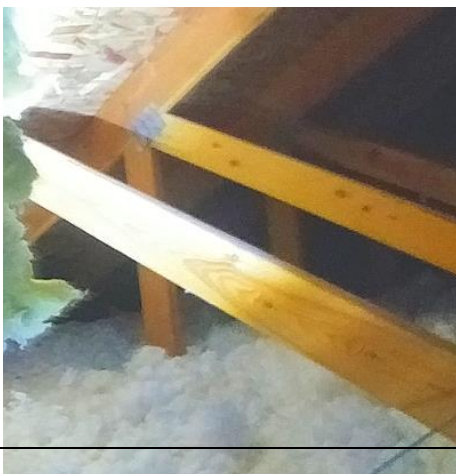
There are no baffles at the eaves. Baffles help keep insulation out of the soffits, allowing air from the soffit vents to freely enter the attic space. If soffit vents are ever installed baffles are recommend.

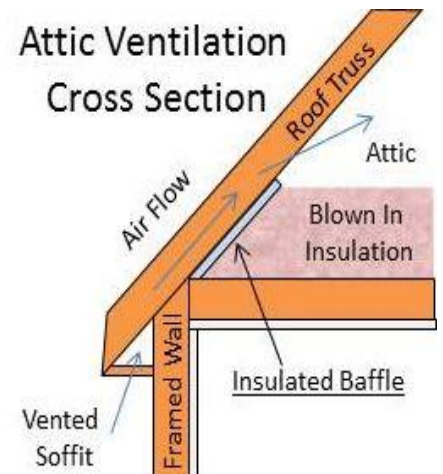
Fans Exhausted To: N/A Attic: Yes No Outside: Yes No Not visible
Chimney Chase: N/A Satisfactory Needs repair Not visible
Structural Problems Observed: Yes No Recommend repair
 Recommend Structural Engineer Evaluate

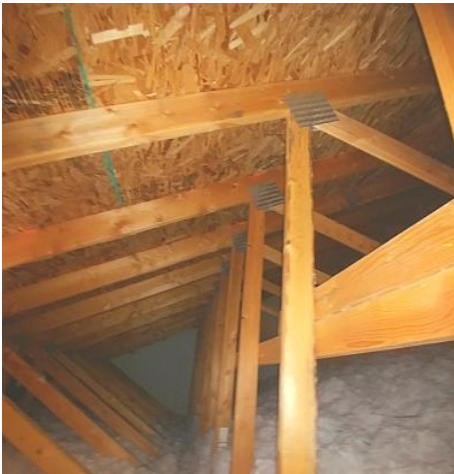
The attic structure is in Satisfactory Condition.

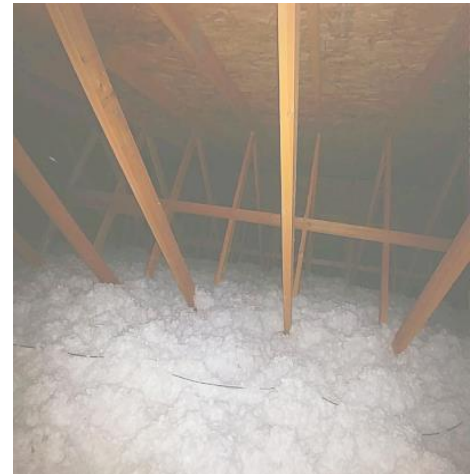
Indications of Mold / Microbial Growth: Yes No

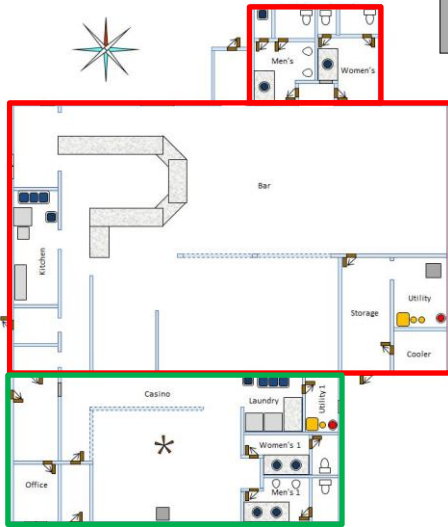
The building has been added on to. There are two separate crawl spaces.

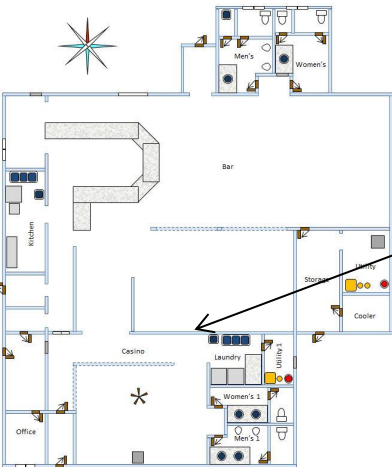
The access is in the crawl space where indicated. This crawl space can only be accessed by going through Crawl Space 2

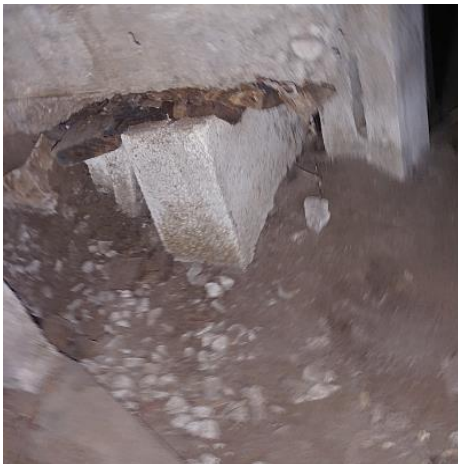
Where the access was cut through the foundation wall stacked concrete blocks are being used to support the wall. The blocks are dry stacked (no mortar) and are not setting on a visible footing. Footings help prevent settling and stability to a structure. Several of the blocks are not in the right orientation (see below) Recommend evaluation/repair by a licensed contractor.

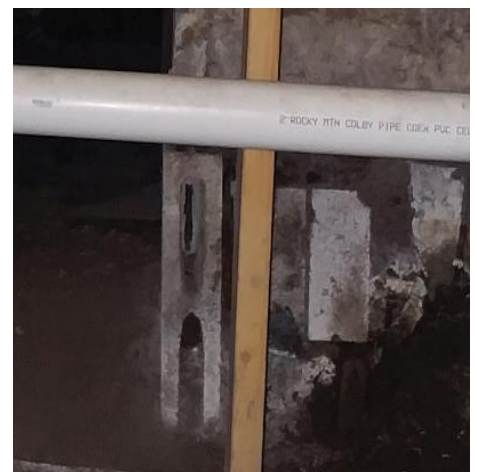
FLOOR **Material:** Concrete Dirt/Gravel Not visible Other
Condition: Satisfactory Marginal Poor Typical cracks

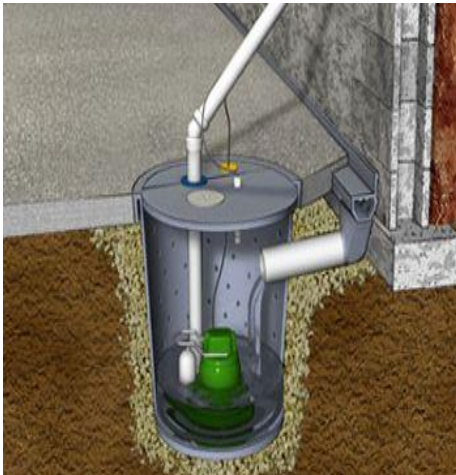
The inspector always recommends drainage of some type. If a sump pump is to be installed a sealed crock unit (illustrated) is recommended.

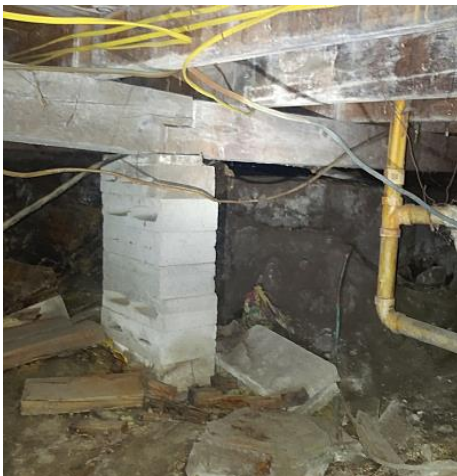
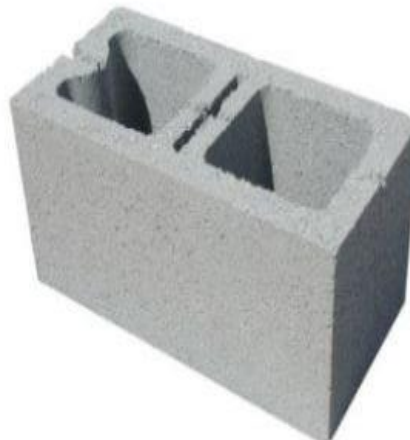
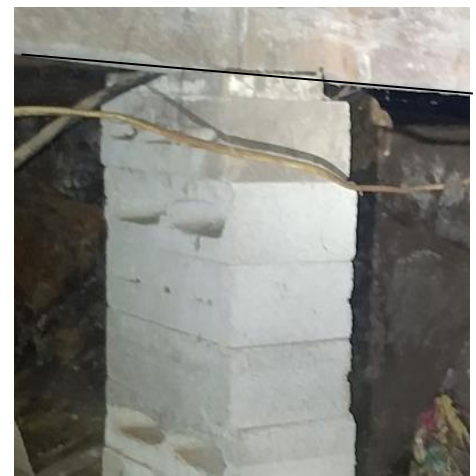
The cinder blocks in the pier are not in the right orientation. Cinder blocks should be stacked as illustrated. This provides maximum structural support and helps reduce the probability of structural failure.

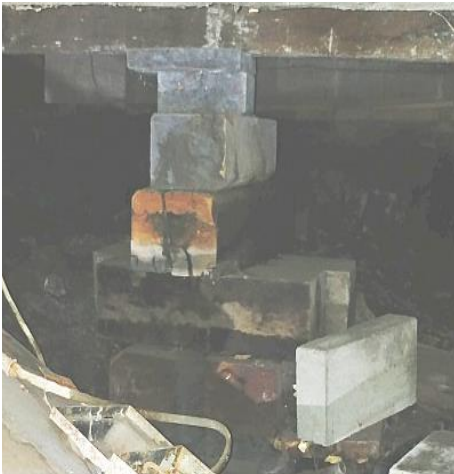
There is no indication of positive attachment between the beam and stacked wood piers. Piers are typically one piece or properly sized wood positively attached to the beam by a gusset plate (illustrated) or some other approved means. Recommend Repair.

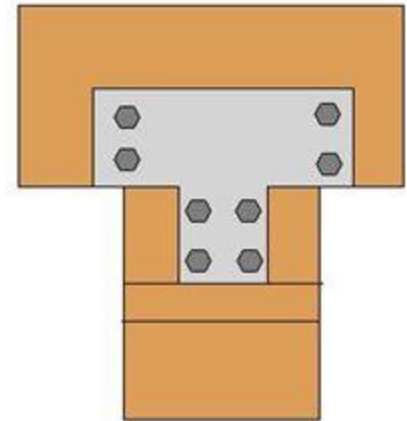
Wood to earth/concrete contact. Untreated wood should never be allowed to be in contact with earth/concrete (can cause deterioration). No indication of

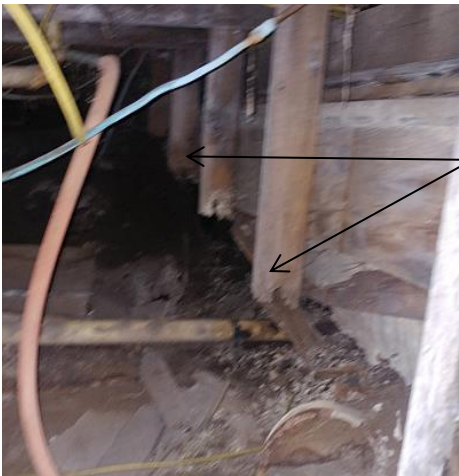
Deterioration observed on the piers running along the foundation wall where indicated. This is a Major Concern. Recommend evaluation/repair by a licensed contractor.

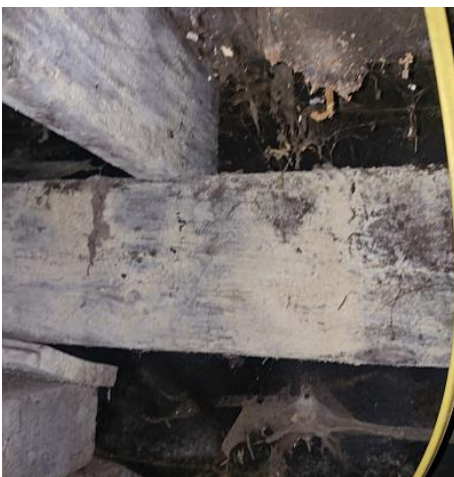
The joists properly overlap the beam. Possible mold growth (the white coloration) observed on the joists and beam. The actual presence or absence of mold can only be verified by testing. Recommend Removal.

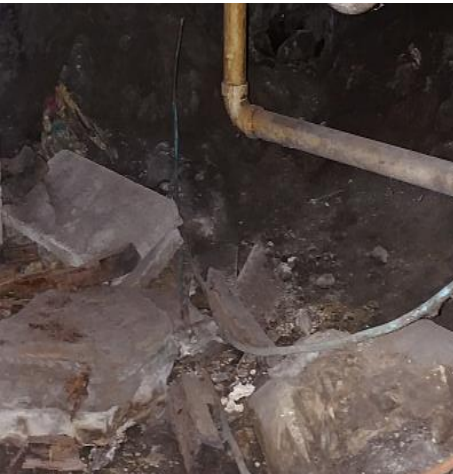
There is no vapor barrier installed. A crawl space vapor barrier helps prevents moisture in the dirt floor of the crawl space from evaporating and then seeping into the air in the crawl space, where it can then enter the structure of the home. A vapor barrier helps prevents problems caused by excess moisture like mold, odors, insects, wood rot and other structural and environmental concerns.

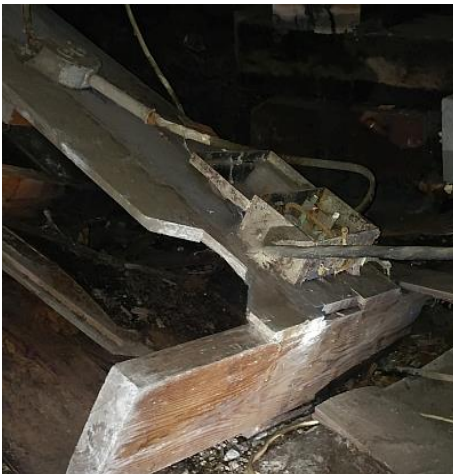
Open fuse box observed (voltage detected). This is a potential Safety Hazard. Recommend Repair.

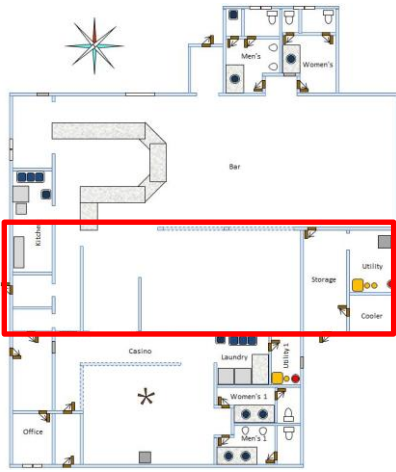
Only the portion of the Crawl Space 1 highlighted was accessible. Access to the remainder of the crawl space is too small for the inspector to fit

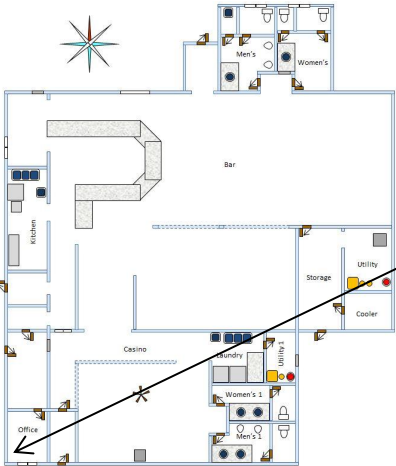
The access is where indicated.

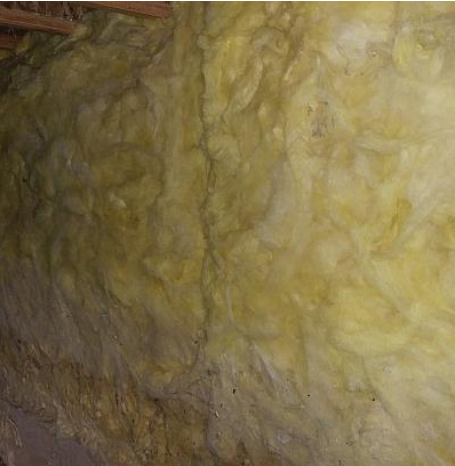
The foundation walls are covered by insulation and could not be visually inspected. There are no obvious indications of problems with the foundation walls.

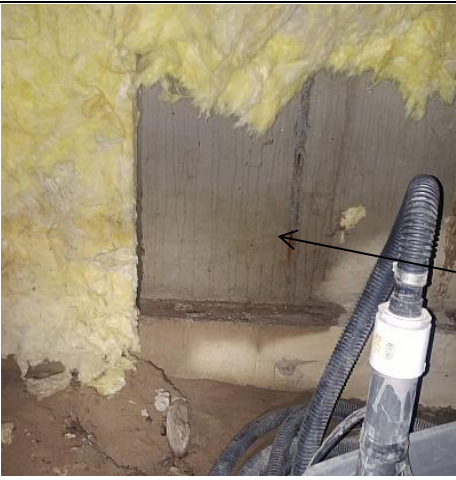
Moisture is penetrating the foundation wall where indicated. The insulation is down in this area. Recommend Repair.

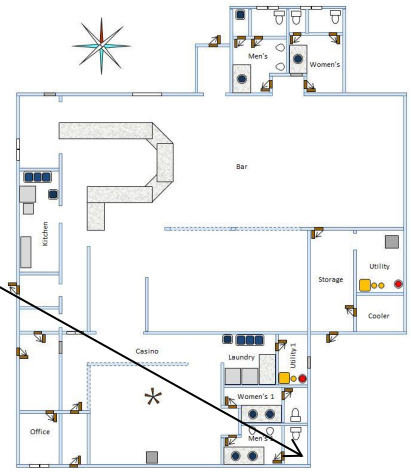
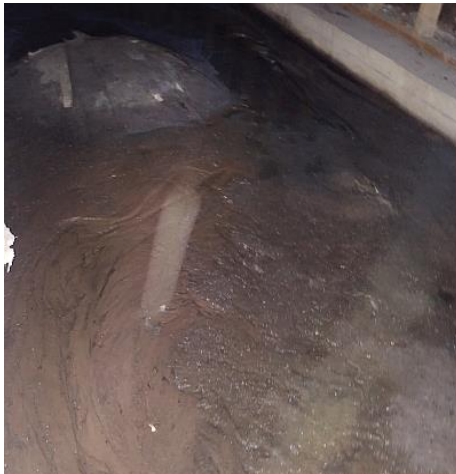
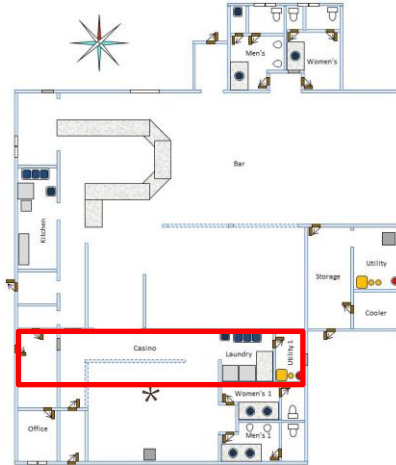
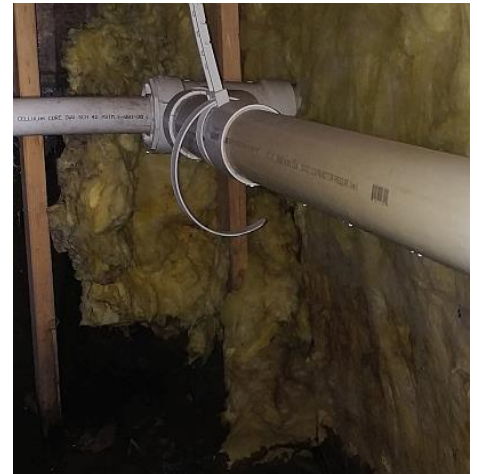
There is standing water/mud in the section of the crawl space highlighted. While this may be ground sourced, there is a lot of moisture on the plumbing drain lines in this area. This is likely condensation (there is no obvious indication of an active leak). The standing water in the crawl space is a Major Concern. Recommend Repair.

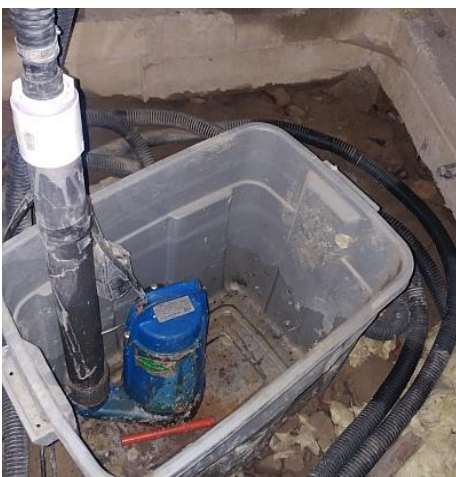
The sump pump is not properly installed. The pump is in a plastic container setting on top of the floor. A properly installed sump pump is buried in a perforated crock. The top of the crock is sealed to help prevent water accumulated in the crock from evaporating back into the crawl space before the sump and pump it to the exterior. Recommend Repair.

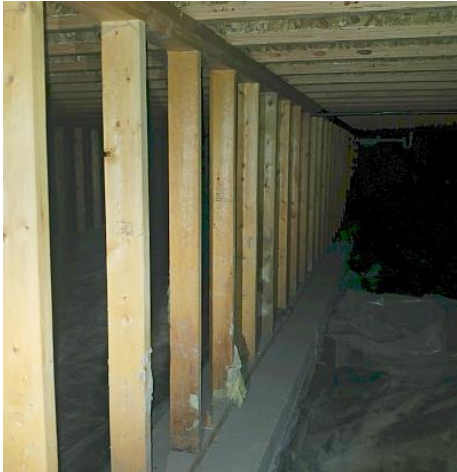
The structure is in Satisfactory Condition. Proper treated wood used for contact with concrete. The rust on the foundation bolts is typical.

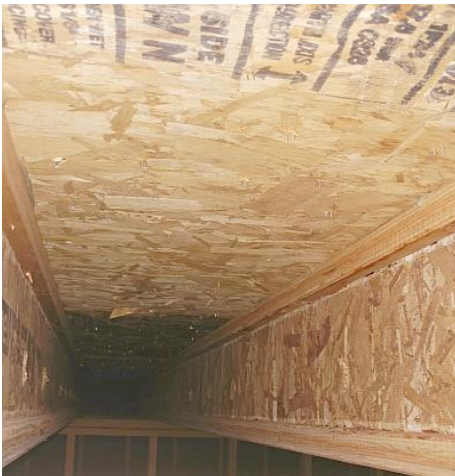
The joists are in Satisfactory Condition.

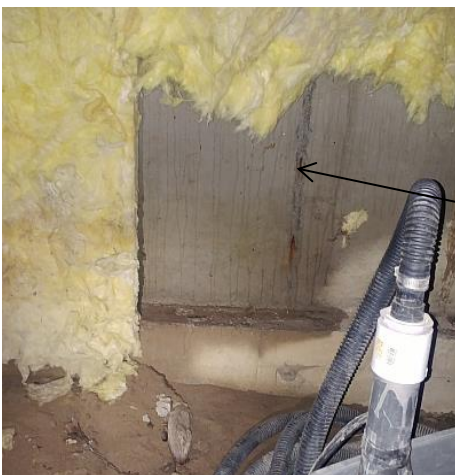
The insulation is displaced where indicated. Recommend Repair/ Replacement.

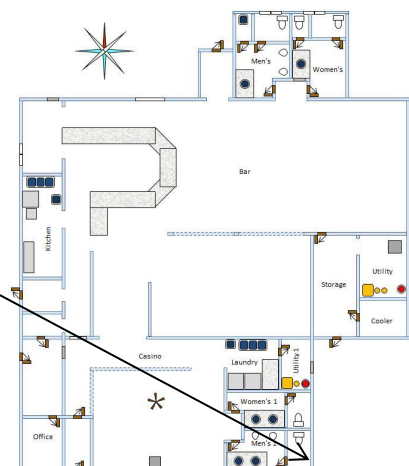
SUB FLOOR Indication of moisture stains/rotting

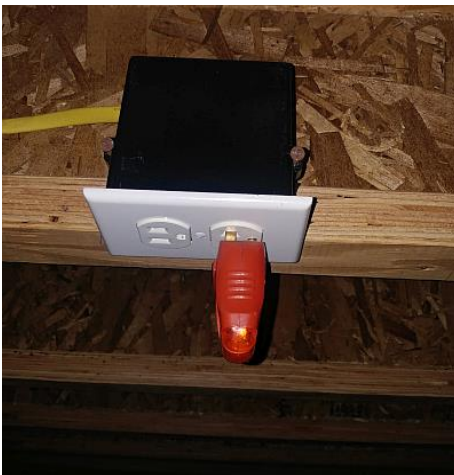
The outlets are not GFCI. This is a potential Safety Hazard. Recommend Repair/Replacement.

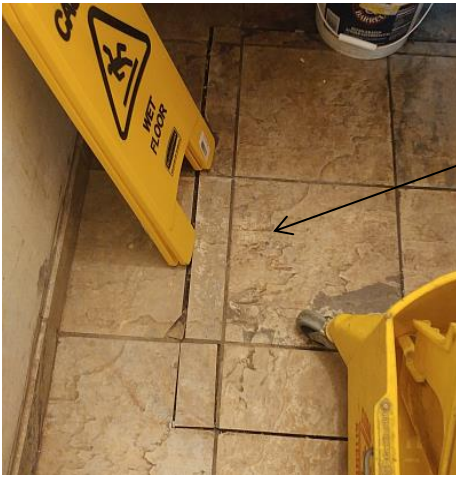
There appears to be another crawl space access where indicated. If this is an access the inspector could not get the cover to move.

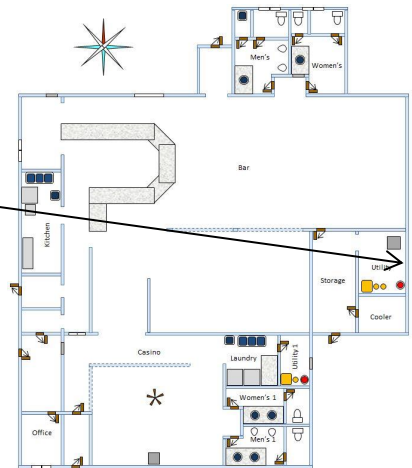
Water Entry Piping: Not visible Copper/Galvanized Plastic (PVC, CPVC, Polybutylene, PEX)

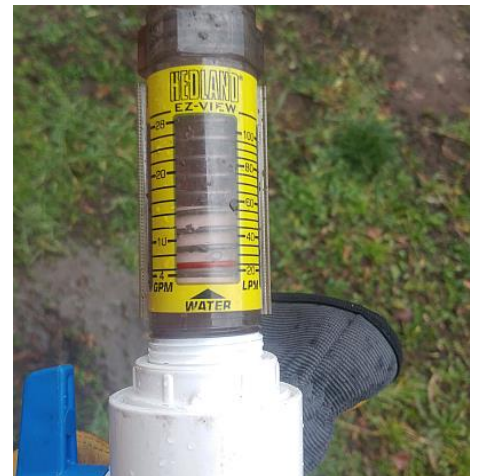
Pipes, Supply/Drain: Corroded Leaking Valves broken/missing Dissimilar metal

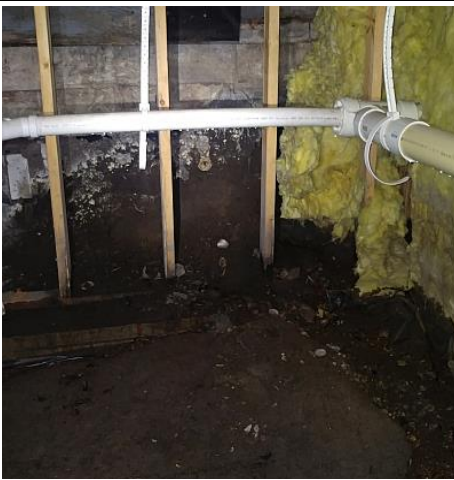
The plumbing lines are properly supported.

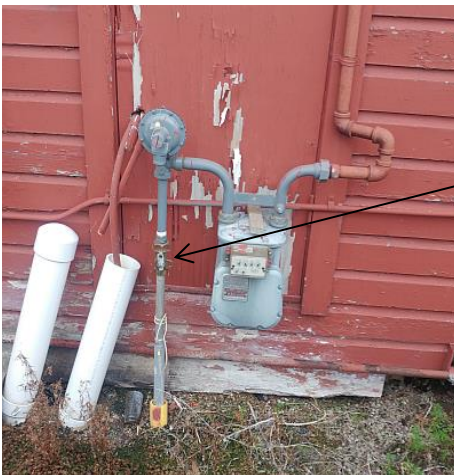
Main fuel shutoff is where indicated.

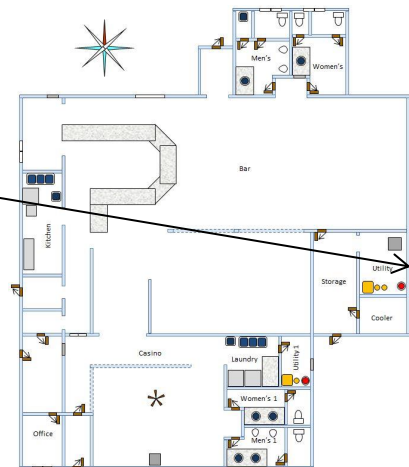
Interior Fuel Storage System: Yes No Leaking: Yes No

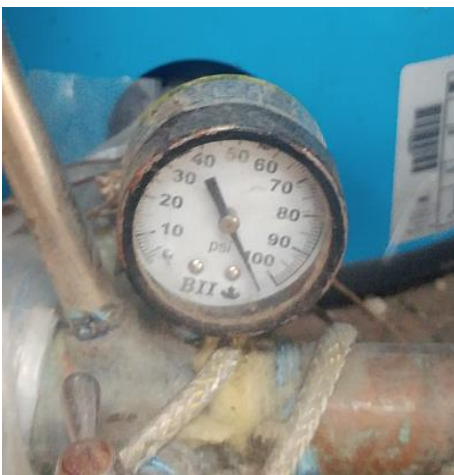
The pressure gauge is 'pegged' and does not appear to be operating. Recommend Repair/Replacement.

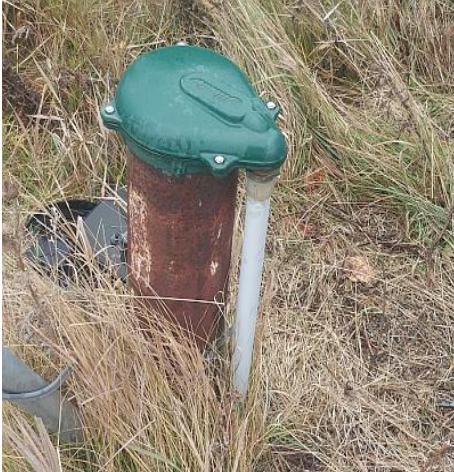
The well casing is in Satisfactory Condition.

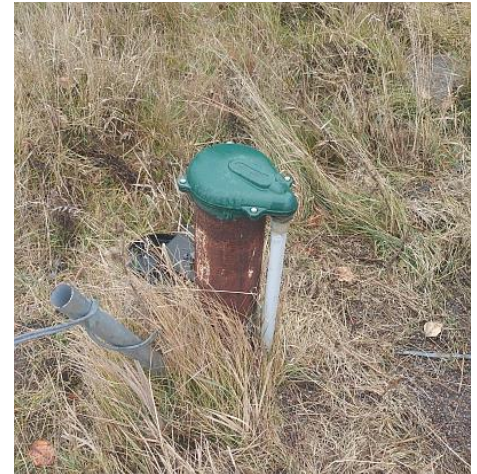
WATER HEATER - GAS **Condition:** Satisfactory Marginal Poor
Brand name: Bradford White **Model #:** MI5036FBN **Serial #:** JF16789845
Unit Elevated/Drain Pan: Yes No N/A

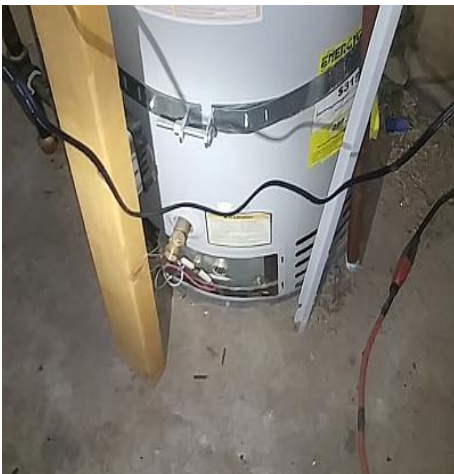
There is no drip pan installed. Current standards state that where water heaters tanks are installed in locations where leakage of the tanks or connections will cause damage, the tank shall be installed in a galvanized steel pan having a minimum thickness of 24 gage, or other pans approved for such use. Ideally the pan should be plumbed to an approved drain. Recommend Repair.

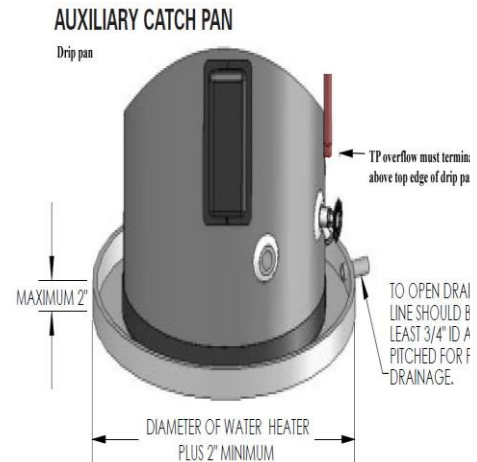
Capacity: 50 gallons **Approximate age:** Manufactured June 2013
Water Temperature: 120°F Other

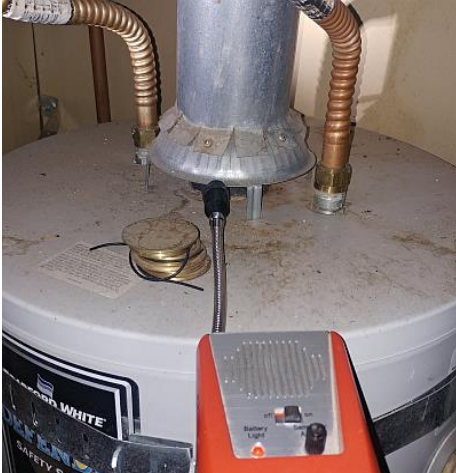
No gas or CO leaks detected. No indication of back drafting.
Testers TIF 8800/DCO 1001.

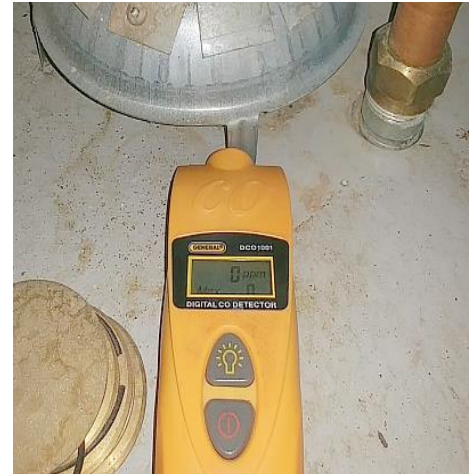
Combustion Air Venting Present: Yes No N/A
Seismic restraints: Yes No Required

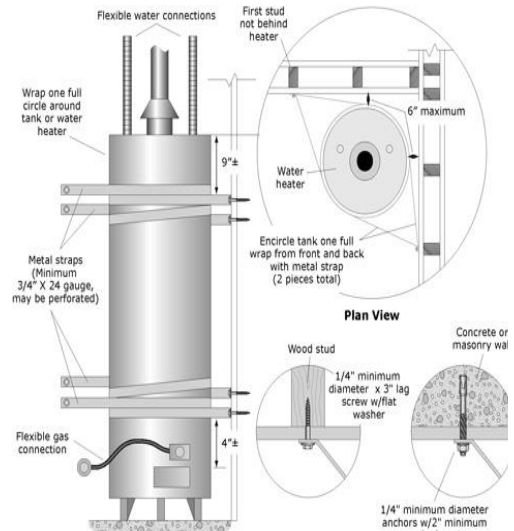
Temperature/Pressure Relief (TPR) Valve: Yes No Extension proper: Yes No
 Missing, Safety Hazard

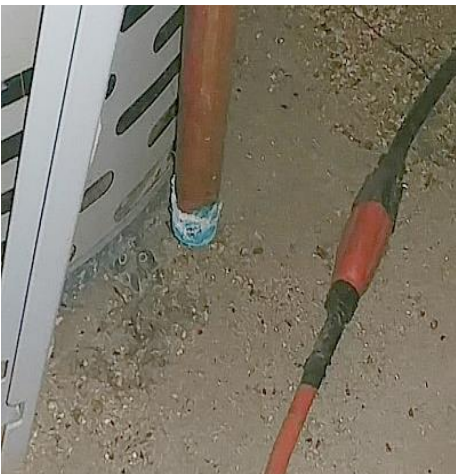
The temperature /pressure relief (TPR) valve extension is in contact with the floor (should terminate within 6 inches of the floor. There are indications the TPR valve is leaking. Recommend Repair/Replacement.

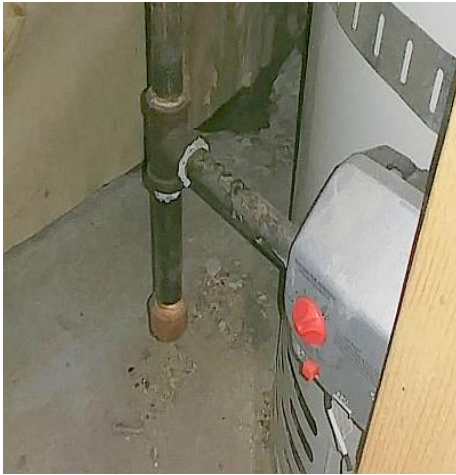
Proper sediment trap installed.

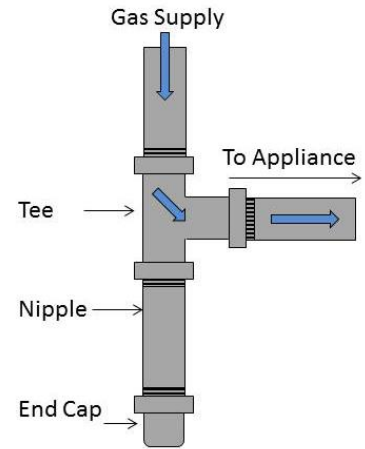
WATER HEATER - ELECTRIC

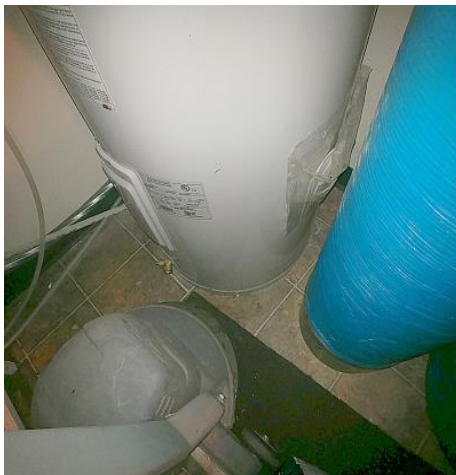
There is no drip pan installed. Current standards state that where water heaters tanks are installed in locations where leakage of the tanks or connections will cause damage, the tank shall be installed in a galvanized steel pan having a minimum thickness of 24 gage, or other pans approved for such use. Ideally the pan should be plumbed to an approved drain. Recommend Repair.
