State of Montana Licensed Home Inspector
HI0163

Inspection Date: 12th of Never
Prepared For: Jane and John Doe

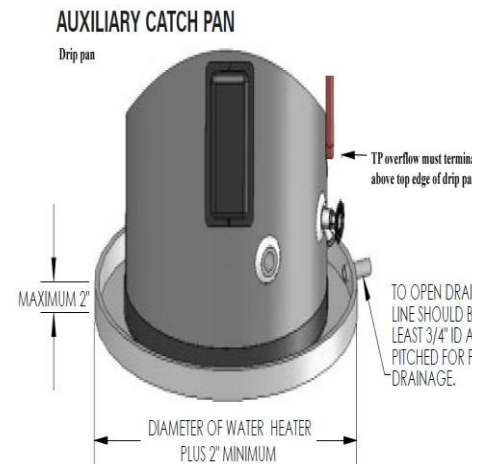
Capacity: 50 gallons **Approximate age:** Manufactured September 2007

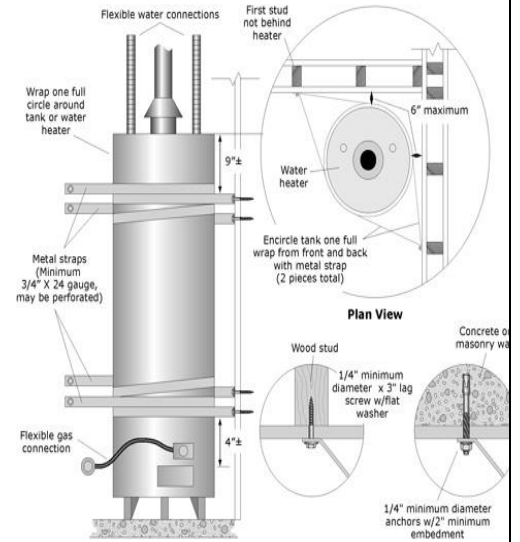
Relief Valve: Yes No **Extension proper:** Yes No *Missing, Safety Hazard*

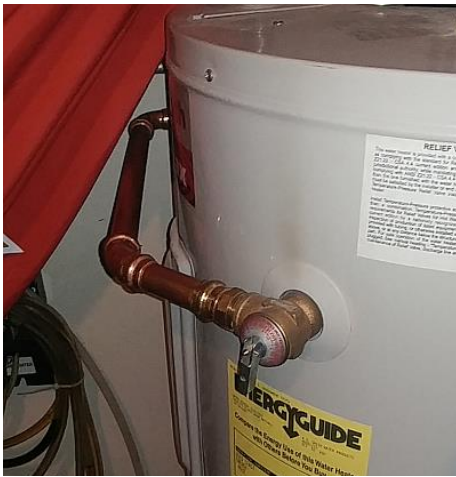
The temperature /pressure relief (TPR) valve extension terminates to the exterior. Current standards state that when the TPR valve discharges to the exterior in areas subject to freezing, discharge piping shall be first piped to an indirect waste receptor through an air gap located in a conditioned area. It will discharge in a manner that does not cause personal injury or structural damage and discharge to a termination point that is readily observable by the building occupants.

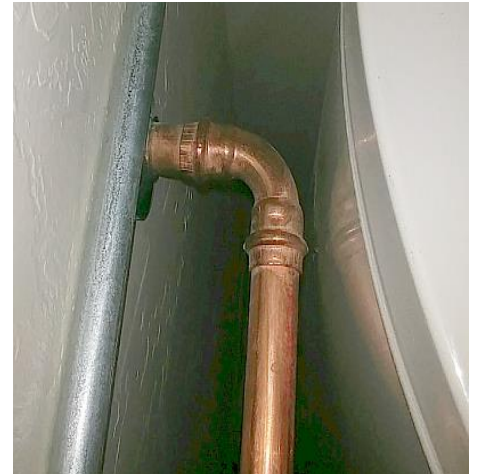
Plumbing Hookups: Leaking: Yes No Corroded: Yes No *Recommend Repair*
Water Isolation Valve: Yes No *Recommend Adding*
Electrical Connections: Wiring/Amperage Proper: Yes No

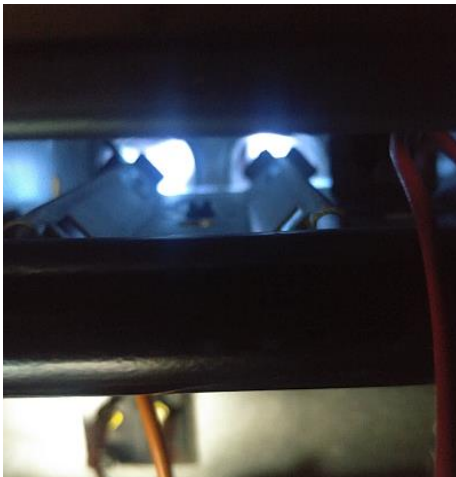
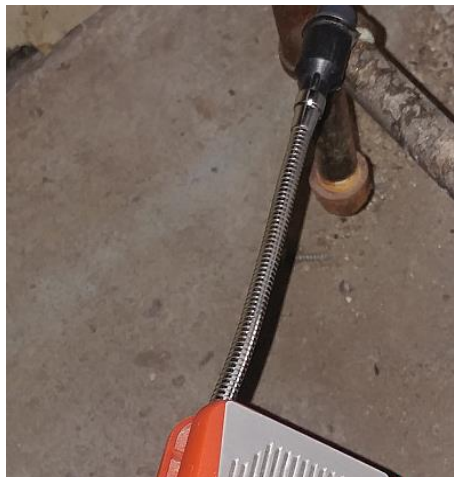
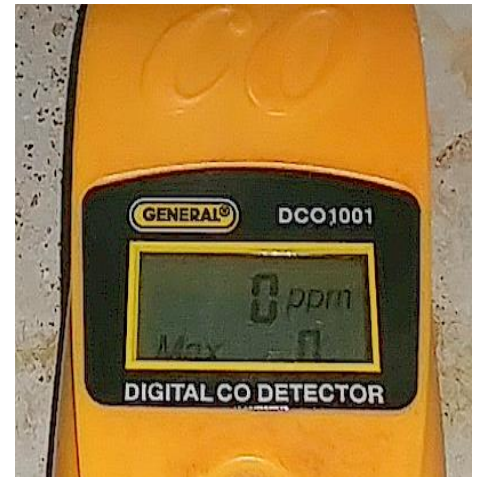
Blue flame observed. No indication of distortion. No indication of gas or CO leaks – Testers TIF 8800/DCO 1001.

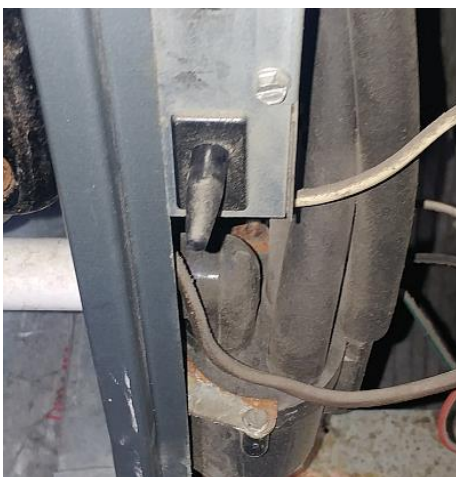
The fan door safety switch is not operating. As this is a safety device, the inoperative switch is a potential Safety Hazard. Recommend Repair/Replacement.

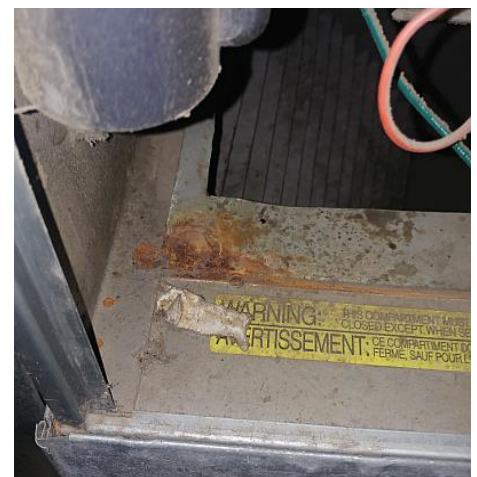
Combustion Air Venting Present: Yes No N/A

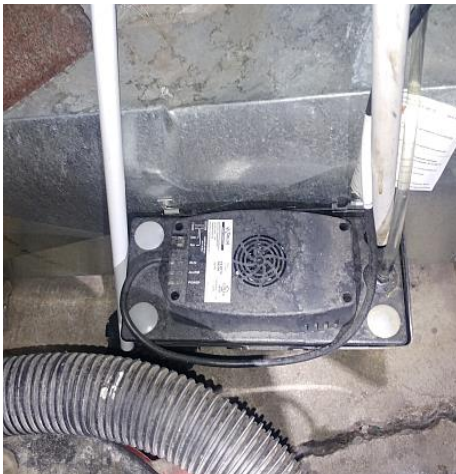
The condensation is collected by a pump which sends the collected condensation into the building exterior.
 The plumbing carrying the condensation to the exterior is disconnected. The condensation is draining to the floor. Recommend Repair.

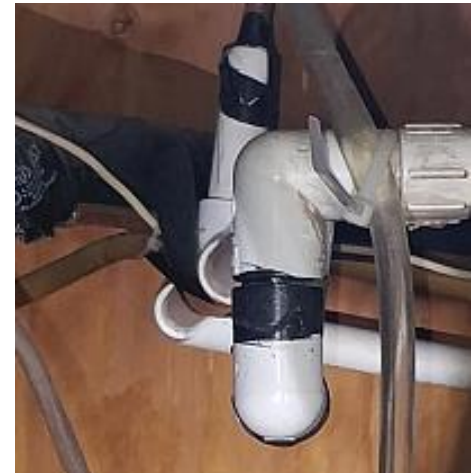
Gas Sediment Trap: Yes No Recommend Adding

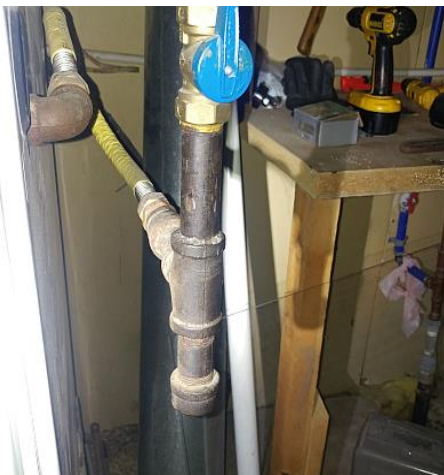
Proper sediment trap installed.

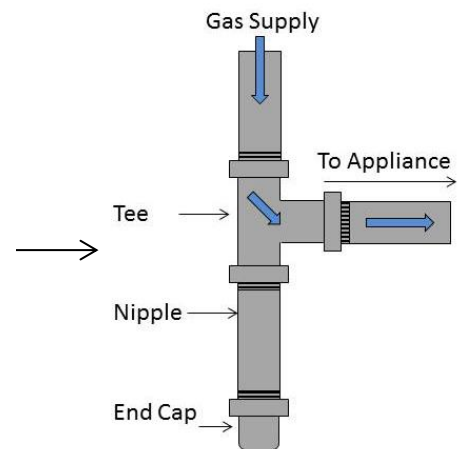
Distribution: Metal duct Insulated flexile duct Duct board
 Cold air returns Yes No **Asbestos-like wrap** **Sub-Slab ducts**

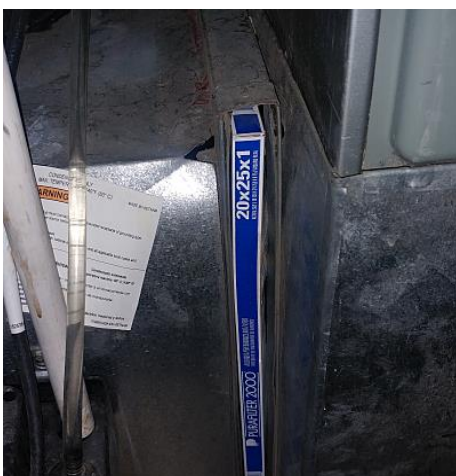
There is no cover on the furnace filter housing and the filter is too large. A cover prevents air within the furnace from spilling out, making the furnace run more efficiently. The cover will also help prevent unfiltered air from entering the furnace cabinet. Unfiltered air can contain particulates which could damage the furnace.

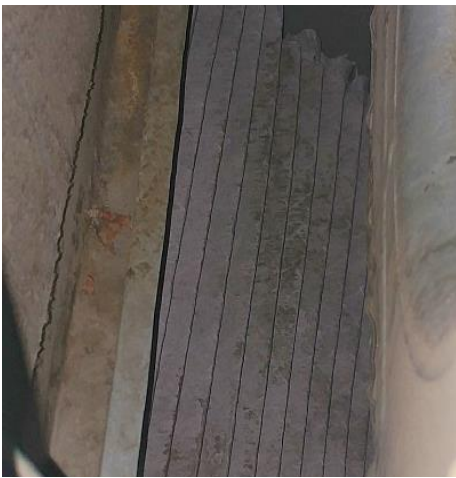
There is a second filter visible inside the lower compartment. The filter is very dirty. HVAC units are designed to operate with one properly sized filter. Adding an additional filter will not increase the air quality and will likely damage the unit or shorten its operational life expectancy. Recommend Removal.

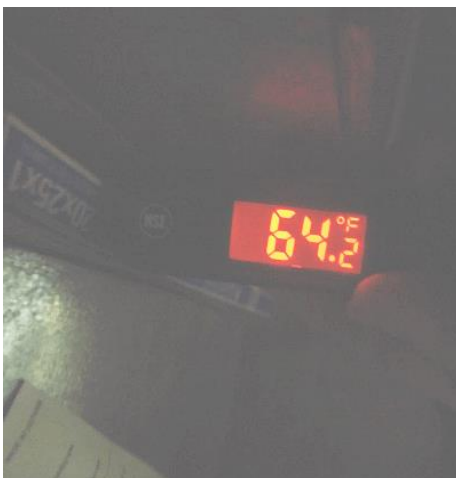
The temperature rise of 49.8°F is within limits.

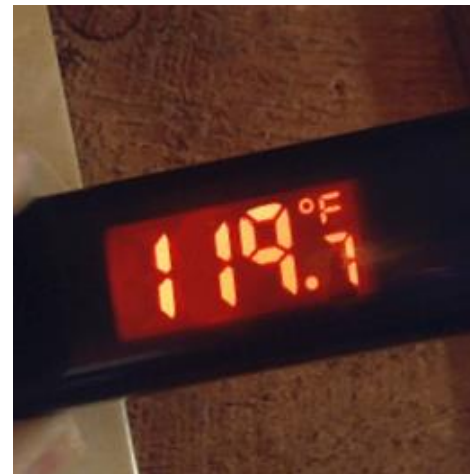
System Condition: Satisfactory Marginal Poor
 Recommend technician examine Before closing

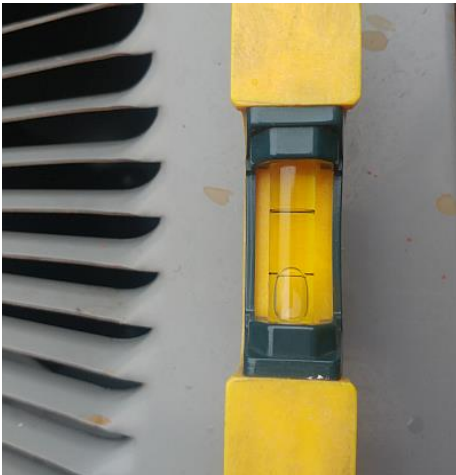
The condensing unit is not level on both axis. Keeping the compressor level can help extend its service life. Recommend Repair.

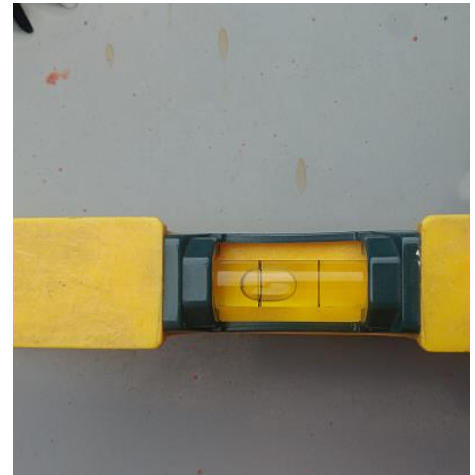
The Condensing Unit is properly spaced from obstructions: N/A Yes No **Recommended**

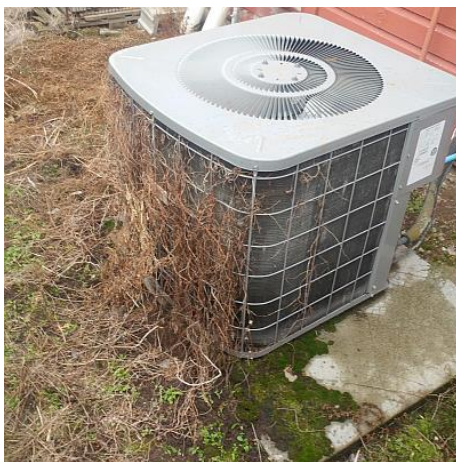
The condensing unit is within 24 inches of vegetation. Debris from vegetation can clog the compressor evaporator coils, making the unit less efficient and possibly shortening the life expectancy of the compressor. Recommend Repair.

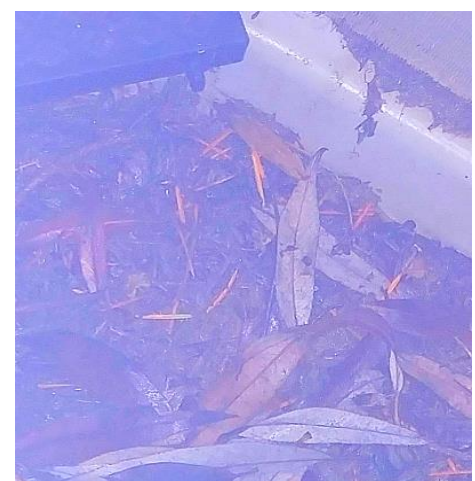
Evaporator Coil: Satisfactory Not visible Needs cleaning Damaged
Condensate Line/Drain: To exterior To pump Floor drain Other

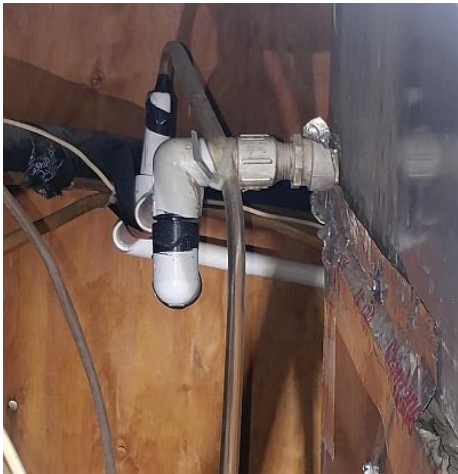
The condensation is plumbed to the exterior. The plumbing carrying the condensation to the exterior is disconnected. The condensation is draining to the floor. Recommend Repair.

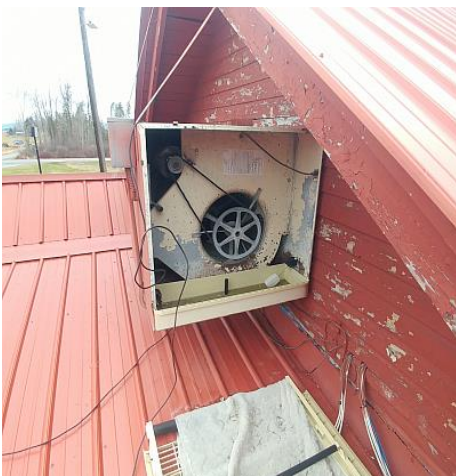
There is an evaporative (swamp) cooler on the roof. The unit does not appear to be operating.

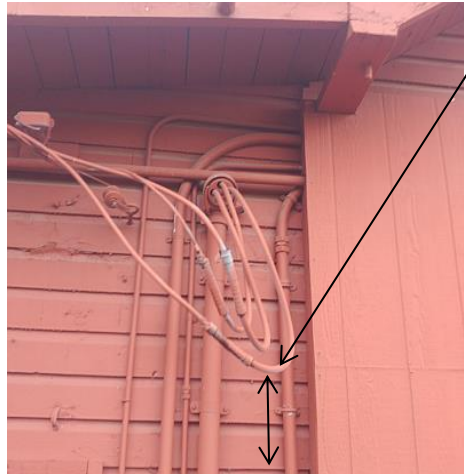
The bottom of the service conductor drip loop must be at least 12 feet above the ground (it is 11 feet above the ground). The entrance cable must have at least 18 inches of excess wire left past the weather head to allow connection of the service wire. This is a potential Safety Hazard. Recommend Repair.

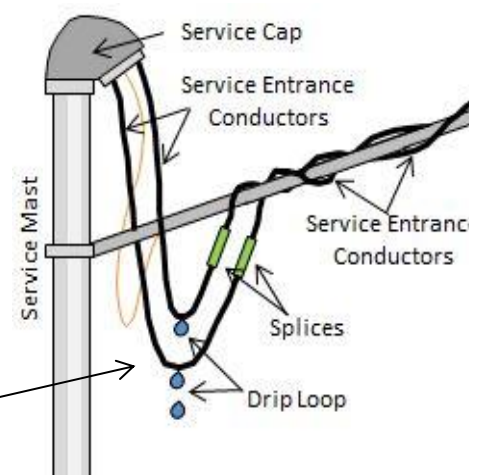
Proper drip loop installed.

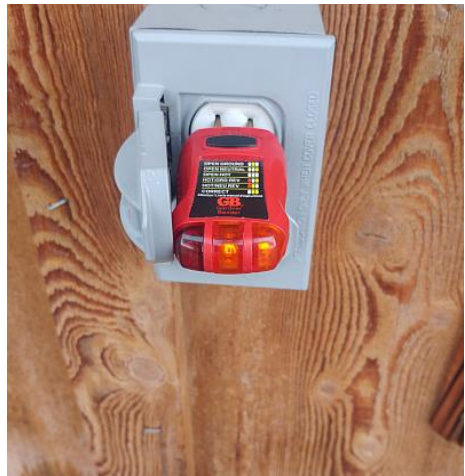
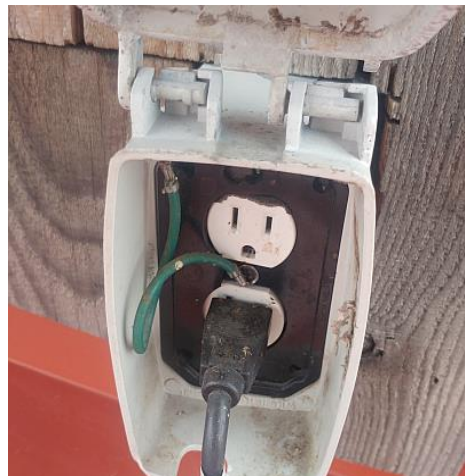
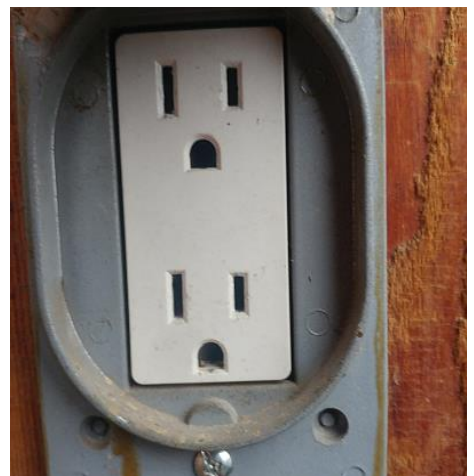
None of the exterior outlets tested test for GFCI. This is a potential Safety Hazard. Recommend Repair.

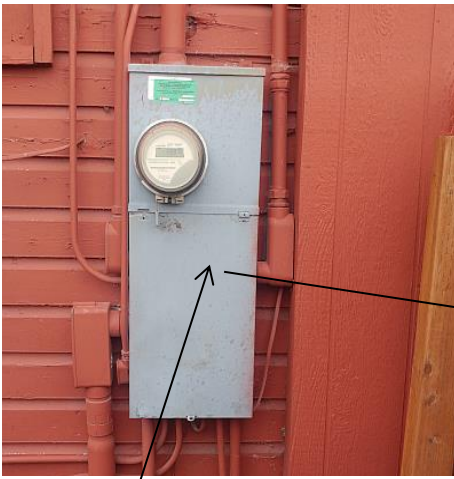
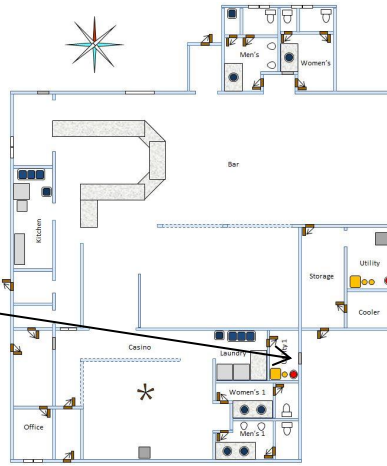
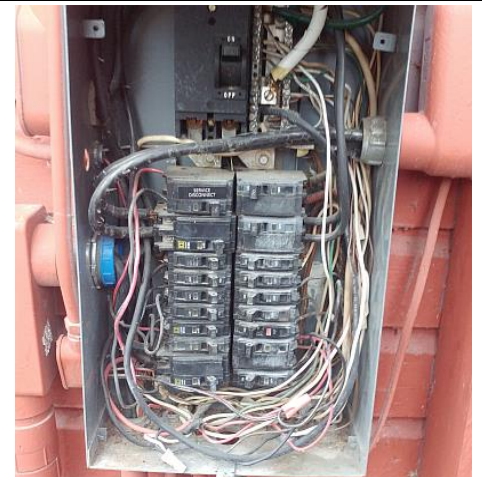
The service entry/main panel are where indicated. This is also the location of the main electric disconnect.

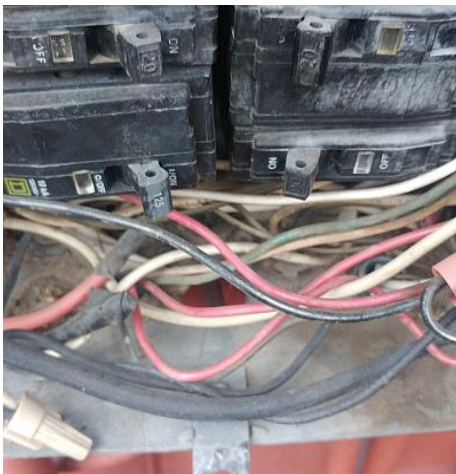
A knock out is missing from the bottom of the panel case. This provides access to the interior (live) portion of the panel. This is a potential Safety Hazard. Recommend Repair/Replacement.

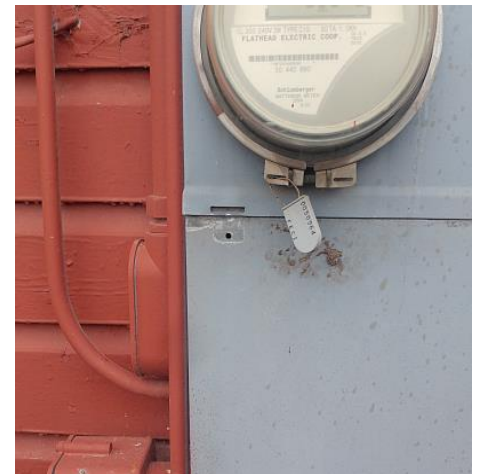
G.F.C.I. present: Yes No

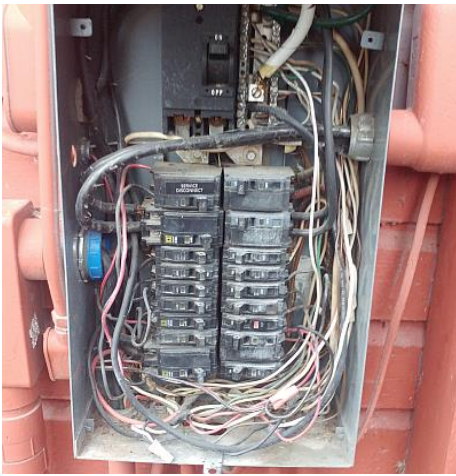
Breakers Labeled: Yes No Recommended

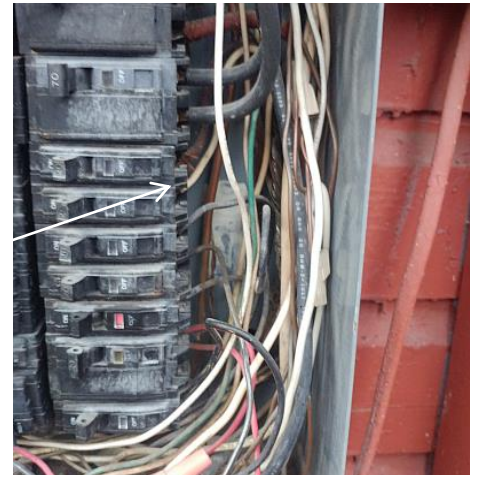
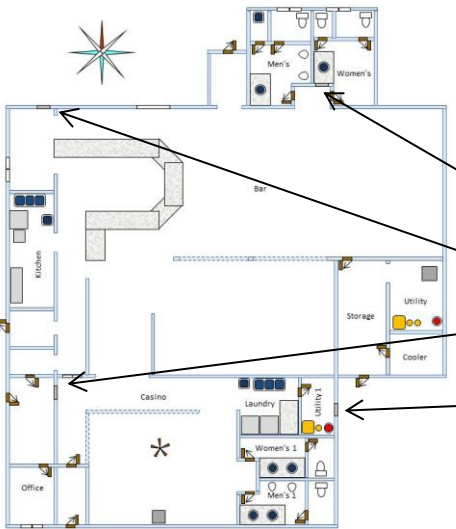
The sub panels are as indicated:

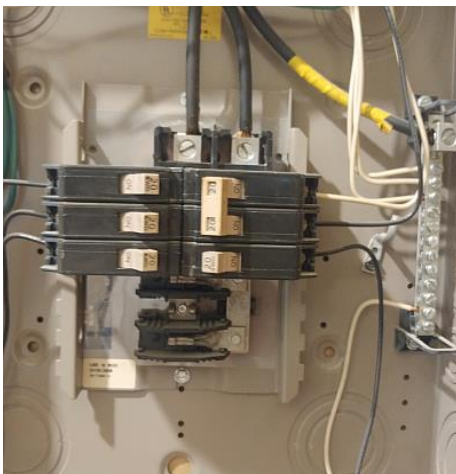
The neutrals and grounds are properly separated.

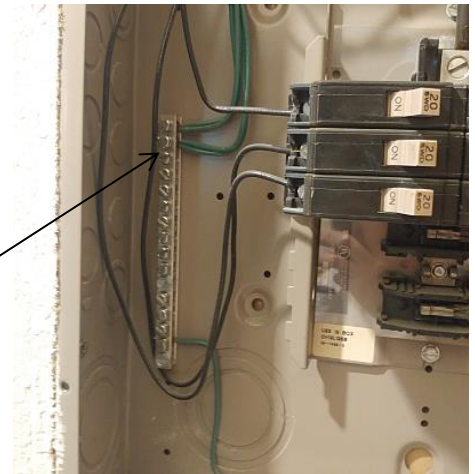
Condition: Satisfactory Marginal Poor *Recommend separating/isolating neutrals*

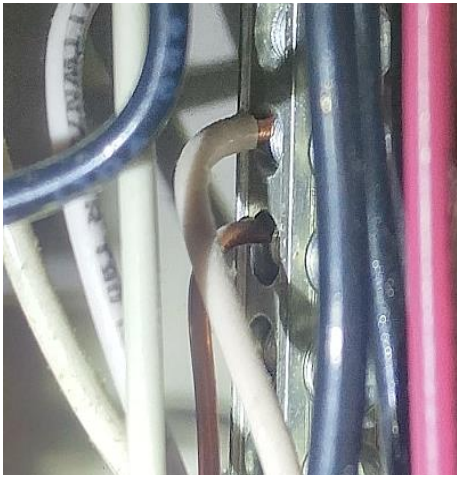
The neutrals and grounds are not isolated. This is a potential Safety Hazard. Recommend Repair.

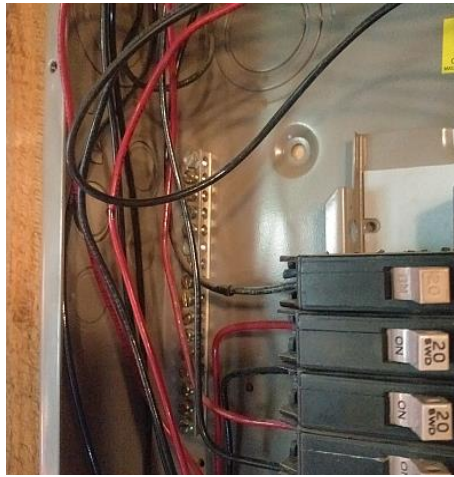
There is no obvious ground. This is a potential Safety Hazard. Recommend Repair.

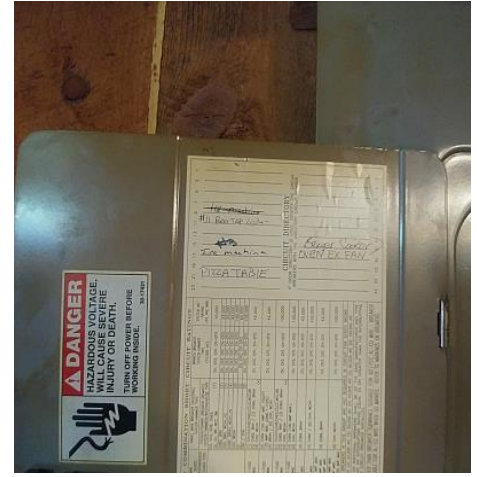
The panel is not completely labeled. Recommend Repair.

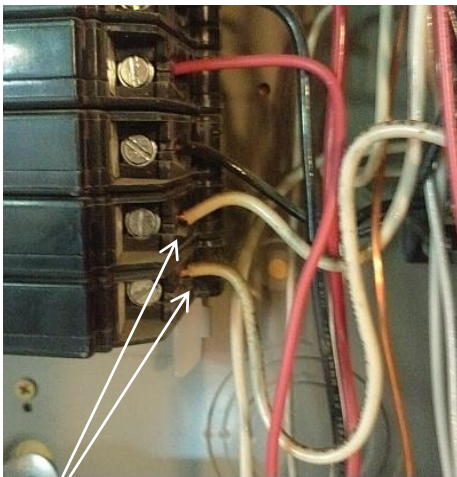
White (neutral) wires used as black (live or line) wires should be color coded black or red with electricians tape.

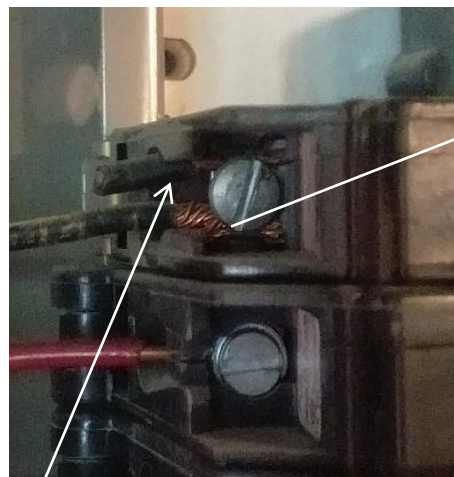
Double tapped breaker where indicated (even though one wire has been cut this is still considered a double tap). This is a potential Fire and Safety Hazard. Recommend Repair.

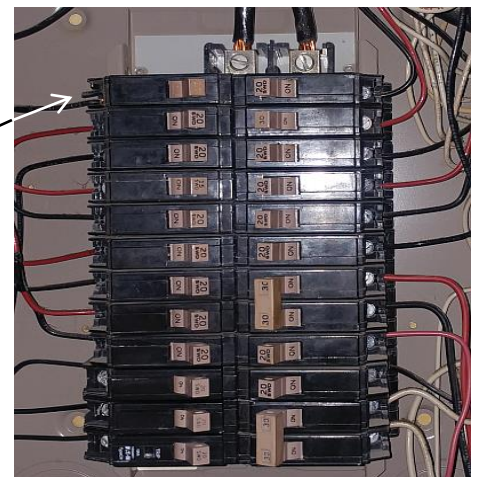
A double tapped circuit breaker (Two wires entering the same breaker from two separate circuits) is one of the most common electrical defects found when checking the main electric panel. The problem with putting two wires in a circuit breaker designed to hold one is that the wires could become loose, even if they feel very tight. Loose wires can lead to overheating, arcing, and possible fire.

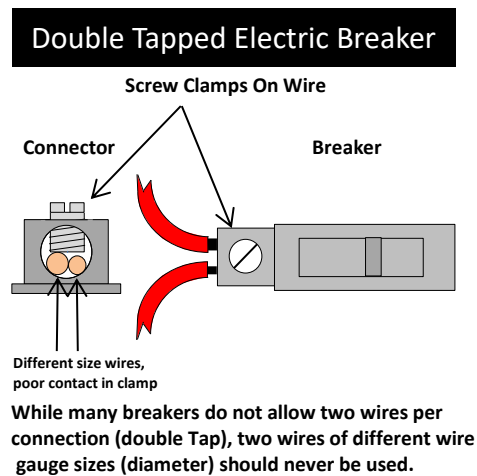
Condition: Satisfactory Marginal Poor *Recommend separating/isolating neutrals*

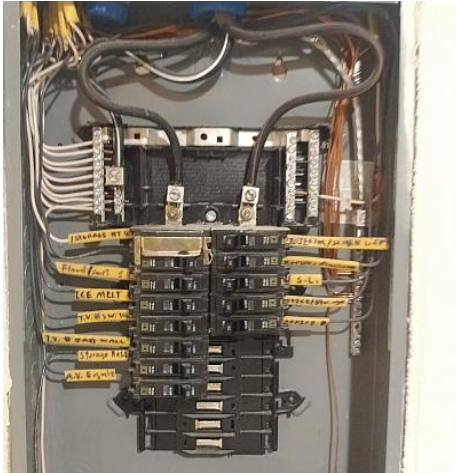
The sub panel is in Satisfactory Condition. The neutrals and grounds are properly isolated.

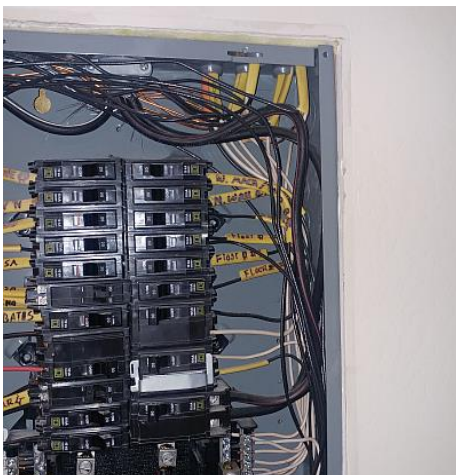
The sub panel is in Satisfactory Condition. The neutrals and grounds are properly isolated.

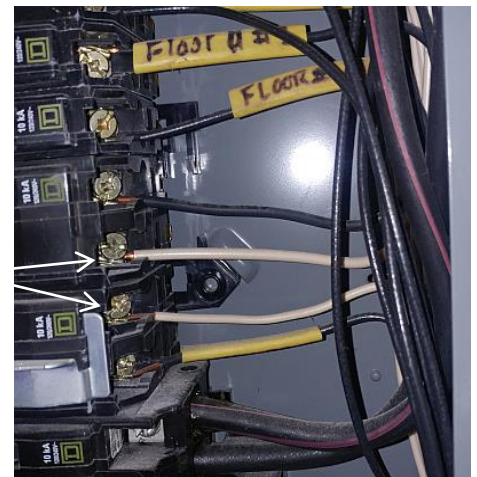
Condition: Satisfactory Marginal Poor *Recommend separating/isolating neutrals*

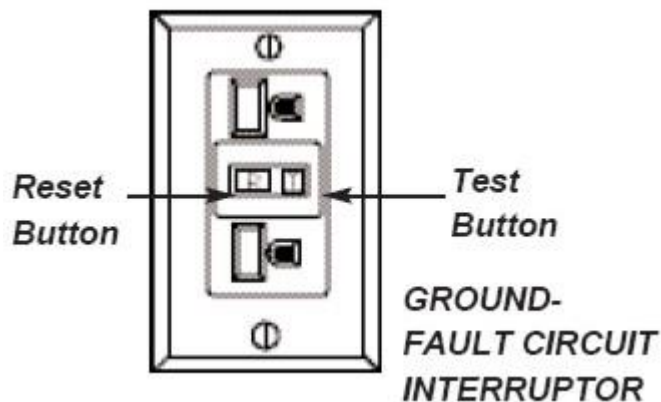
If you do have G.F.C.I.'s, it is recommended that you test (and reset) them monthly. When you push the test button, the reset button should pop out, shutting off the circuit. If it doesn't, the breaker is not working properly. If you don't test them once a month, the breakers have a tendency to stick and may not protect you when needed.
