Inspection Date: 12th of Never

Prepared For: Jane and John Doe

Gunstock Home Inspection LLC
33136 East Bay Lane Polson, MT 59860
(406) 887-2058 (406) 253-8333
montanamike1@centurytel.net

Report Number: 12000000

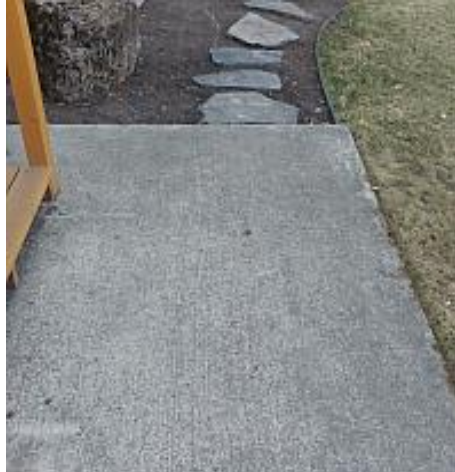
Material has eroded from underneath the service walks. Recommend Repair (backfill).

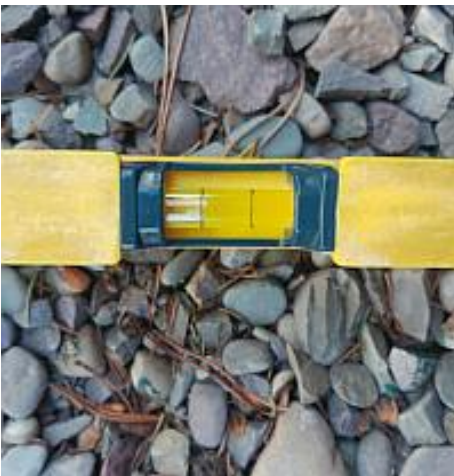
The driveway is pitched toward the home. Recommend Repair.

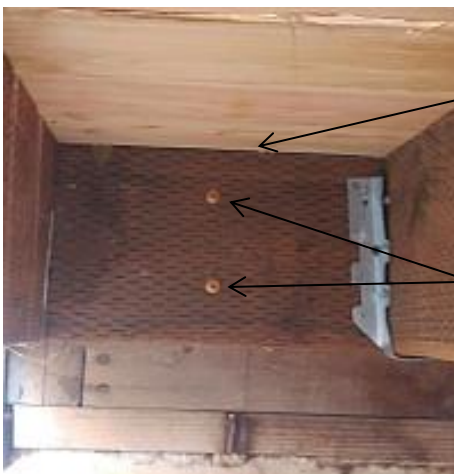
The floor is not flashed. Flashing helps prevent moisture intrusion at the deck/home junction. If the floor is ever replaced recommend flashing be added.

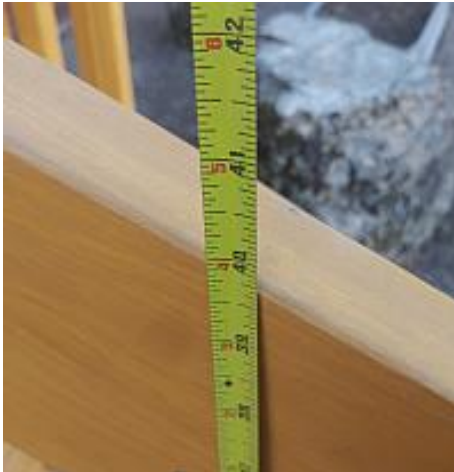
There are no balusters installed.
Recommend Repair.

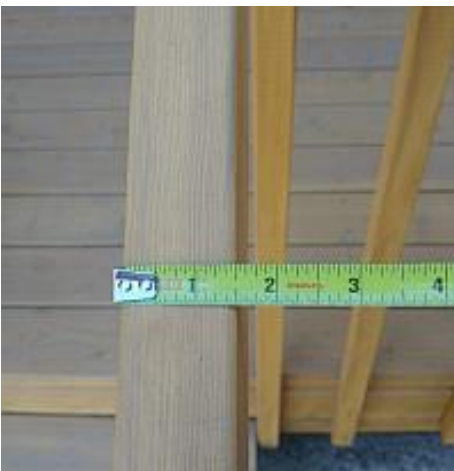
The grip surface is not proper.
Illustrated are a few (but not the only) types of proper grip surfaces.
Recommend Replacement.

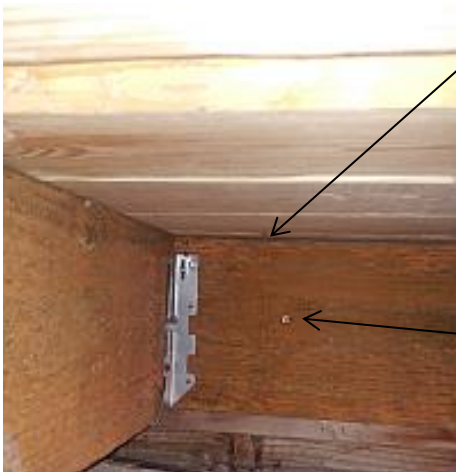
The floor is not flashed. Flashing helps prevent moisture intrusion at the deck/home junction. If the floor is ever replaced recommend flashing be added.

The ledger board is not properly attached to the home structure. Lag bolts are one (but not the only) means of positively attaching the ledger board to the home structure. Recommend Repair.

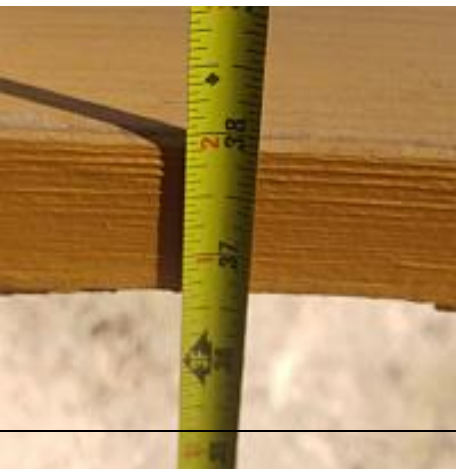
Balusters are not installed. Recommend Repair.

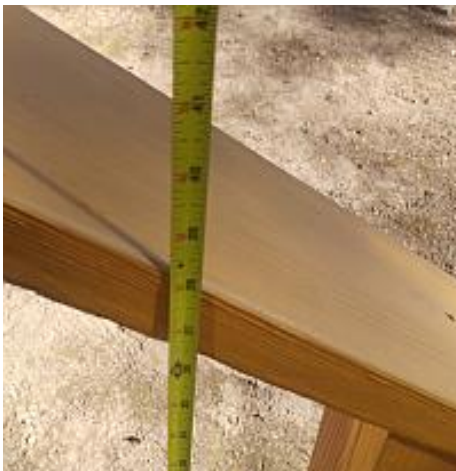
Balusters are not installed
 Recommend Repair.

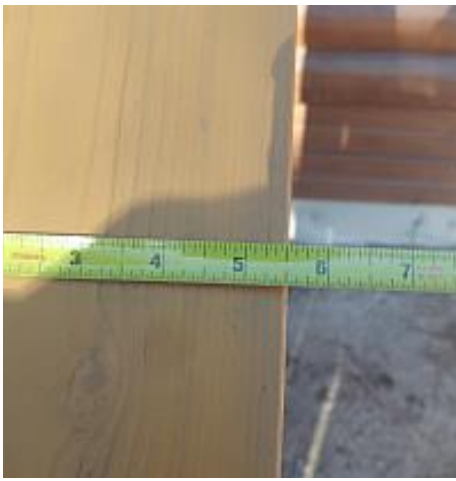
The grip surface is not proper. Illustrated are a few (but not the only) types of proper grip surfaces. Recommend Replacement.

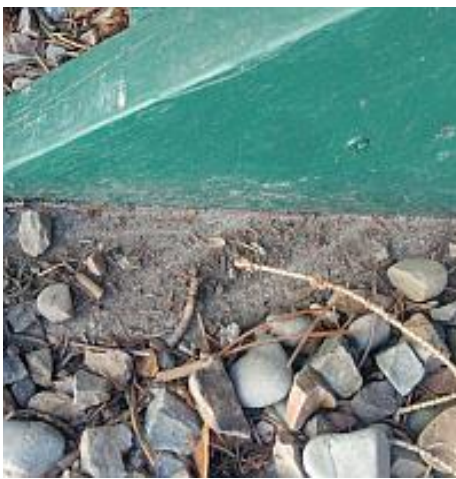
Wood to concrete contact. Untreated wood should never be allowed to be in contact with concrete (can cause deterioration).

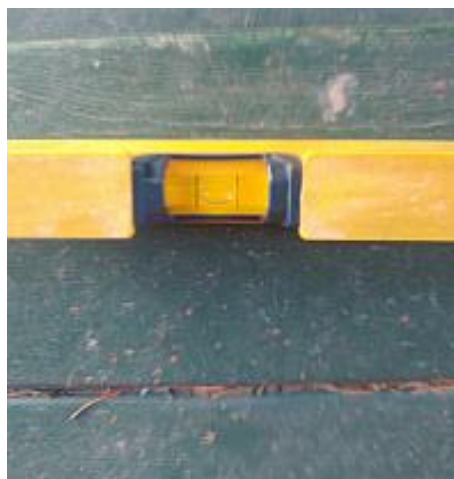
The steps are not properly pitched. Recommend Repair.

No deterioration detected at the time of the inspection. Recommend Monitoring.

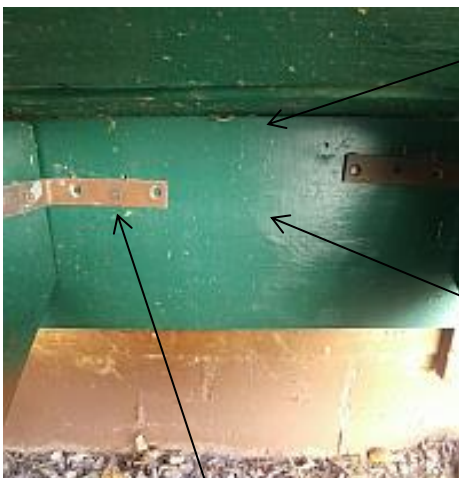
The steps are not flashed. Flashing helps prevent moisture intrusion at the deck/home junction. If the floor is ever replaced recommend flashing be added.

The ledger board is not properly attached to the home structure. Lag bolts are one (but not the only) means of positively attaching the ledger board to the home structure. Recommend Repair.

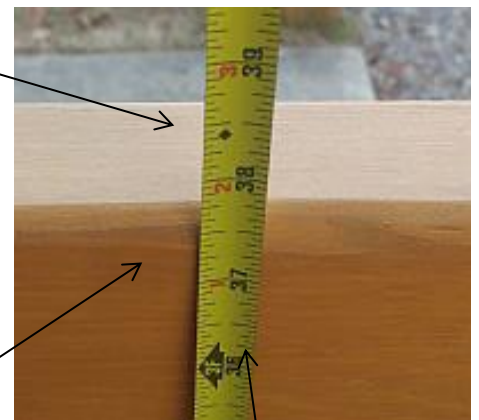
Joist hangers are the recommended method of securing structure to a ledger board. Recommend Repair.

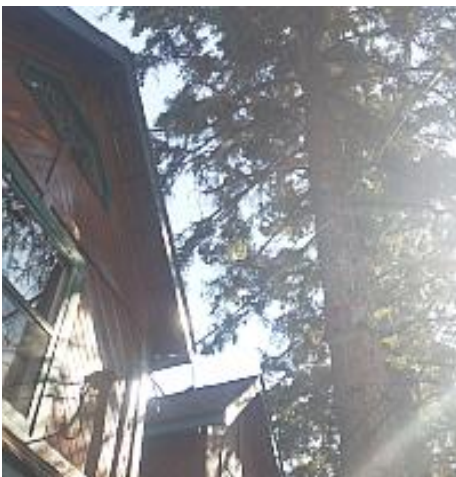
Vegetation in several areas is in direct contact with/overgrowing the home. Recommend Trimming.

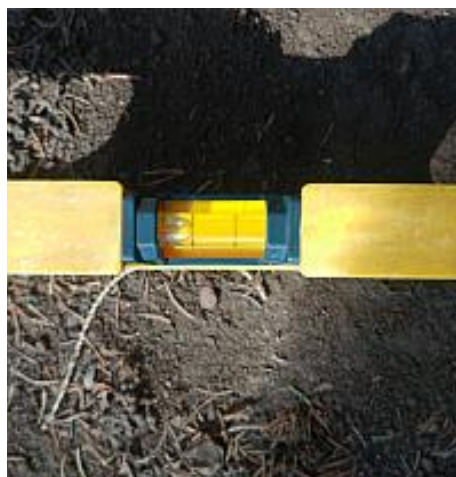
Negative grade observed in several areas. Recommend Repair (backfill).

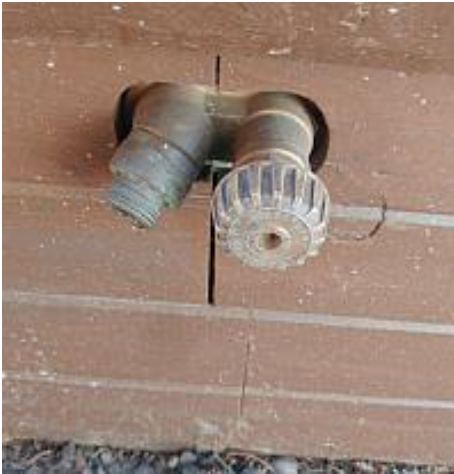
Proper anti-siphon valve installed on all external faucets (bibs).

When the bibs are turned on and then off the anti-siphon valves are briefly directing water back toward the home. As the valves are not flush mounted with the log siding the water is getting behind the logs. Recommend Repair.

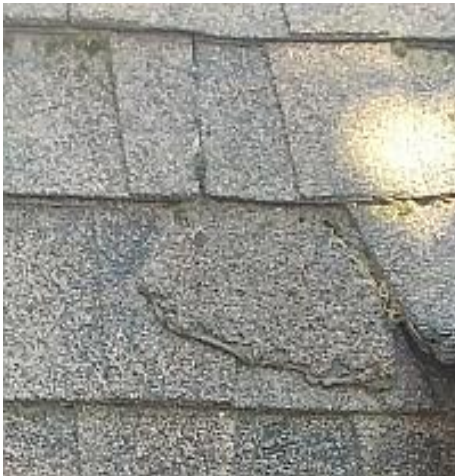
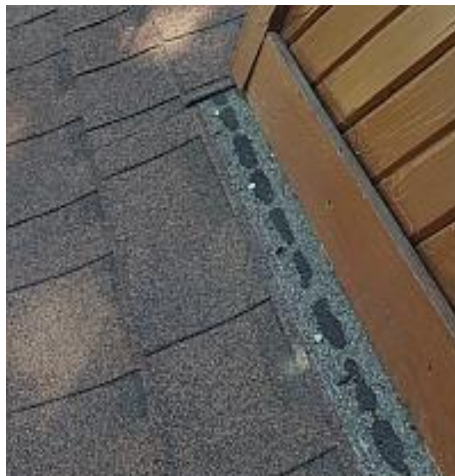
Broken/missing shingles observed. Granule loss observed. Recommend Repair/Replacement.

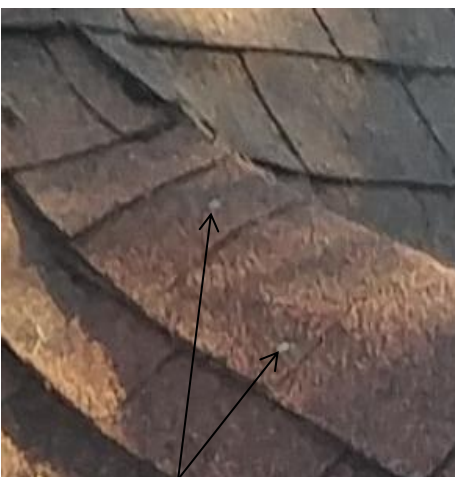
Exposed nail heads observed. Recommend sealing to help prevent moisture intrusion.

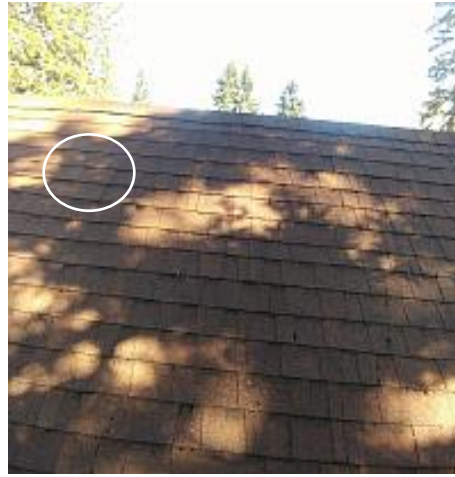
Slight 'bow' observed in the roof cover in one area (not really visible in the photo). Cause unknown. Recommend Repair.

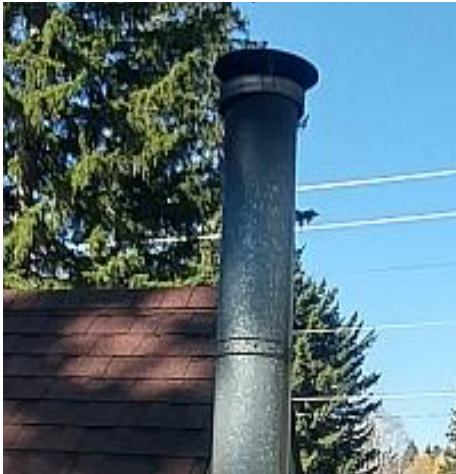
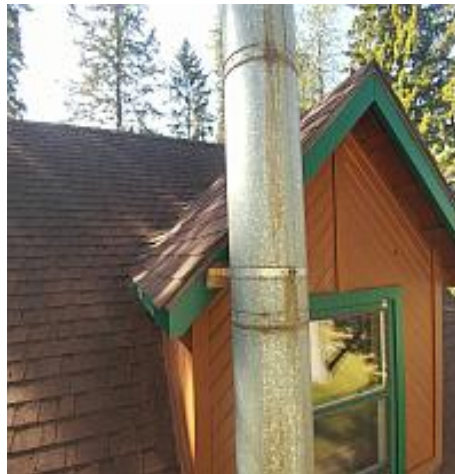
Indications of creosote buildup observed. Recommend cleaning and seasonal cleaning thereafter.

Some rusting observed. Recommend Repair.

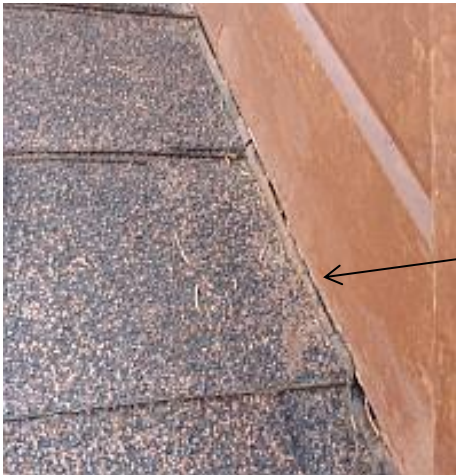
The inspector verified that sidewall flashing is being used on the dormers.

The siding is in direct contact with the roof cover (a one inch offset is recommended). Recommend Repair.

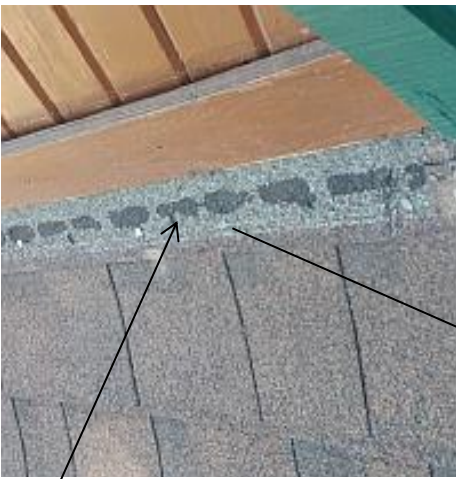
There is no visible headwall flashing. Headwall flashing helps prevent leaks at the wall/roof cover junction. Recommend Repair.

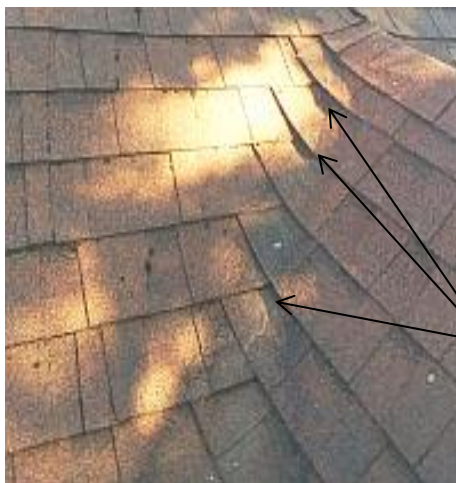
A weave pattern is being used in the valleys. The weave should be tight and the shingles should lay flush with the roof surface to help prevent leaks.

Raised shingles observed in all of the valleys. Recommend Repair.

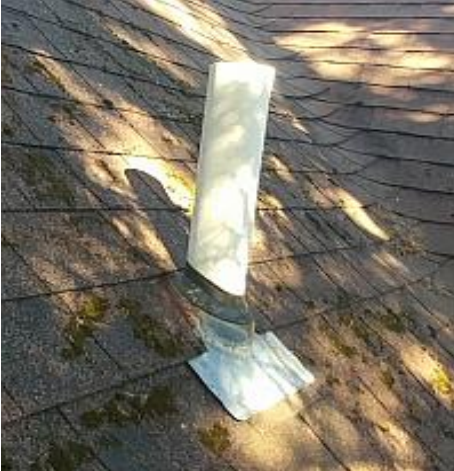
The plumbing vents are in Satisfactory Condition.

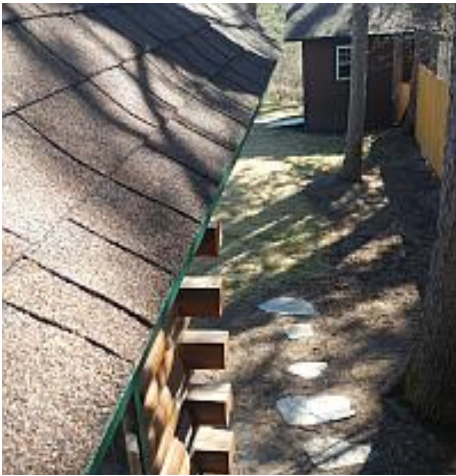
Recommend gutters to help channel runoff away from the foundation and help keep backsplash off the homes' siding.

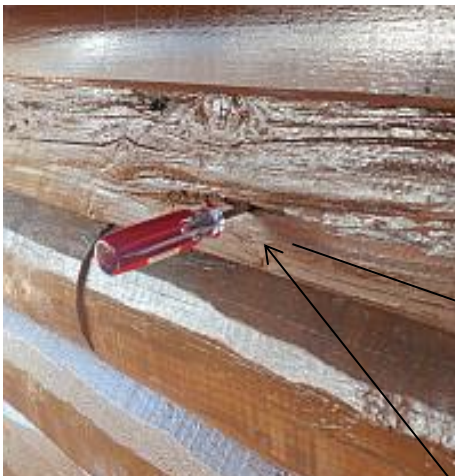
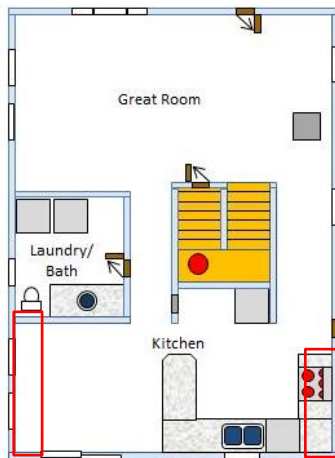
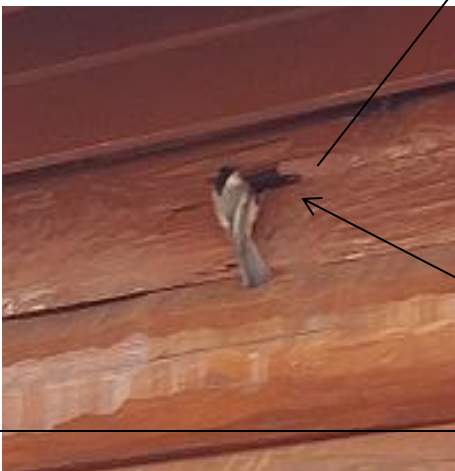
Two deteriorated logs where indicated. The log siding is the load bearing component of a log home. This is a Major Concern. Recommend Evaluation/Repair by a licensed contractor.

Birds are nesting in this deteriorated log.

Inspector's Note: This deterioration could be the result of moisture infiltration. Anytime there is moisture infiltration there is the possibility of hidden damage.

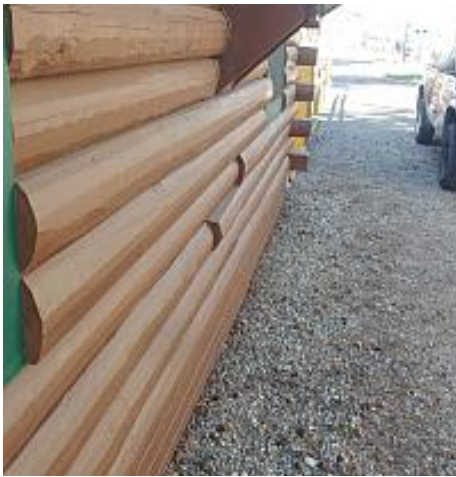
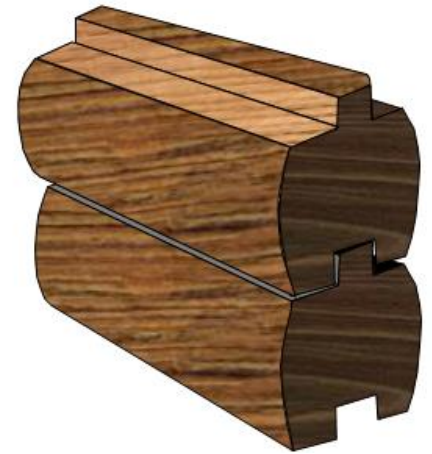
Numerous offset logs observed. This home is constructed of single tongue and groove milled logs. These types of log are designed to fit tightly together. The tongue and groove should help minimize the type of offsetting observed.

Inspector's Note: The home could have been built this way. Logs of different diameters would explain the offsetting.

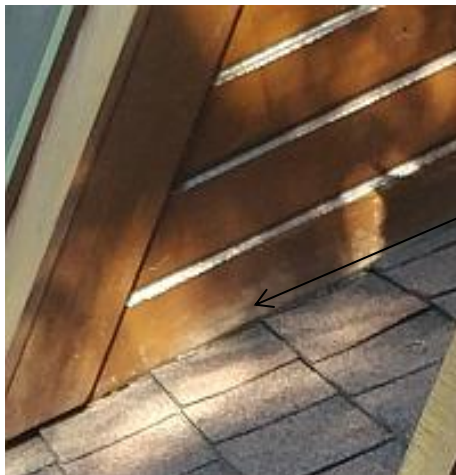
Weathering/early indications of deterioration observed where the siding is in contact with the roof cover (see page 17). Recommend Repair.

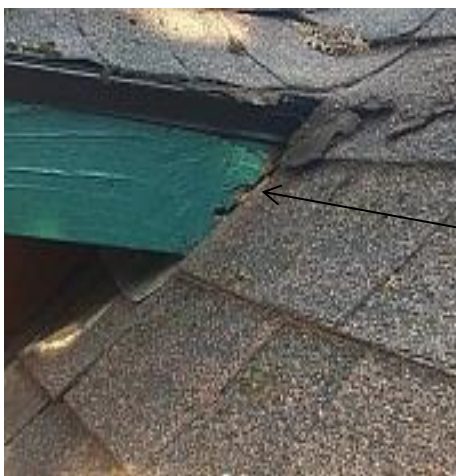
Weathering/early indications of deterioration observed where the fascia is in contact with the roof cover (see page 17). Recommend Repair.

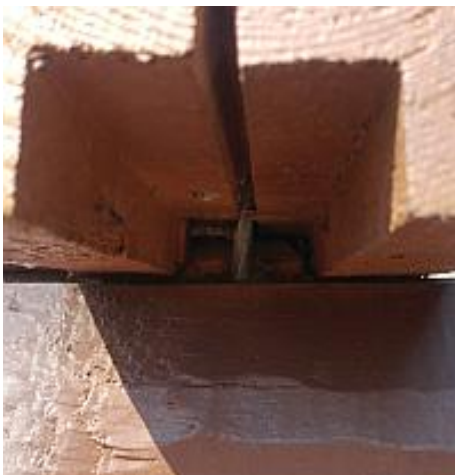
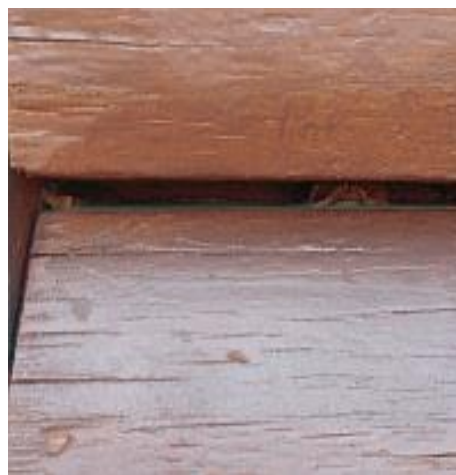
There is no visible chinking/sealing between the logs. There are several large gaps observed. Chinking helps seal out moisture and air and helps with the overall insulation of the structure. Recommend Repair.

Recommend sealing all utility penetrations.

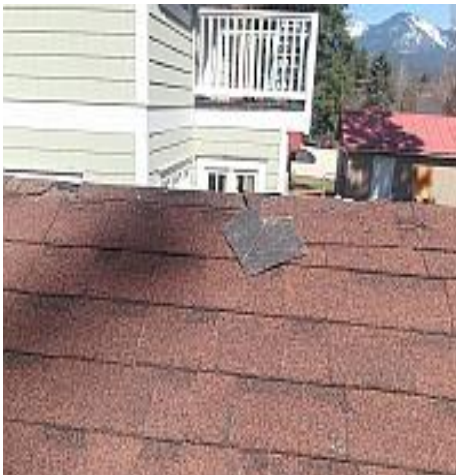
Missing/damaged shingles observed. Recommend Repair/Replacement.

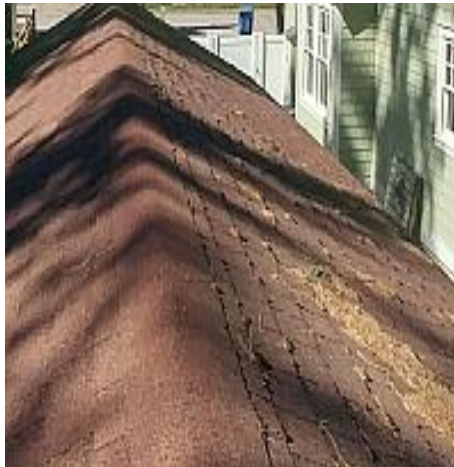
Moss/lichen growth observed. This growth can, over time, deteriorate a roof cover. Recommend Removal.

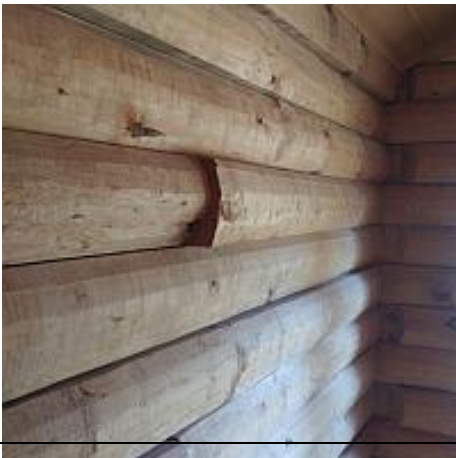
Numerous offset logs observed. This home is constructed of single tongue and groove milled logs. These types of log are designed to fit tightly together. The tongue and groove should help minimize the type of offsetting observed.

Inspector's Note: The home could have been built this way. Logs of different diameters would explain the offsetting.

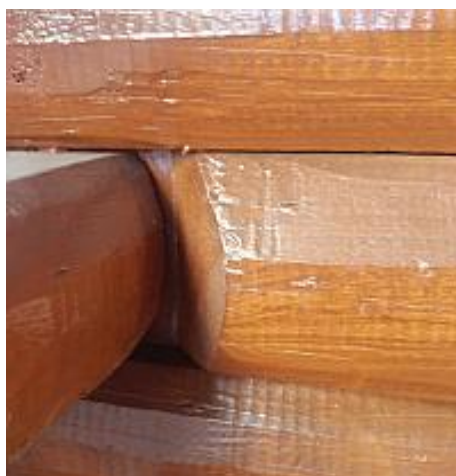
There is no visible chinking/sealing between the logs. There are several large gaps observed. Chinking helps seal out moisture and air and helps with the overall insulation of the structure. Recommend Repair.

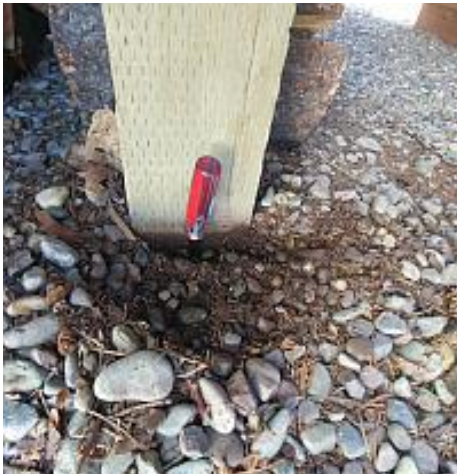
There are no visible footings (the inspector probed down six inches and could not find footings). Footings help stabilize a structure and help prevent settling. Recommend Replacement.

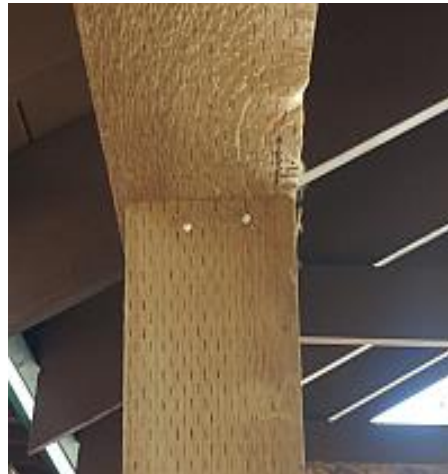
There is no indication of positive attachment between the piers and beam. The piers are secured to the beam by nails toenailed into the structure. The inspector recommends gusset plates (illustrated) to ensure positive attachment.

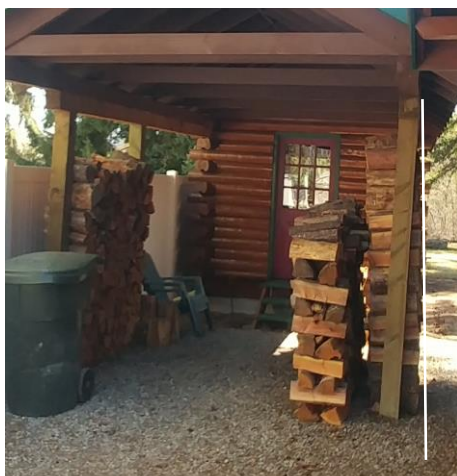
The entry structure is leaning noticeably. This is a Major Concern. Recommend Repair.

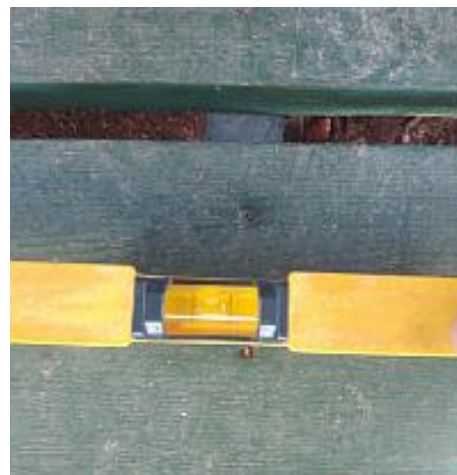
The steps are in Satisfactory Condition. Properly pitched.

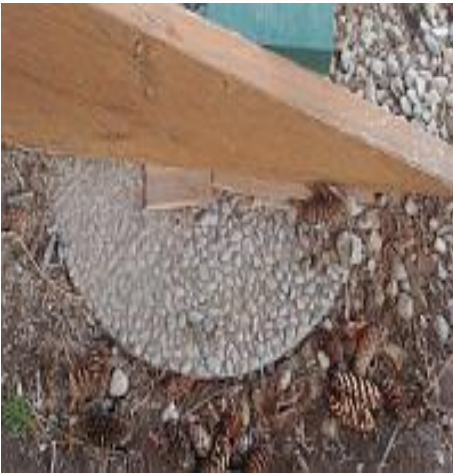
Proper treated wood used for contact with concrete.

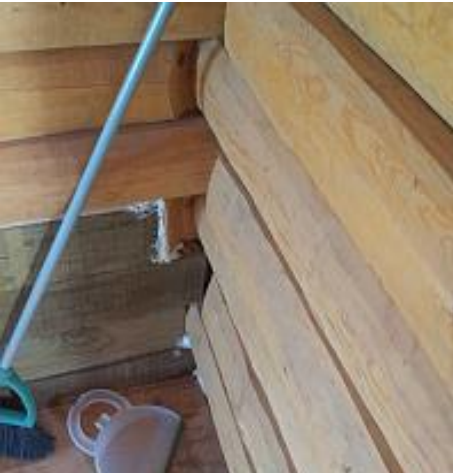
The walls are in overall Satisfactory Condition. There is visible caulking in some areas.

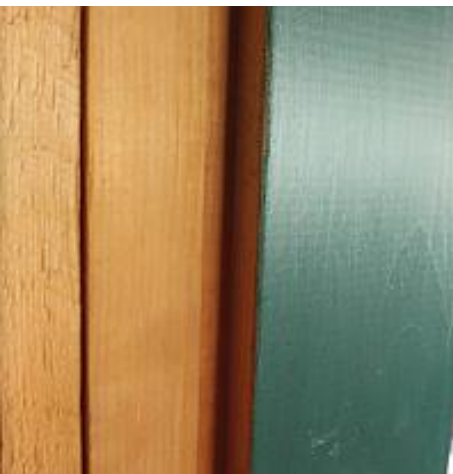
The door is not weather stripped. Recommend Replacement.

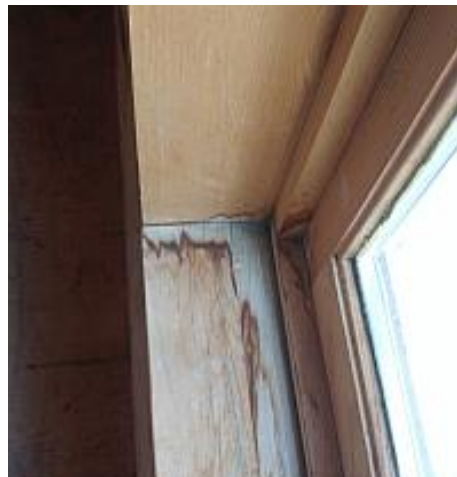
Moisture stains observed on the window sill. Although the area tested dry with a moisture meter, the stains came from somewhere. Recommend Repair.

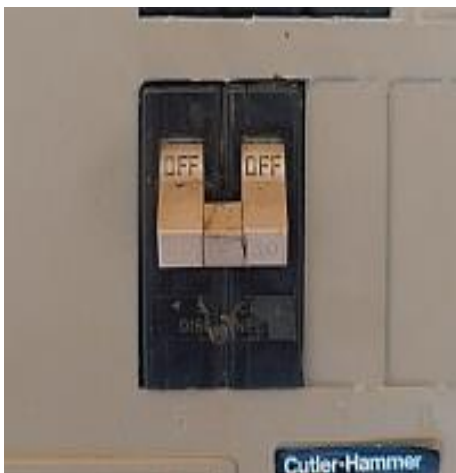
Power to the building was turned off at the sub panel. The electric system could not be tested.

Wiring should not be exposed within a living area. Recommend Repair.

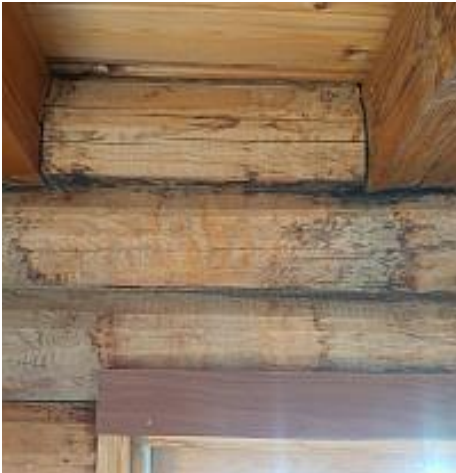
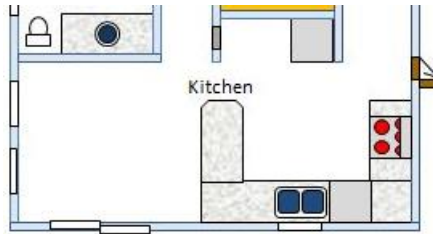
There are numerous moisture stains on the walls, particularly where indicated. While testing with a moisture meter showed the walls to be dry, the stains came from somewhere. Anytime there is

moisture penetration there is the possibility of hidden damage. Recommend Repair.

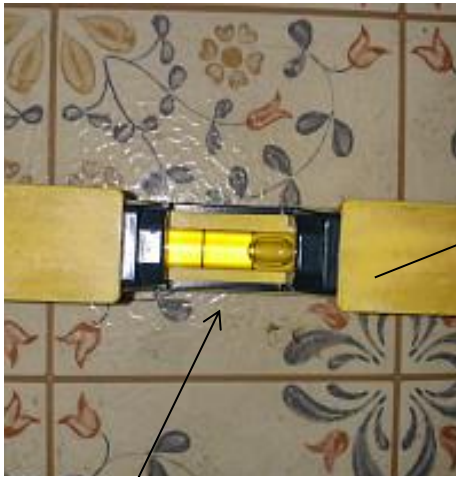
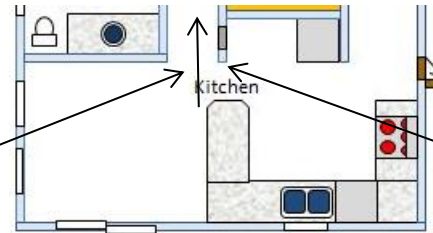
The floor is noticeably sloped where indicated. Recommend Repair.

The floor is holed where indicated and loose at the edges (no baseboard trim installed). Recommend Repair.

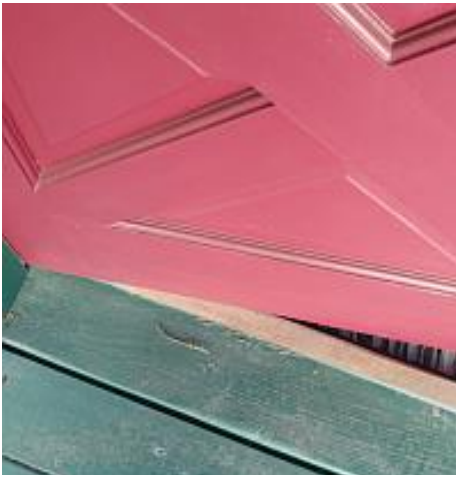
The door scrapes on the threshold when opened/closed. Recommend Repair/Adjustment.

The door has to be lifted slightly for the dead bolt to engage. Recommend Repair/Adjustment.

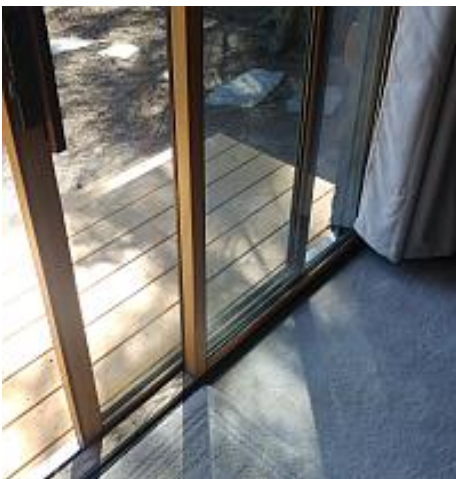
The sliding glass door is installed backwards (the track is on the exterior). This makes to door relatively easy to remove from the exterior and difficult to secure. Recommend Repair.

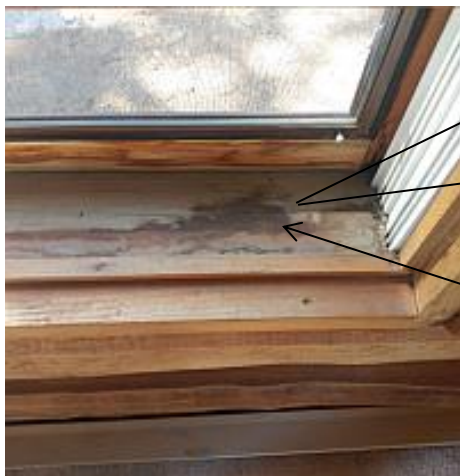
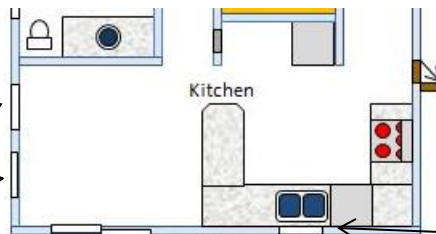
Moisture stains observed in the windows indicated. Indications of leaking insulated glass observed in the window indicated. Recommend Repair/Replacement.

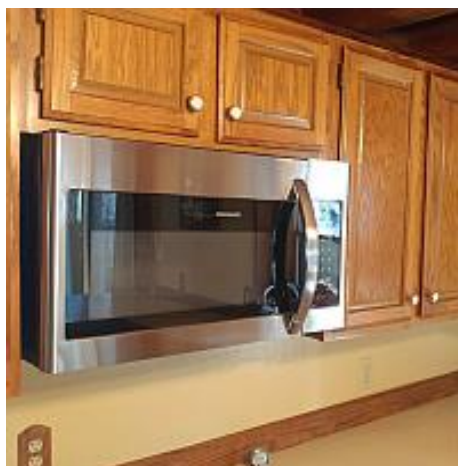
The exhaust fan vents into the kitchen. Exhaust fan must be vented to the exterior unless alternate mechanical or natural ventilation (window) is provided. It is always recommended that kitchen exhaust fans be vented to the exterior.

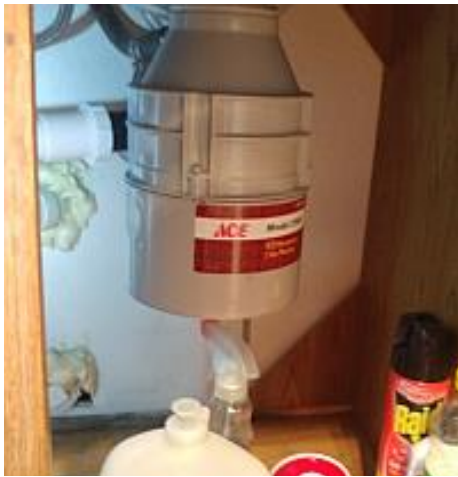
The disposal is not operating.
Recommend Repair/Replacement.

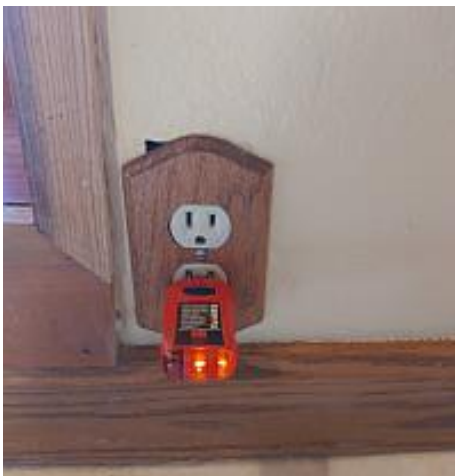
The kitchen outlets are not GFCI. While required by current standards, this home was constructed before those standards were in place. It is highly recommended that all kitchen outlets be GFCI. Recommend Repair/Replacement.

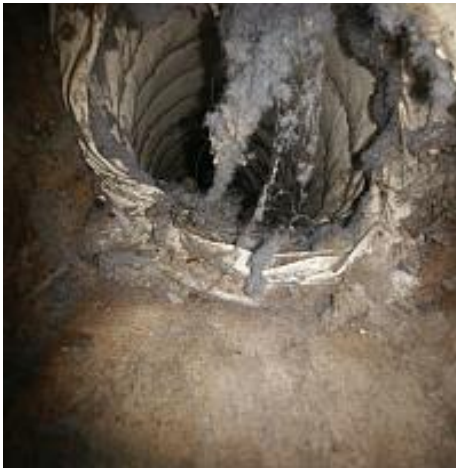
Dryer duct properly vented to the exterior.

Dryer duct is dirty. Recommend cleaning and annual cleaning thereafter.

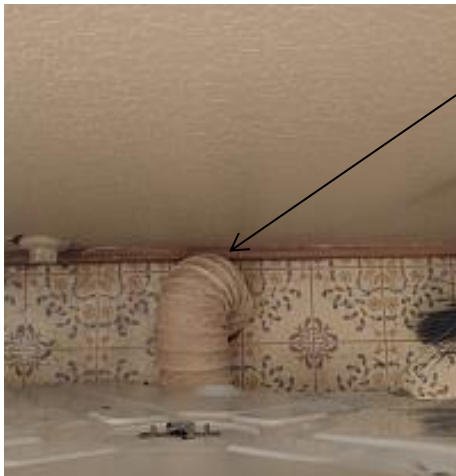
Wire bound vinyl or plastic ducting is being used to connect the dryer to the dryer duct. This ducting can melt and will not contain a fire within the dryer.

The most preferred material for connecting the dryer to dryer duct is aluminum flexible duct.

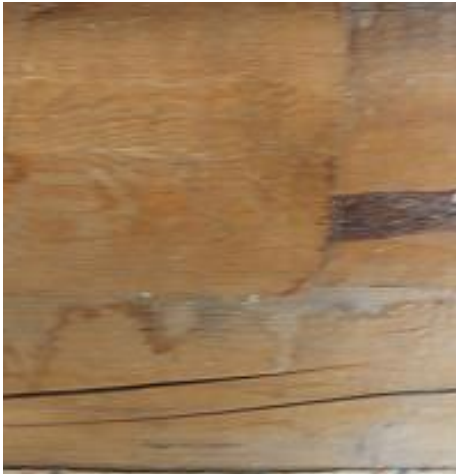
There are numerous moisture stains on the exterior wall and bubbled paint on the ceiling. While testing with a moisture meter showed the walls to be dry, the stains came from somewhere. Anytime there is moisture penetration there is the possibility of hidden damage. Recommend Repair.

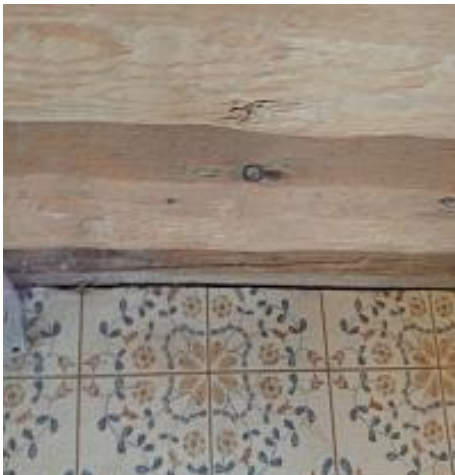
The floor is gapped at the wall junction (there is no base board trim installed). Recommend Repair.

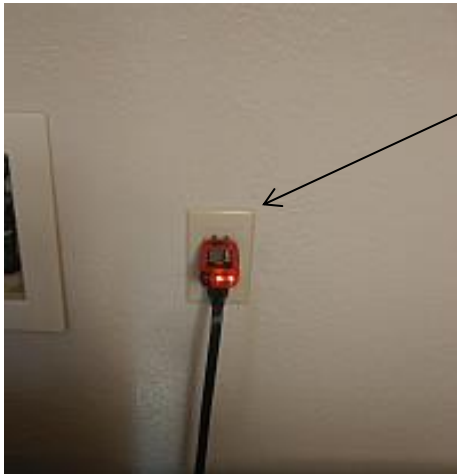
The GFCI for the countertop outlet is in the main electric panel. The outlet indicated is not GFCI. Current standards call for all bath outlets to be GFCI. This is a potential Safety Hazard. Recommend Repair/ Replacement.

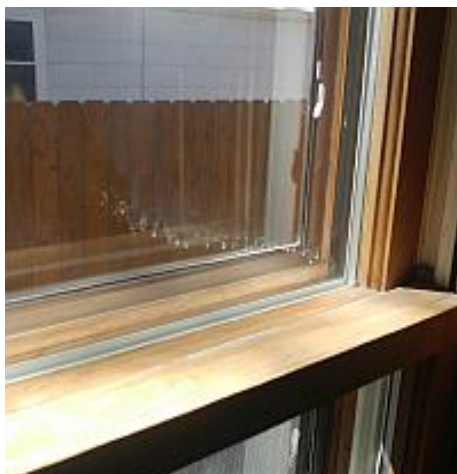
Indications of leaking insulated glass observed. Recommend Replacement.

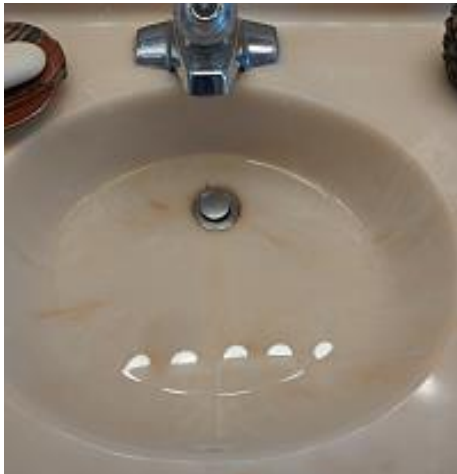
The sink drains slowly. Recommend Repair.

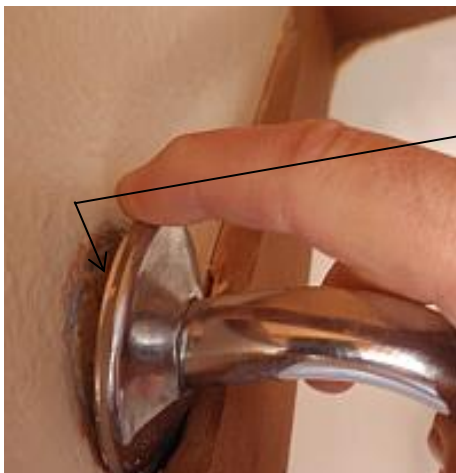
Recommend calking where indicated to help prevent moisture penetration into the walls.

The showerhead is leaking. Recommend Repair.

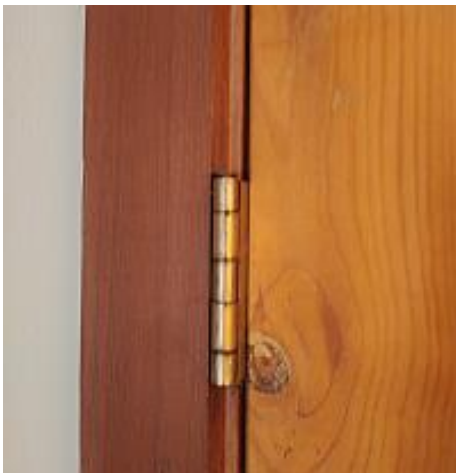
The upper hinge squeaks. Recommend Repair (lubrication).

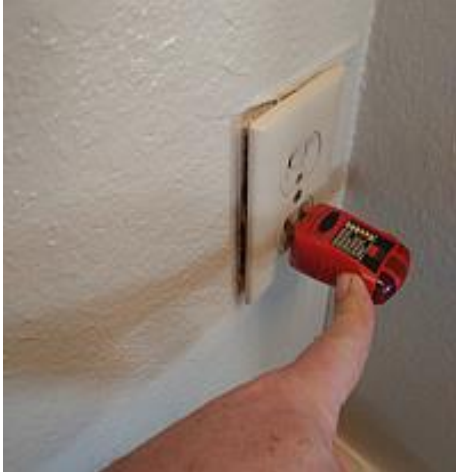
The GFCI is in the main electric panel. The outlet is loose. Recommend Repair.

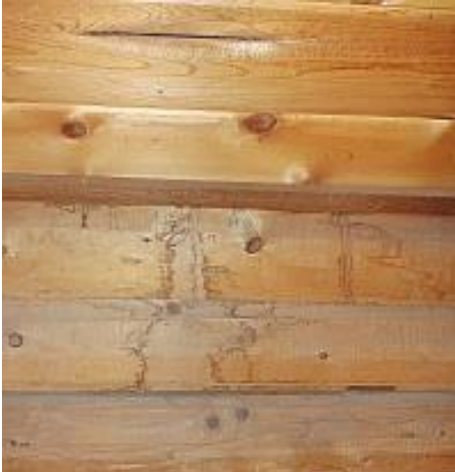
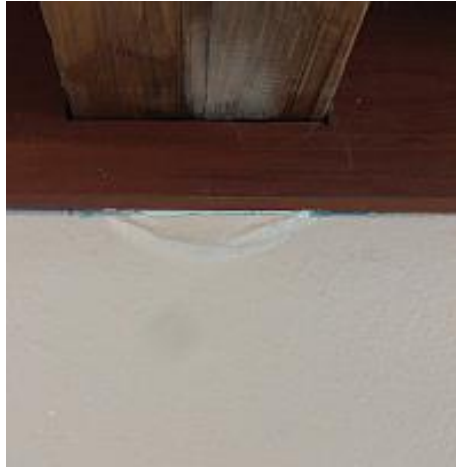
There are numerous moisture stains on the exterior walls and bubbled paint on the walls. While testing with a moisture meter showed the walls to be dry, the stains came from somewhere. Anytime there is moisture penetration there is the possibility of hidden damage. Recommend Repair.

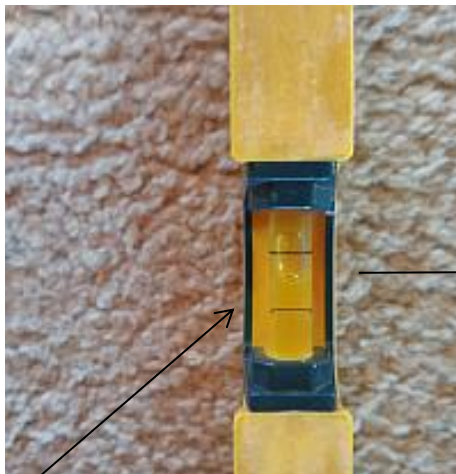
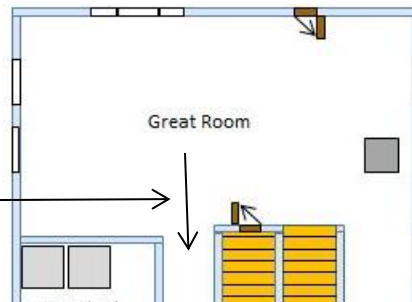
The floor slopes where indicated. Recommend Repair.

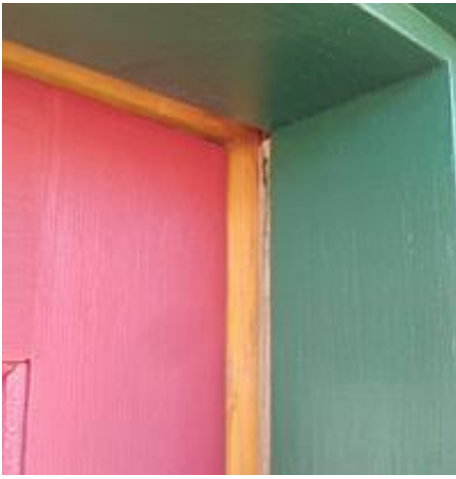
Door scrapes on the frame when opened/closed. Recommend Repair/Adjustment.

The door is gapped where indicated. Recommend Repair/Adjustment.

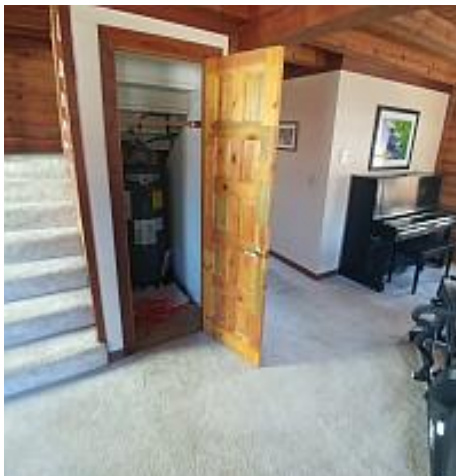
The door to the water heater scrapes on the floor cover when opened/closed. Recommend Repair/Adjustment.

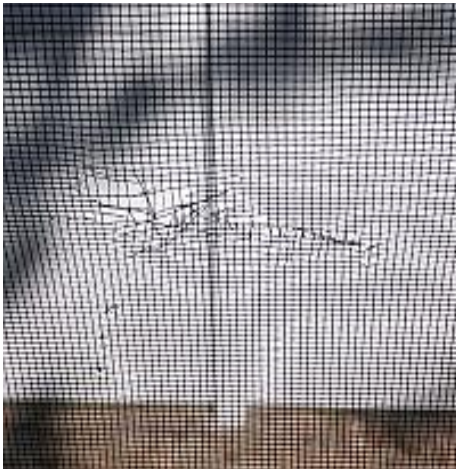
The screens in both windows are holed. Recommend replacement.

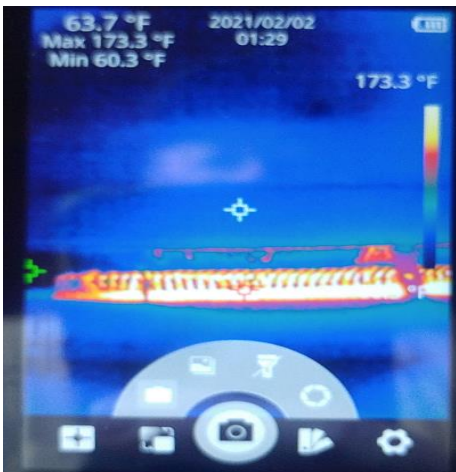
The baseboard electric heater is operating.

Inspector’s Note. These heaters are not maintenance free. Annual cleaning of the heating element is recommended. Without preventative maintenance the heating element can clog with dust and as a result the unit can run hot.

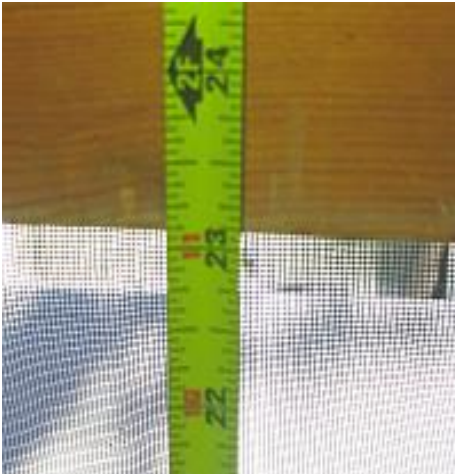
The window is too small and does not open far enough to be considered an egress window. Recommend Replacement.

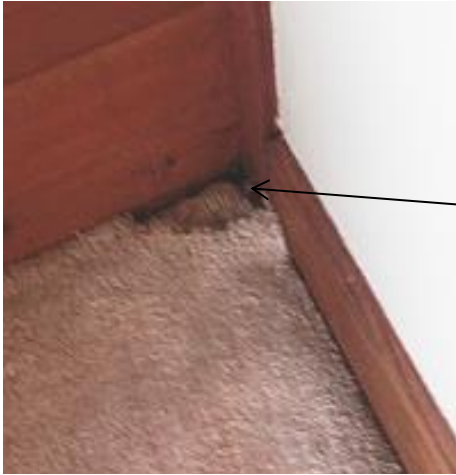
The carpet where indicated is torn/missing. Recommend Repair.

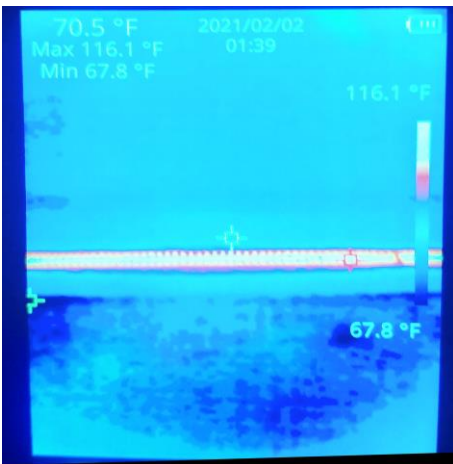
The baseboard electric heater is operating.

Inspector's Note. These heaters are not maintenance free. Annual cleaning of the heating element is recommended. Without preventative maintenance the heating element can clog with dust and as a result the unit can run hot.

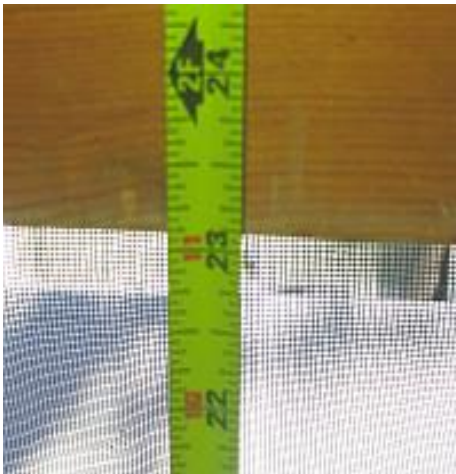
The window is too small and does not open far enough to be considered an egress window. Recommend Replacement.

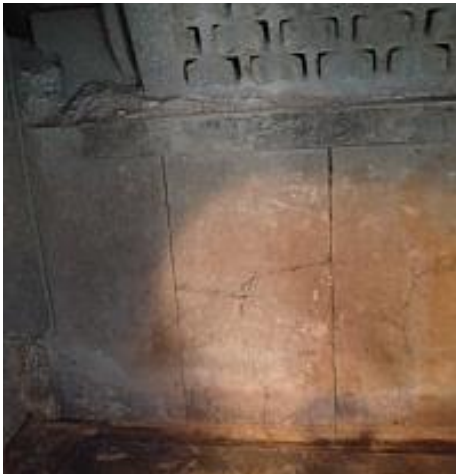
The cracked fire bricks are typical. The door gasket is showing expected indications of wear.

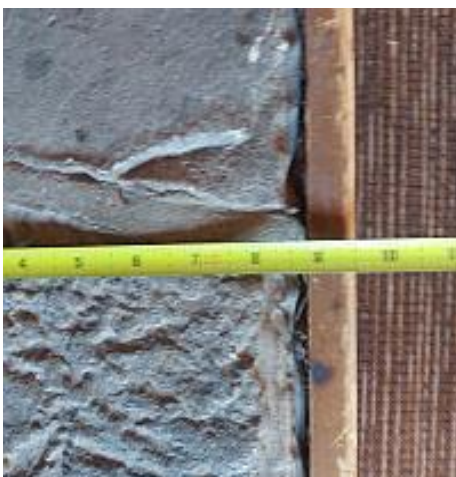
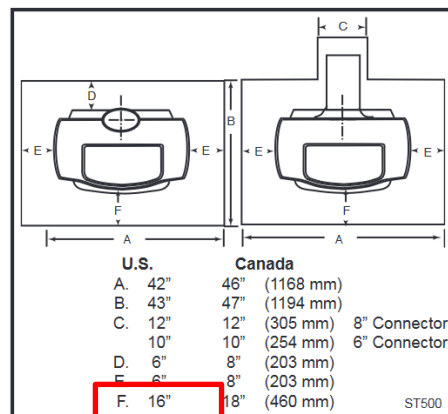
According to the owner’s manual there should be 16 inches of hearth in front of the unit. The hearth only extends 9 inches to the front of the unit. This is a potential Safety Hazard. Recommend Repair.

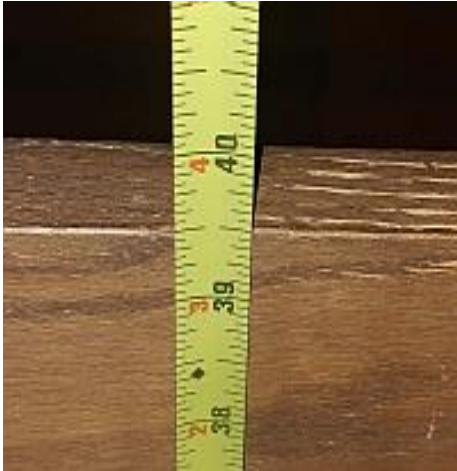
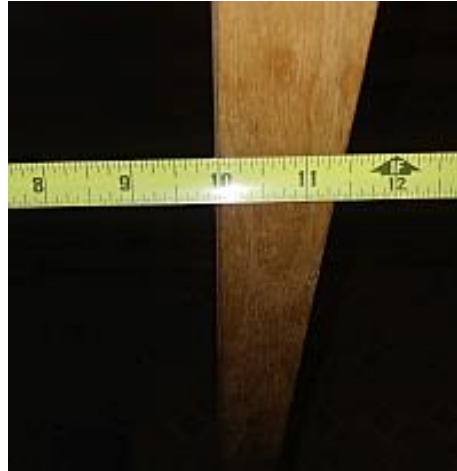
The stair guard/stair rail is the proper height (36 inches minimum). The balusters are not properly spaced (4 inches maximum). Recommend Repair.

All of the stair guards/rails and balcony rails are loose to some degree. Recommend Repair.

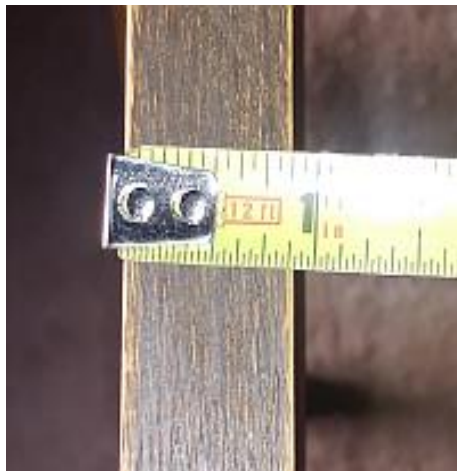
The grip surface is not proper. Illustrated are a few (but not the only) types of proper grip surfaces. Recommend Replacement.

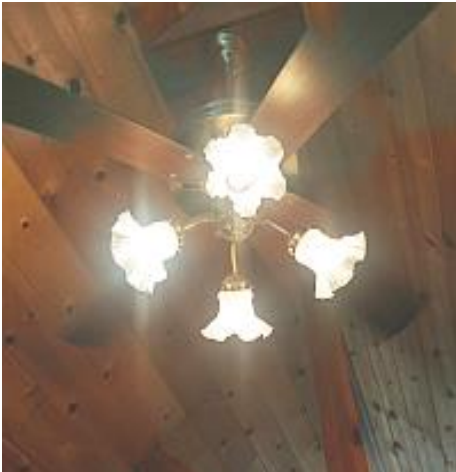
The ceiling fan is operating.

The variable speed controller will only turn the ceiling fan on – it does not vary the speed. Recommend Replacement.

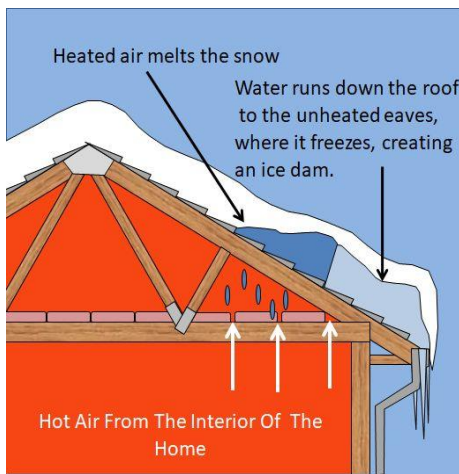
Inspector’s Note: A word about ice damming. There is a possibility that the moisture stains seen throughout the home on the walls and ceiling are the result of ice damming. As mentioned previously in this report, the attic ventilation is not adequate. This could allow heat from the interior of the home to melt snow on the roof, which can cause ice damming. Correcting the attic ventilation could correct this problem.

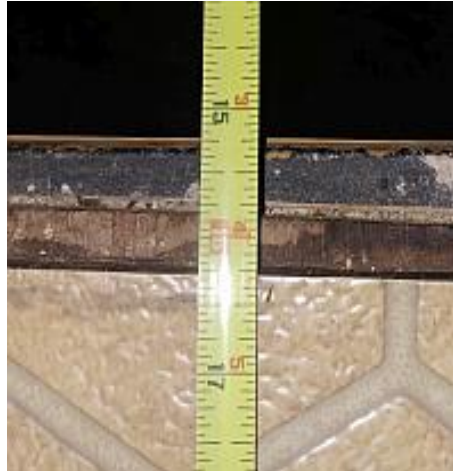
The crawl space access is too small (18 x 24 inches minimum). IN addition to being too small the access is blocked by one electric and two water lines that run across the crawl space opening. Because of this the inspector was not able to get completely into the crawl space.

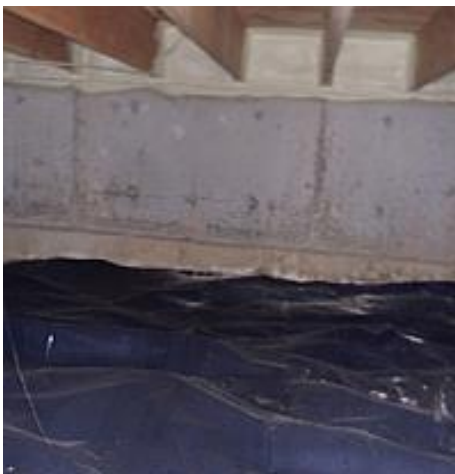
The visible foundation walls are in Satisfactory Condition.
