Inspection Date: 12th of Never

Prepared For: Jane and John Doe

Gunstock Home Inspection LLC
33136 East Bay Lane Polson, MT 59860
(406) 887-2058 (406) 253-8333
montanamike1@centurytel.net

Report Number: 12000000

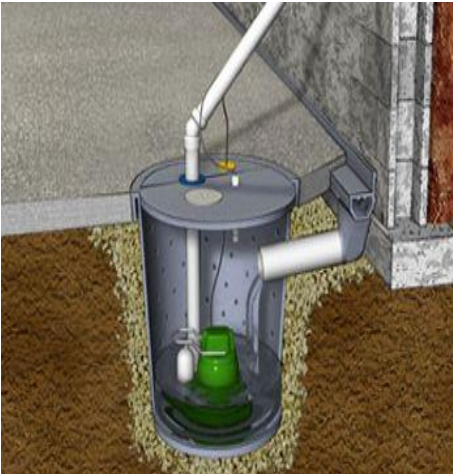
The inspector always recommends drainage of some type. If a sump pump is to be installed a sealed crock unit (illustrated) is recommended.

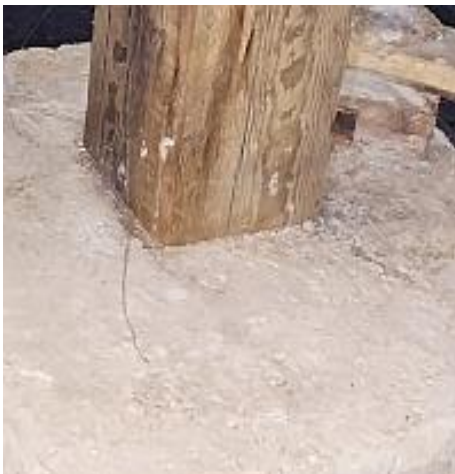
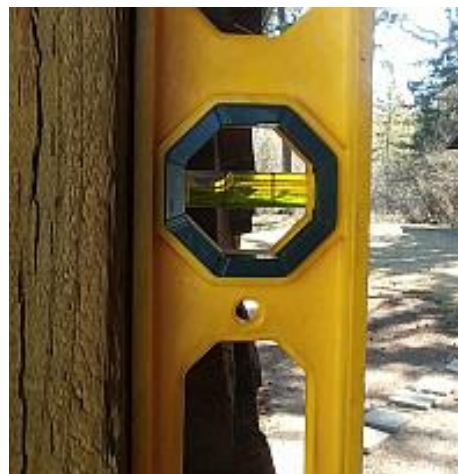
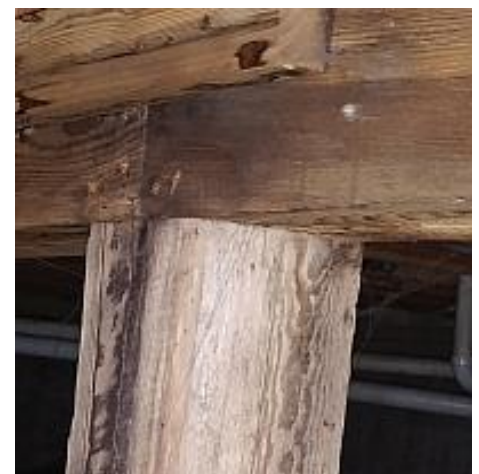
Wood to concrete contact. Untreated wood should never be allowed to be in contact with concrete (can cause deterioration).

There is no indication of positive attachment between the piers and beam. The piers are secured to the beam by nails toenailed into the structure. The inspector recommends gusset plates (illustrated) to ensure positive attachment.

No deterioration detected at the time of the inspection. Recommend Monitoring.

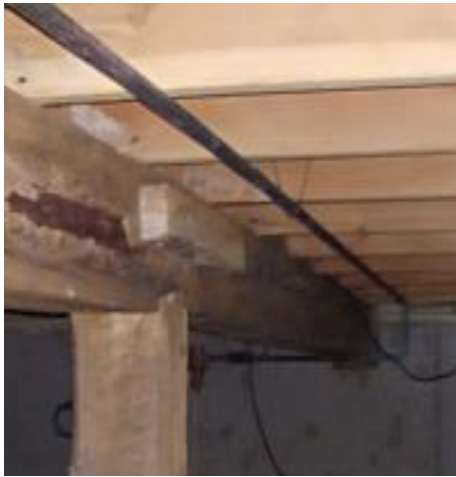
The joists are in Satisfactory Condition. Proper overlap of the beam observed.

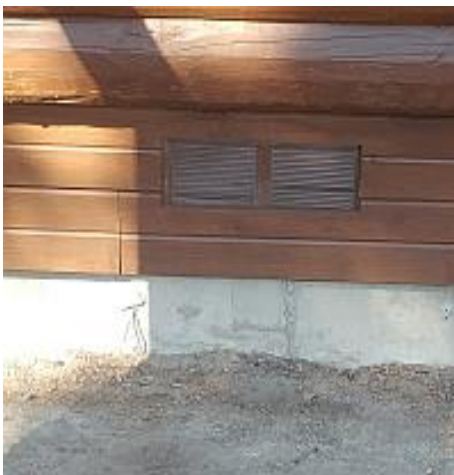
The ventilation does not appear adequate. There is only one visible wall vent. Recommend Repair.

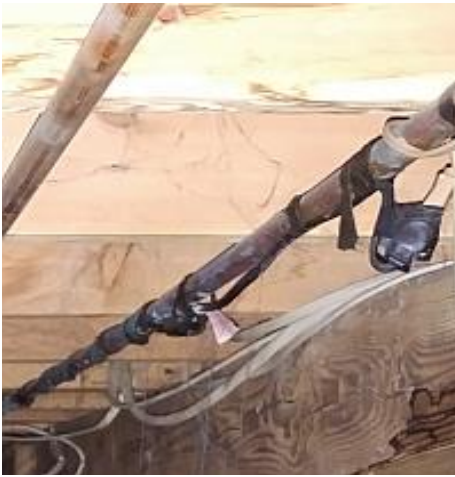
Some (not all) of the water lines are wrapped in heat tape. The heat tape is plugged into extension cords that run out of the crawl space and into the home (the heat tape was not plugged in at the time of the inspection). Extension cords are not a substitute for permanent wiring.

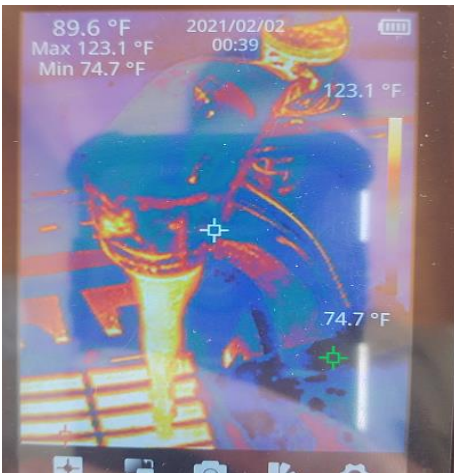
Water temperature is 123.1°F. A water temperature of 120°F is considered optimal for domestic use.

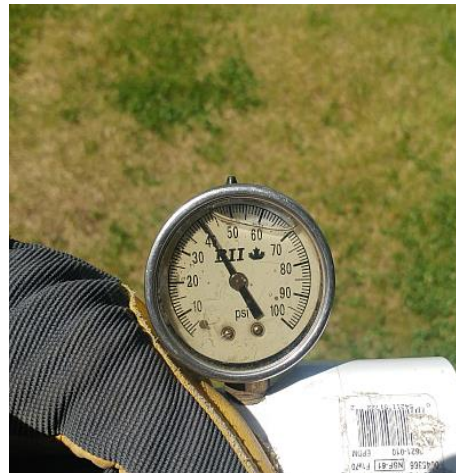
The water pressure is 40psi, which is within acceptable limits.

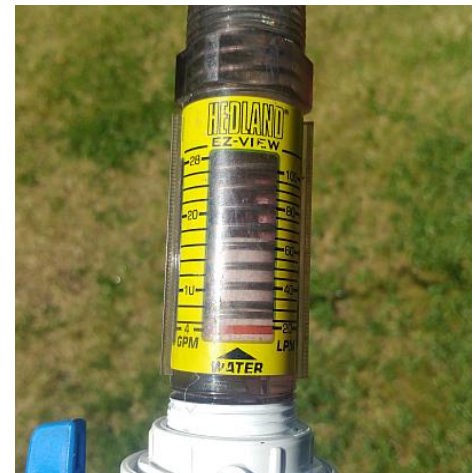
The flow rate is 6 gpm, which is within acceptable limits.

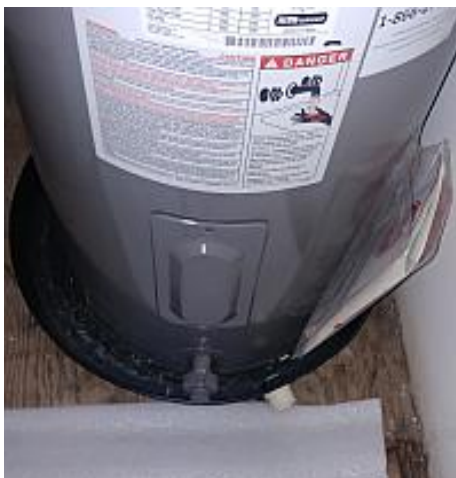
Proper drip pan installed. Current standards state that where water heaters tanks are installed in locations where leakage of the tanks or connections will cause damage, the tank shall be installed in a galvanized steel pan having a minimum thickness of 24 gage, or other pans approved for such use. Ideally the pan should be plumbed to an approved drain.

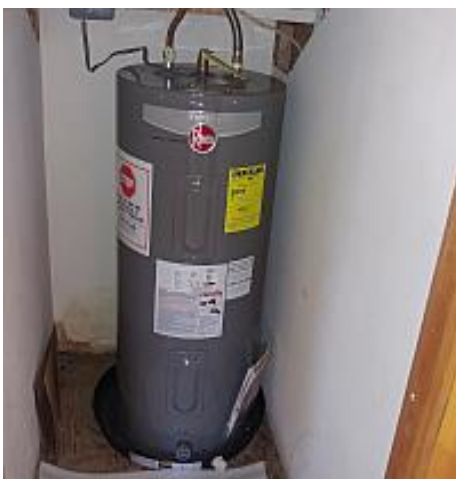
There are no seismic restraints on the water heater. Current standards require seismic restraints in this region of Montana. Water heaters shall be anchored or strapped to resist horizontal displacement due to earthquake motion. Strapping shall be at points within the upper one-third (1/3) and lower one third (1/3) of its vertical dimensions. At the lower point, the strapping will be a minimum distance of four (4) inches above the controls.

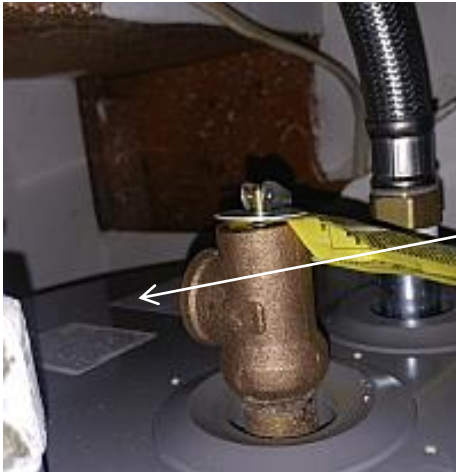
The temperature /pressure relief (TPR) valve extension is missing. This is a potential Safety Hazard. Recommend Replacement.

The temperature /pressure relief valve extension is typically made of a heat resistant material (copper and galvanized are common). It must extend to with 6 inches of the floor and terminate in a non-threaded end.

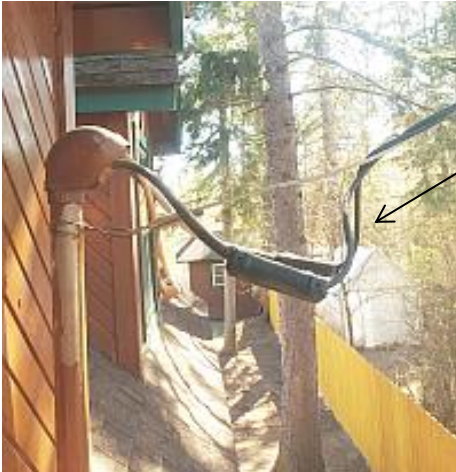
The drip loop is not properly installed. The drip loop should channel runoff away from the splices. Recommend Repair.

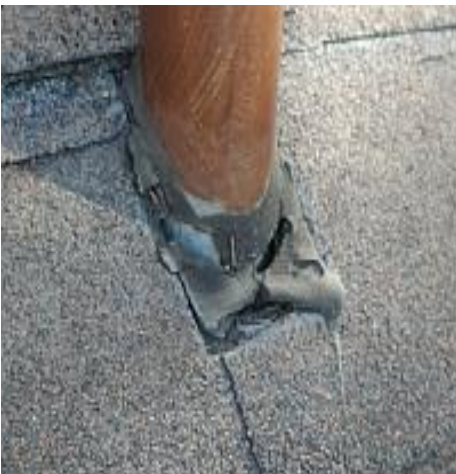
The weather boot is cracked/holed. This is a Major Concern. Recommend Replacement.

The service mast and conductors are less than 3 feet from an opening window. Overhead service conductors must maintain a clearance of 3 feet from windows that open or similar locations. This is a potential Safety Hazard. Recommend Repair.

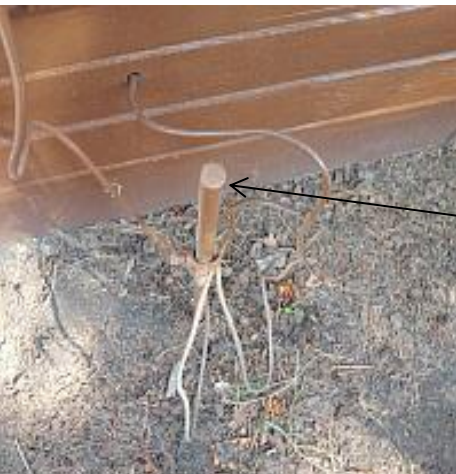
The ground is not proper. All of the grounding rod must be buried. A portion of the grounding rod is visible above ground. This is a Major Concern. Recommend Repair.

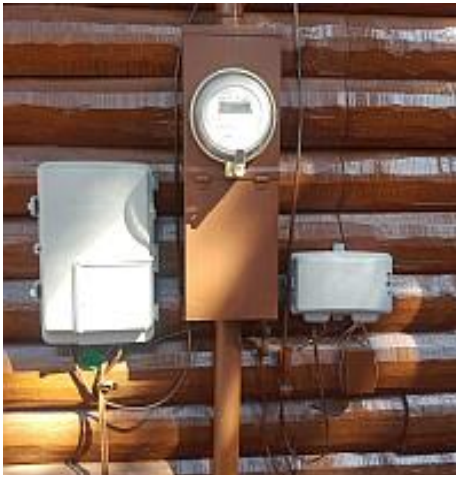
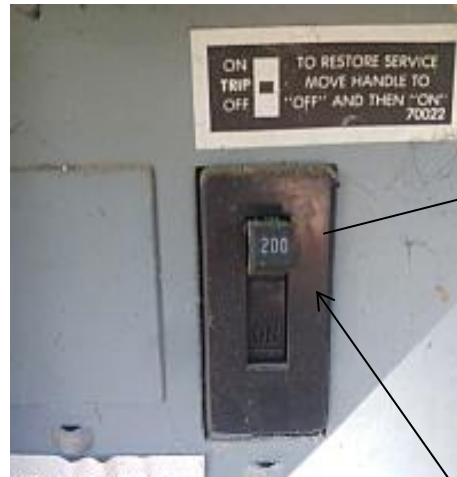
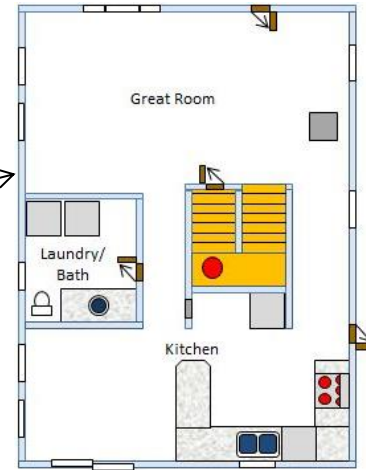
The exterior service panel is in Satisfactory Condition. This is also the location of the main electrical disconnect.

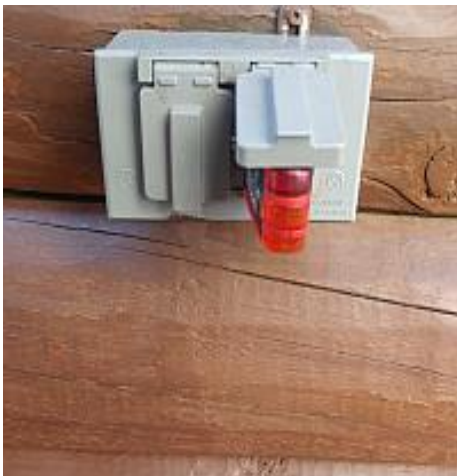
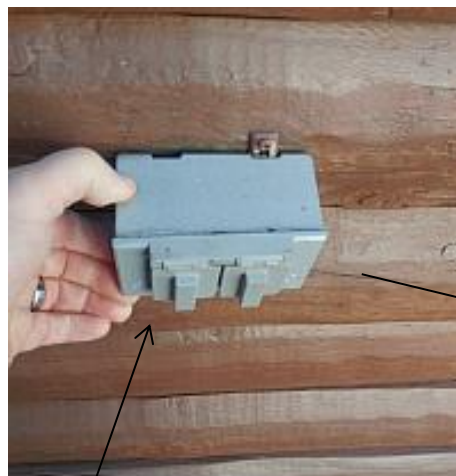
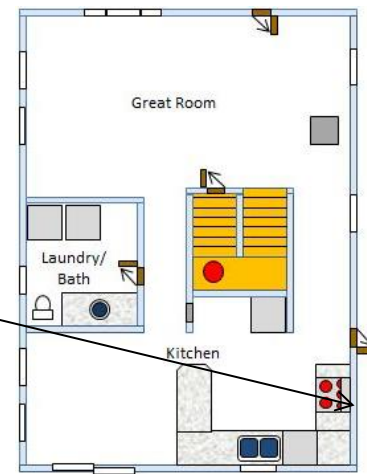
All exterior outlets tested are GFCI. The GFCI is in the main electric panel.

The outlet where indicated is loose. Recommend Repair.

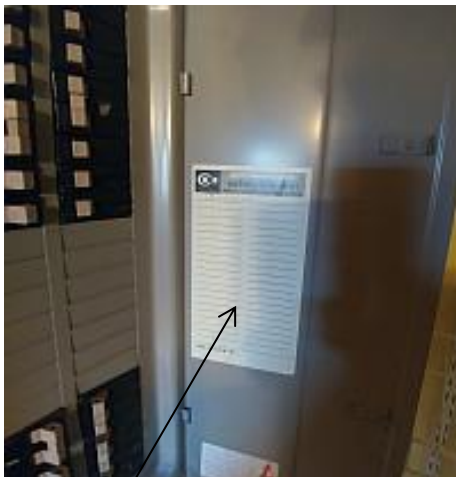
The breakers are not labeled.
Recommend Repair.

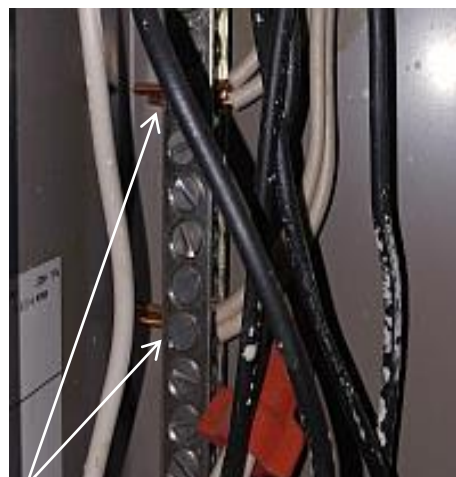
There are numerous double tapped neutral and ground wires. Unless otherwise marked these terminals are designed for one wire per lug. Recommend Repair.

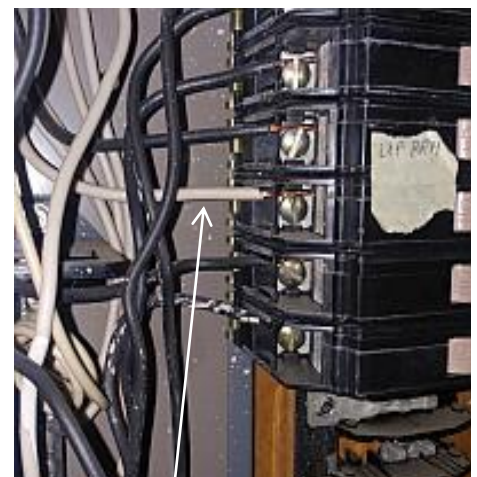
White (neutral) wires used as black (live or line) wires should be color coded black or red with electricians tape.

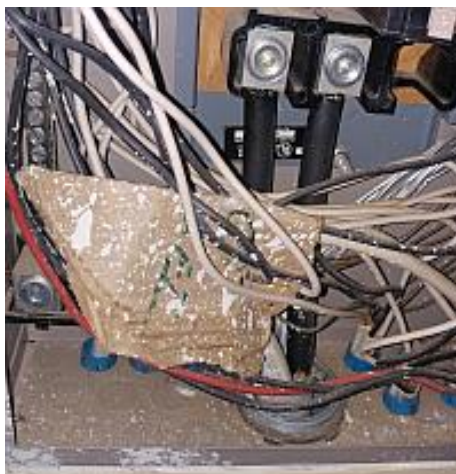
A piece of cardboard is being used to label a wire. There are (nonflammable) products designed specifically for this. Recommend

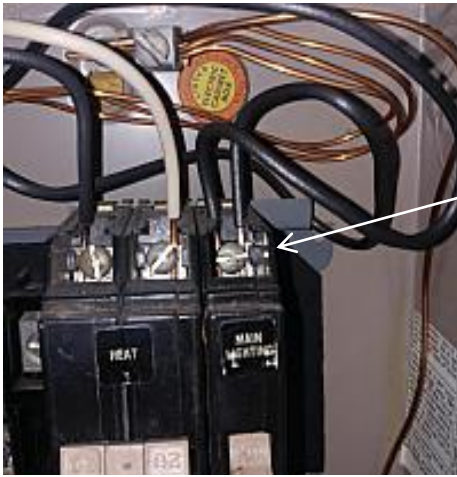
Double tapped breaker where indicated. This is a potential Fire and Safety Hazard. Recommend Repair.

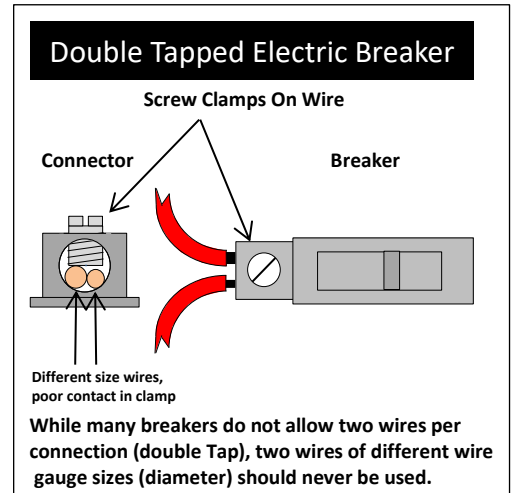
A double tapped circuit breaker (Two wires entering the same breaker from two separate circuits) is one of the most common electrical defects found when checking the main electric panel. The problem with putting two wires in a circuit breaker designed to hold one is that the wires could become loose, even if they feel very tight. Loose wires can lead to overheating, arcing, and possible fire.

When this condition is observed it is always recommended that the breaker be checked for safety by a licensed electrician

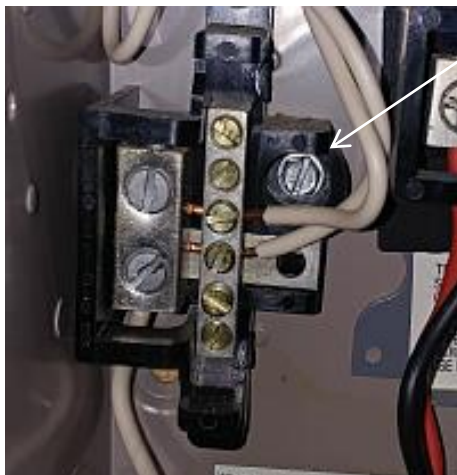
The bonding screw has not been removed. This means the neutrals and grounds are not isolated (required on a sub panel). This is a potential Safety Hazard. Recommend Repair.

Scorching observed on the main wire indicated. This can be an indication of overheating. This is a potential Safety Hazard. Recommend Repair.

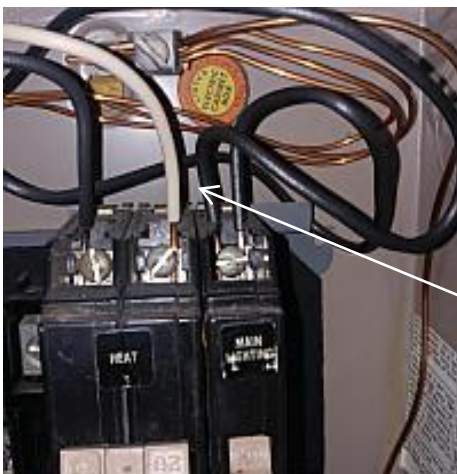
There are numerous double tapped neutral wires. Unless otherwise marked these terminals are designed for one wire per lug. Recommend Repair.

White (neutral) wires used as black (live or line) wires should be color coded black or red with electricians tape.

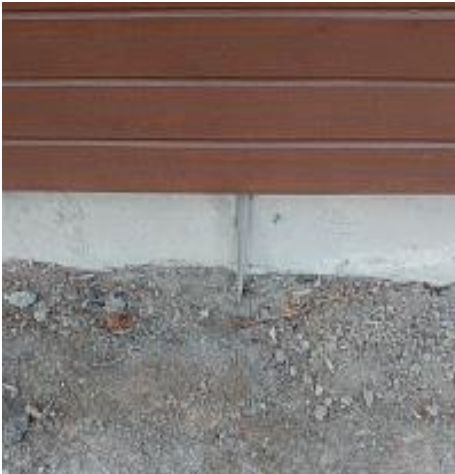
The electric line to the guest house is exposed (should be in conduit).
Recommend Repair.
