**Inspection Date: 12<sup>th</sup> of Never**

**Prepared For: John and Jane Doe**

Gunstock Home Inspection LLC

**Report Number: JJD12NEVER**

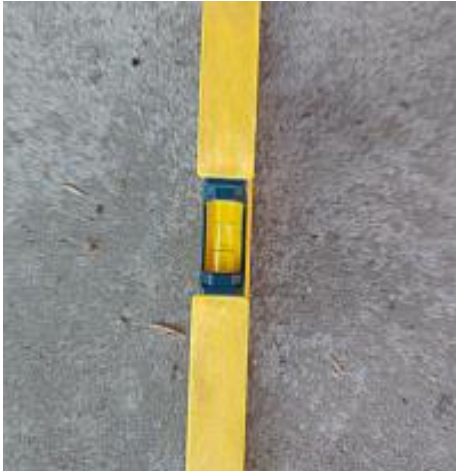
The service walks are in Satisfactory Condition. Properly pitched away from the home.

Minor scaling observed. Repairs would be cosmetic.

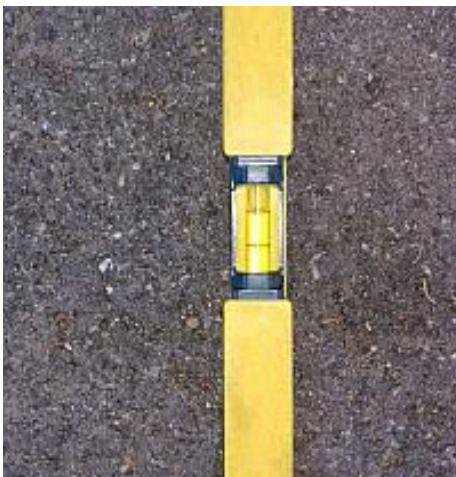
The driveway is in Satisfactory Condition. Properly pitched away from the building.

The driveway is properly pitched toward a central drain.

Typical cracks on driveway. No indication of recent movement, no trip hazard.

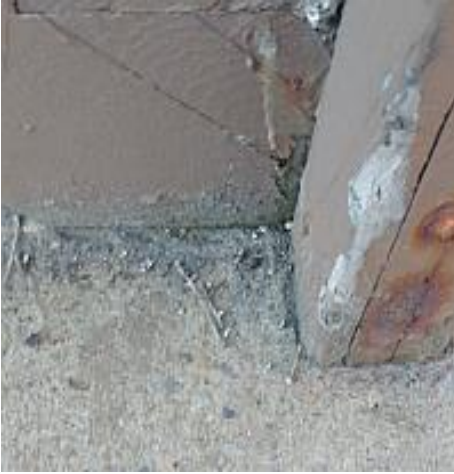
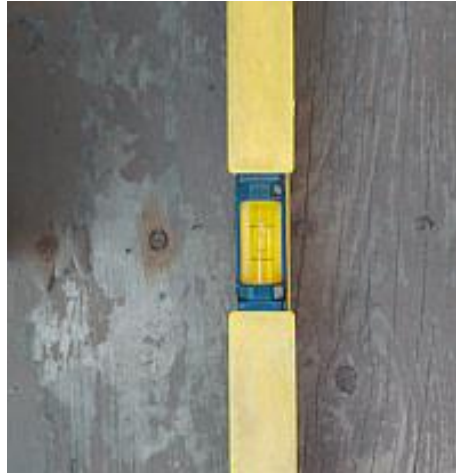
Wood to concrete contact. Untreated wood should never be allowed to be in contact with earth/concrete (can cause deterioration). No deterioration detected at the time of the inspection. Recommend Monitoring.

The steps are properly pitched.

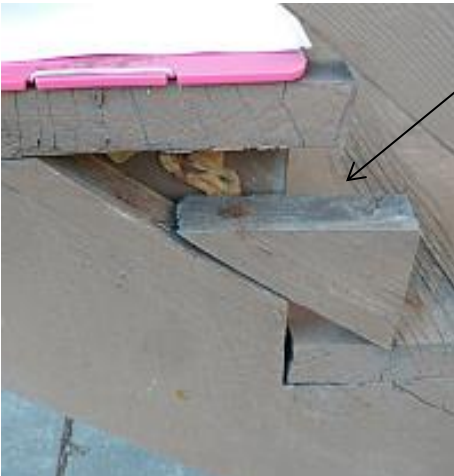
Cracks observed in the stringers. One step support is completely loose. This is a Major Concern. Recommend Repair/Replacement.

The steps are weathering. Recommend prepping and sealing (painting/staining). Recommend Repair.

There is too much of a gap in the open risers (4 inches maximum). Recommend Repair.

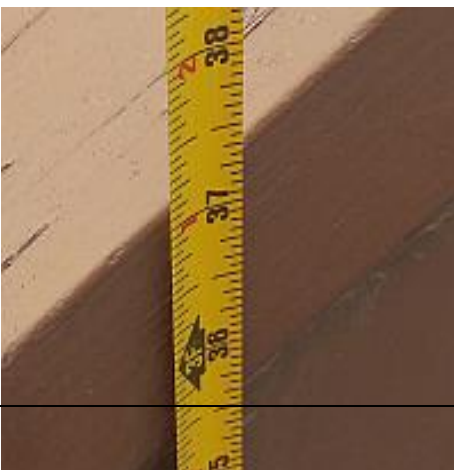
The railing is the proper height. Balusters are improperly spaced. Recommend Repair.

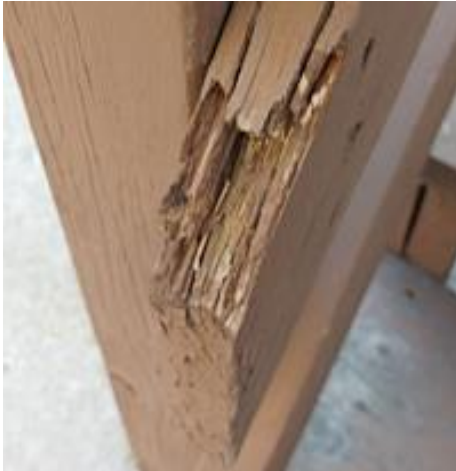
The railing is deteriorated in areas. This is a Major Concern. Recommend Repair/Replacement.

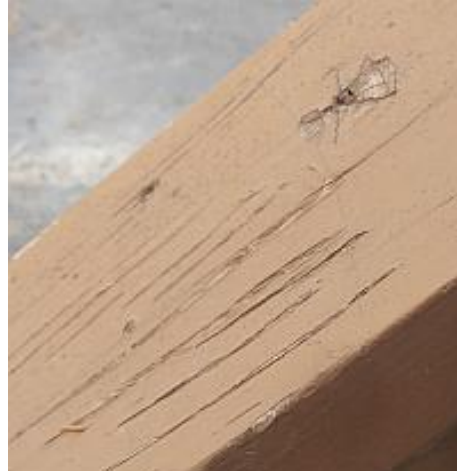
The railings are weathering. Recommend prepping and sealing (painting/staining). Recommend Repair.

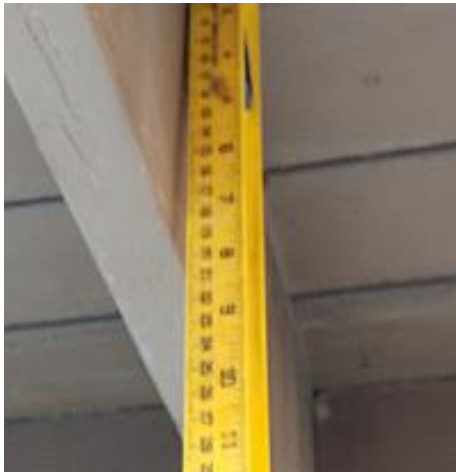
The floor is cantilevered 47 inches. According to current standards, cantilevers can extend up to one-fourth the back span of the joist. So the un-spliced joist would have to span 16 feet to allow the additional 47 inch cantilever. The joist structure is not visible so the inspector cannot make a determination if the cantilever is proper.

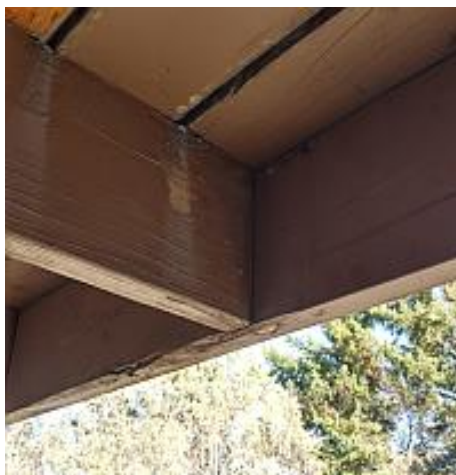
There are no joist hangers installed on the rim joist. Although not specifically required as the rim joists carry little load on a cantilevered deck, the inspector recommends properly installed joist hangers to help ensure positive attachment between the joists and rim joist.

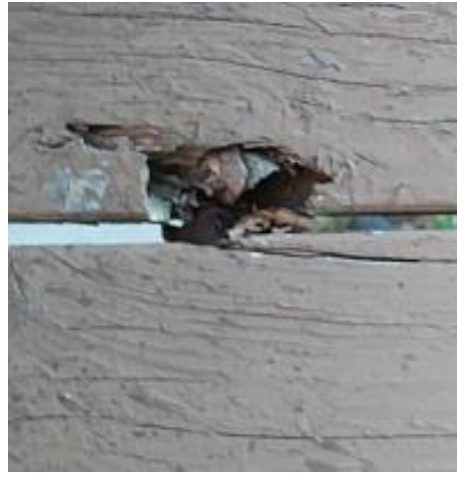
The floor is deteriorated in several areas. This is a potential Safety Hazard. Recommend Repair/ Replacement.

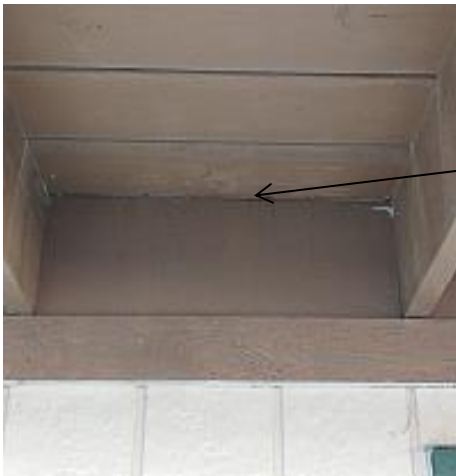
The floor is not flashed. Flashing helps prevent moisture intrusion at the deck/home junction. If the floor is ever replaced recommend flashing be added.

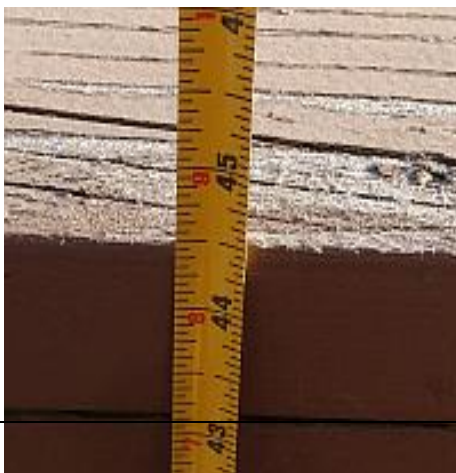
The railing is the proper height. Balusters are properly spaced.

Balusters are improperly spaced. Recommend Repair.

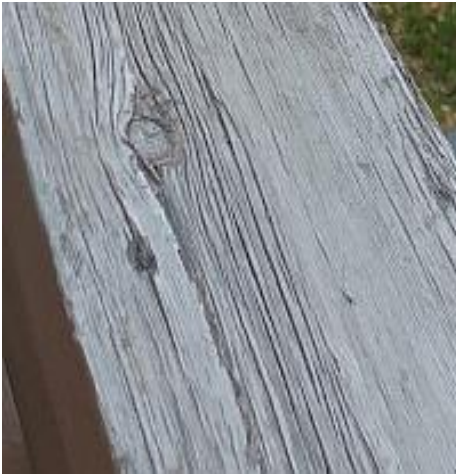
The railings are weathering. Recommend prepping and sealing (painting/staining). Recommend Repair. The railing is slightly loose. Recommend Repair

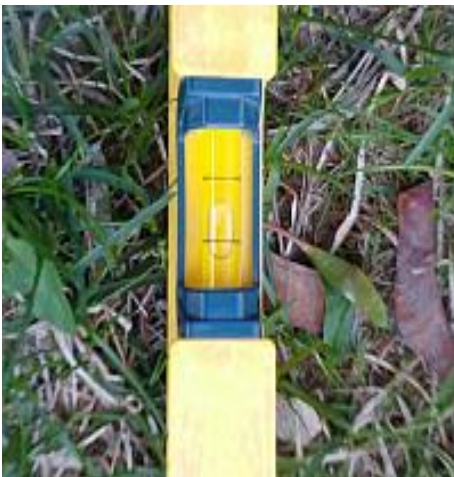
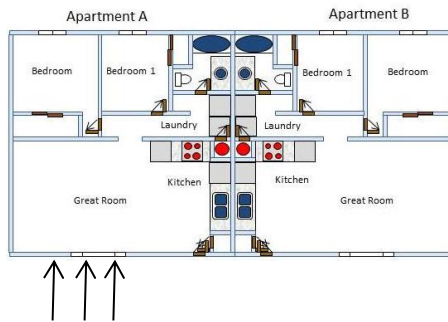
Negative grade where indicated. Recommend Repair (backfill).

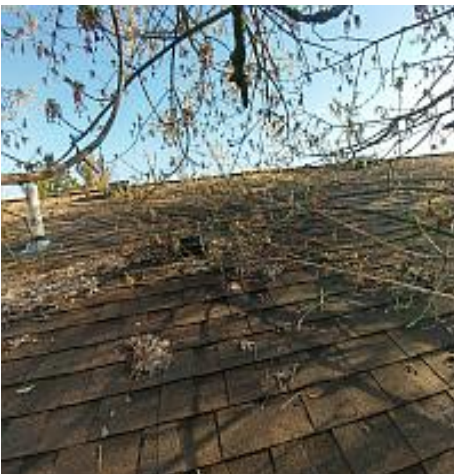
Vegetation where indicated is in direct contact with/overgrowing the structure. Recommend Trimming

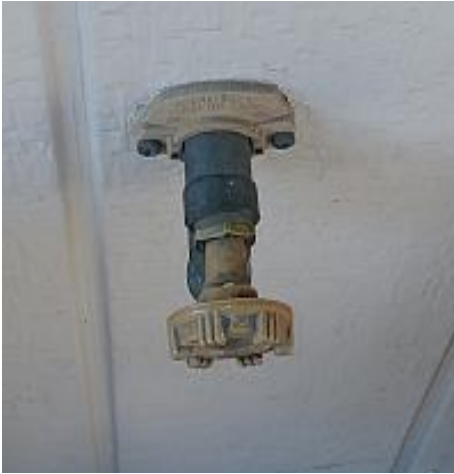
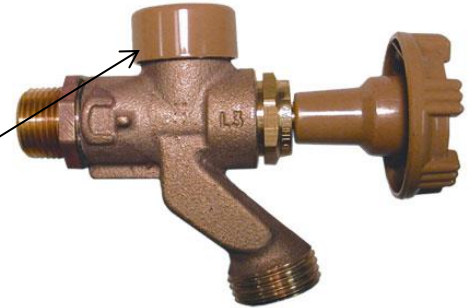
External faucets (bibs) should have either a frost free valve or a means of internally turning the water off (isolation valve) to keep them from freezing in temperatures below 32°F.

No anti-siphon valve installed on the external faucets (bibs). This valve prevents water from the bib or attached hose from inadvertently being siphoned back into the homes water supply. Illustrated is one (but not the only) type of bib with an anti-siphon valve built in. Recommend Replacement.

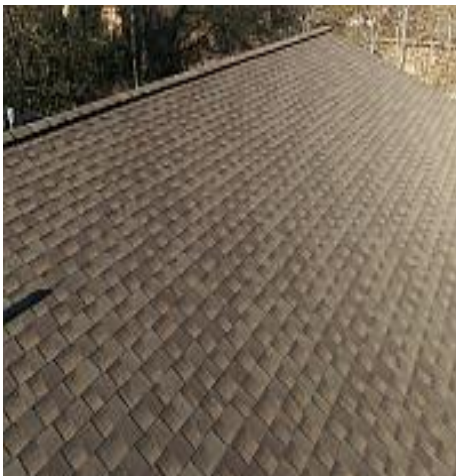
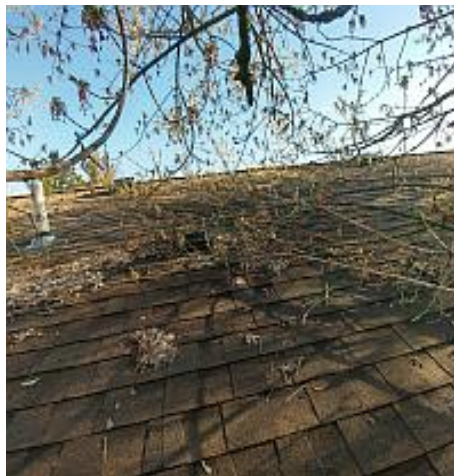
Most of the roof cover is in Satisfactory Condition. Trees are overgrowing the roof cover. Branches scraping on the roof cover have damaged shingles. This is a Major Concern. Recommend Repair/Replacement.

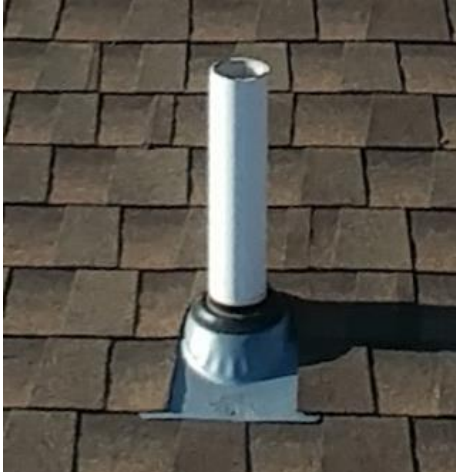
The plumbing vents are in Satisfactory Condition.

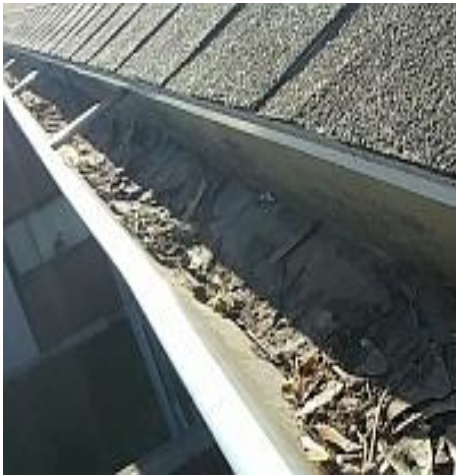
The gutters are dirty. Recommend Cleaning and seasonal cleaning thereafter.

Down spout extensions needed. Extensions should be a minimum of three feet in length and carry runoff directly away from the home.

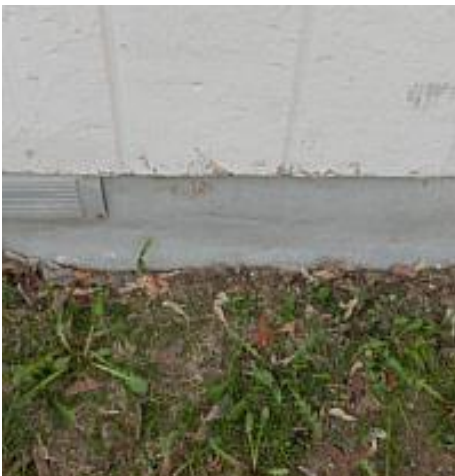
The siding is weathering. Recommend prepping and sealing (painting/staining). Recommend Repair.

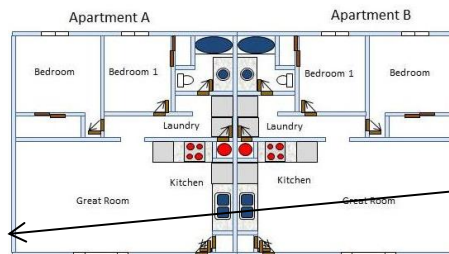
The siding is beginning to deteriorate where indicated (backsplash from an incorrectly run gutter downspout). Recommend Repair/Replacement.

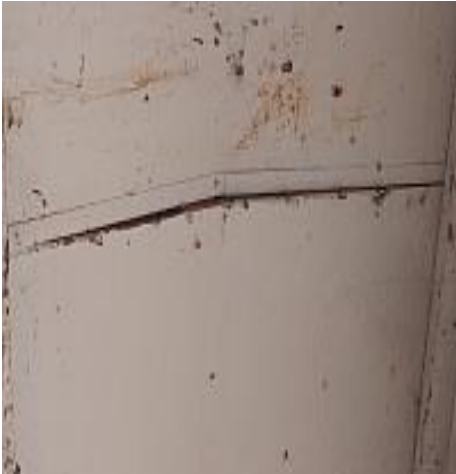
The soffit is loose in several areas. Recommend Repair.

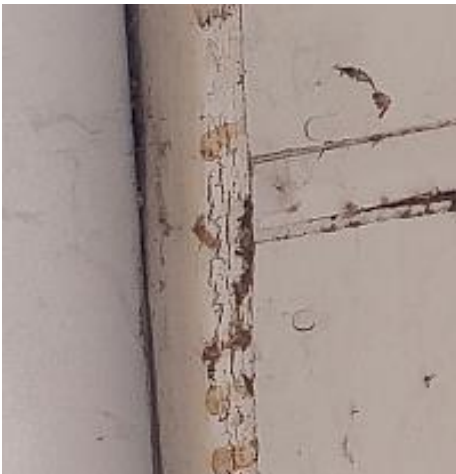
The fascia is weathering. Recommend prepping and sealing (painting/staining). Recommend Repair.

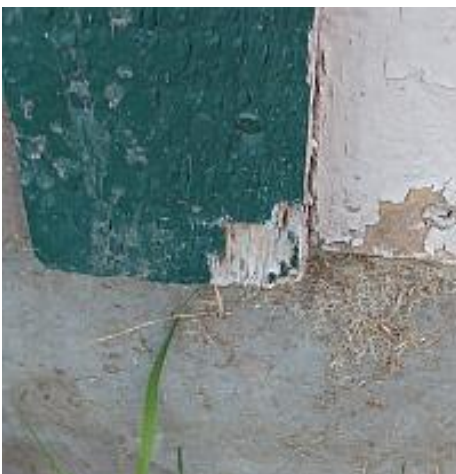
The trim is weathering/slightly damaged. Recommend prepping and sealing (painting/staining). Recommend Repair.

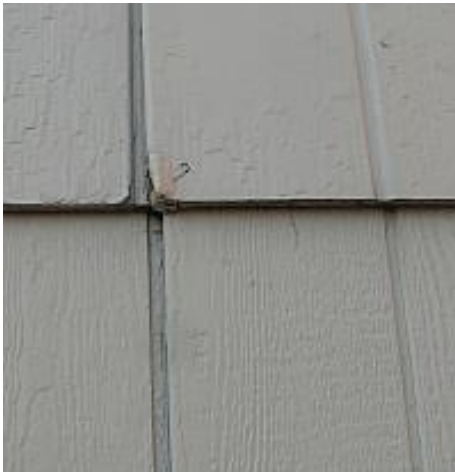
There is no visible calk at the siding transitions. Installed calk is cracked. Recommend Repair (re-caulking).

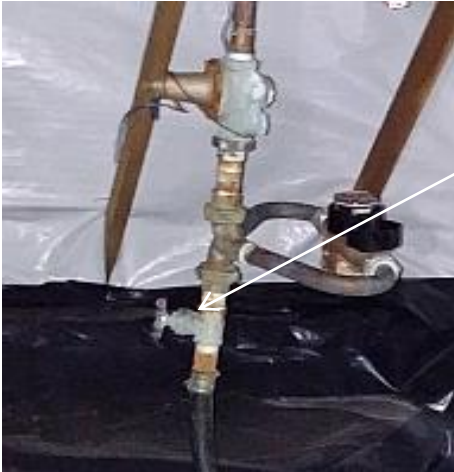
Main water shutoff is in the crawl space where indicated.

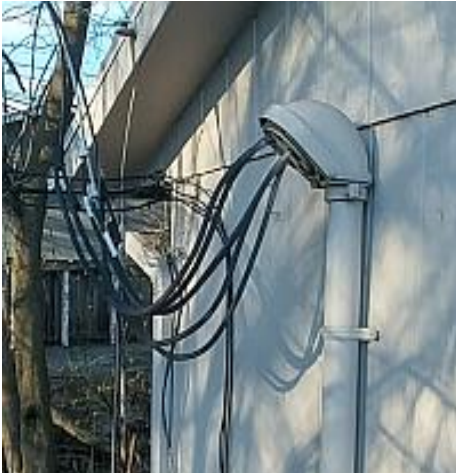
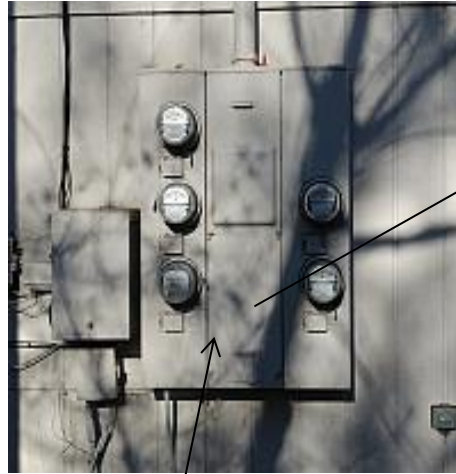
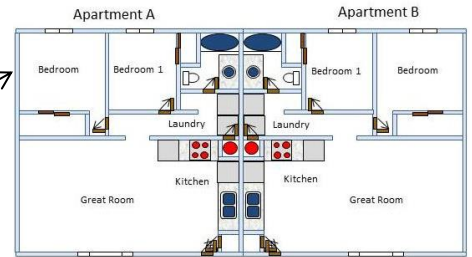
The overhead service entry is in Satisfactory Condition.

This is the location of the main electrical disconnects.

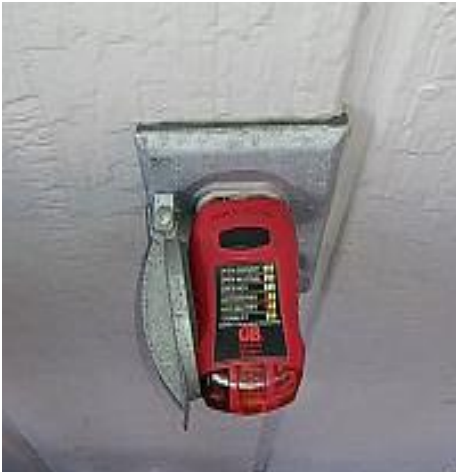
All exterior outlets tested are GFCI. The GFCI is in the Bath

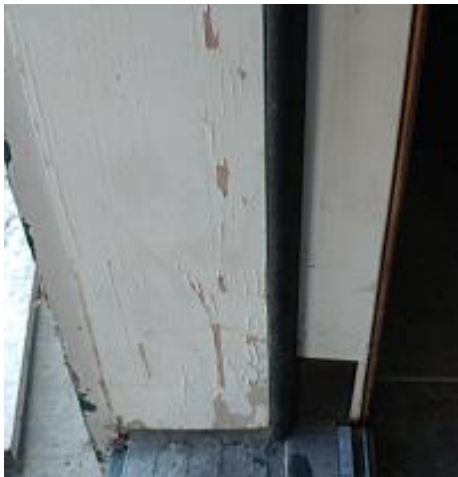
The exterior door frame is weathered. Recommend prepping and sealing (painting/staining). Recommend Repair

The door is dinged/rusted. The threshold weather stripping is torn. Recommend Repair/replacement.

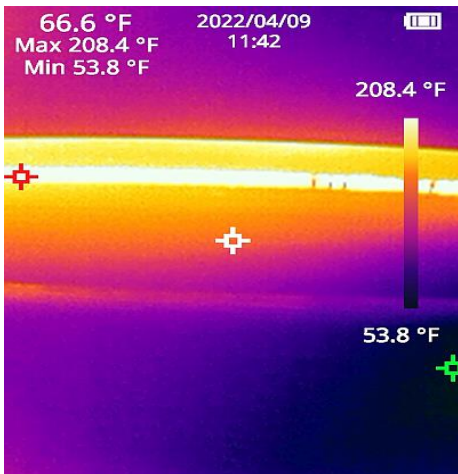
The baseboard electric heater is operating.

Inspector’s Note. These heaters are not maintenance free. Annual cleaning of the heating element is recommended. Without preventative maintenance the heating element can clog with dust and as a result the unit can run hot.

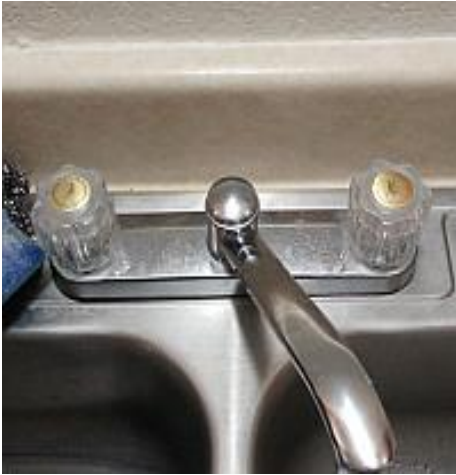
The labels on the faucet are reversed (hot should be on the left, cold should be on the right). Recommend Repair.

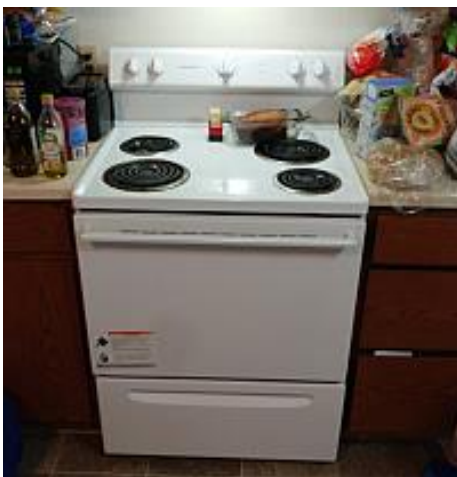
The range tip bracket is missing. The tip bracket keeps the range from tilting forward (could happen with the oven door open). Recommend Replacement.

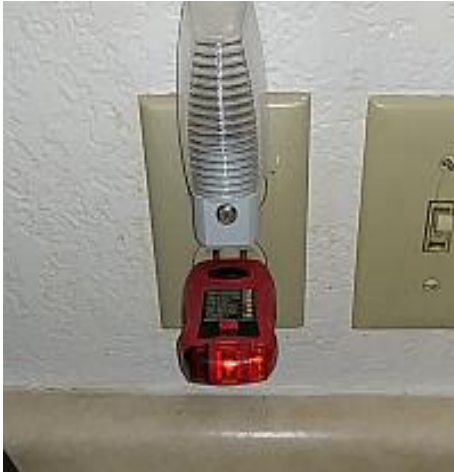
The kitchen outlets are not GFCI. While required by current standards, this home was constructed before those standards were in place. It is highly recommended that all kitchen outlets be GFCI. Recommend Repair/Replacement.

The refrigerator outlet is not GFCI. A GFCI outlet for a refrigerator *in the kitchen* is not required by current standards.

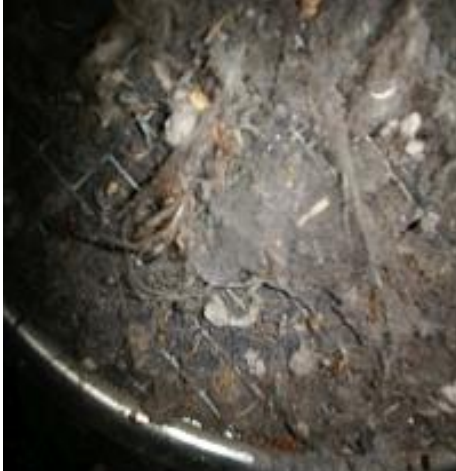
Dryer duct properly vented to the exterior.

There is a screen installed on the dryer duct termination. Screens should never be installed on dryer duct terminations as they can trap dryer lint and cause the dryer duct to clog.

The dryer duct is clogged. Dryer lint is very flammable. This is a Major Concern. Recommend Repair.

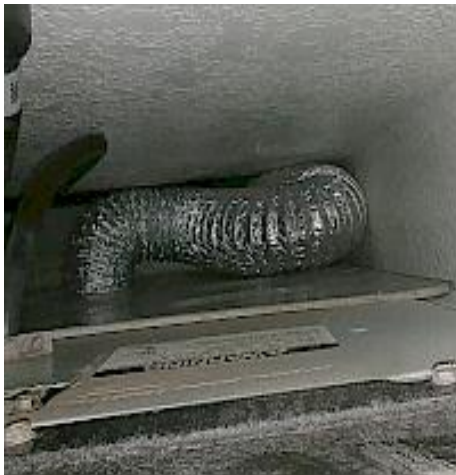
Wire bound vinyl or plastic ducting should not be used to connect the dryer to the dryer duct. This ducting can melt and will not contain a fire within the dryer.

The most preferred material for connecting the dryer to dryer duct, aluminum flexible duct, is being used.

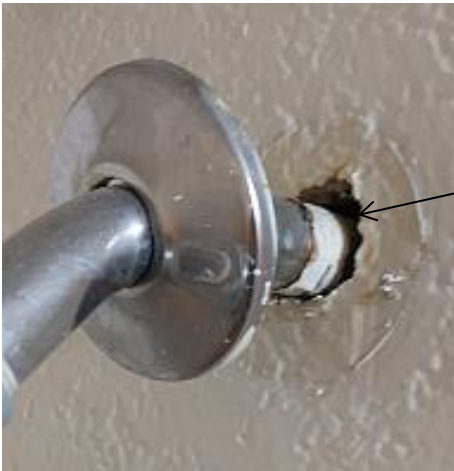
Recommend calking where indicated to help prevent moisture penetration into the walls.

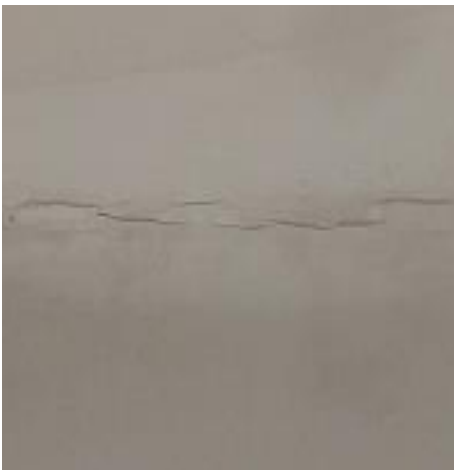
The tub bottom is cracked. In the crawl space the area immediately under the tub is moisture stained. The testing with a moisture meter shows the area is wet. Recommend Repair.

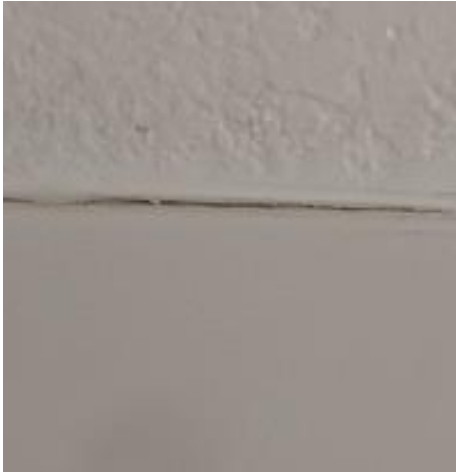
Calking needed at the wall/surround junction. Recommend Repair.

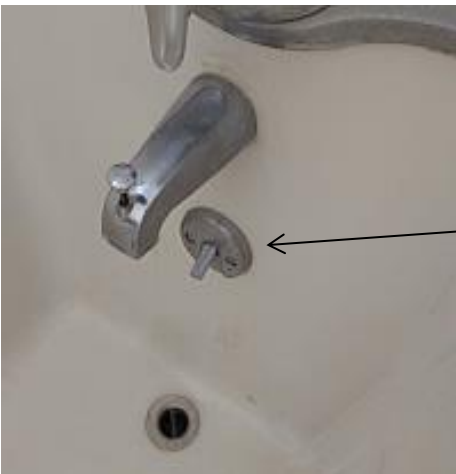
The built in stopper is not operating. Recommend Repair.

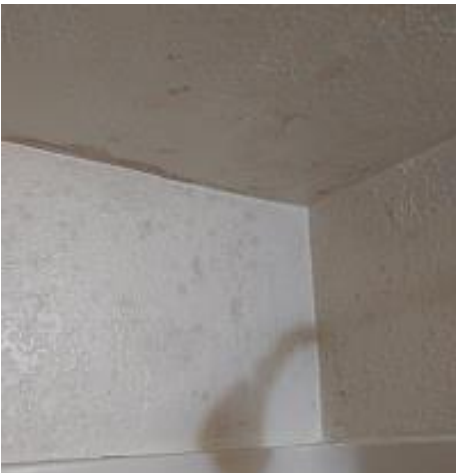
Indications of mold growth on the walls and ceiling. The presence or absence of mold can only be verified by testing. Recommend Removal.

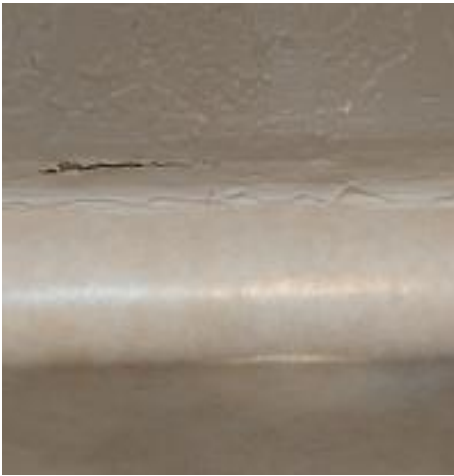
Calking needed at the backsplash/wall junction. Recommend Repair.

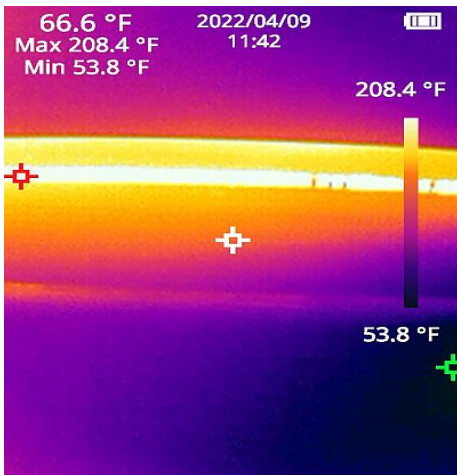
The baseboard electric heater is operating.

Inspector's Note. These heaters are not maintenance free. Annual cleaning of the heating element is recommended. Without preventative maintenance the heating element can clog with dust and as a result the unit can run hot.

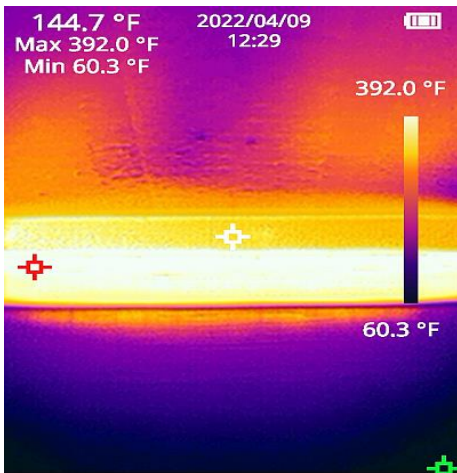
The baseboard electric heater is operating.

Inspector’s Note. These heaters are not maintenance free. Annual cleaning of the heating element is recommended. Without preventative maintenance the heating element can clog with dust and as a result the unit can run hot.

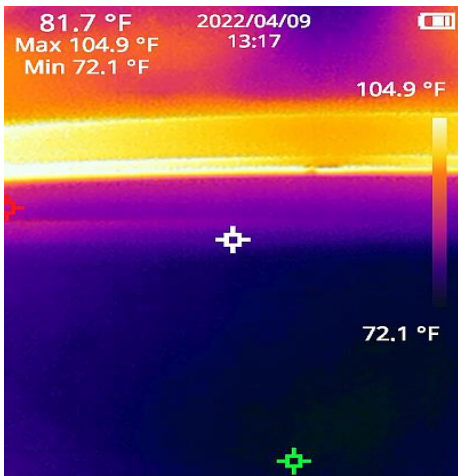
The baseboard electric heater is operating.

Inspector’s Note. These heaters are not maintenance free. Annual cleaning of the heating element is recommended. Without preventative maintenance the heating element can clog with dust and as a result the unit can run hot.

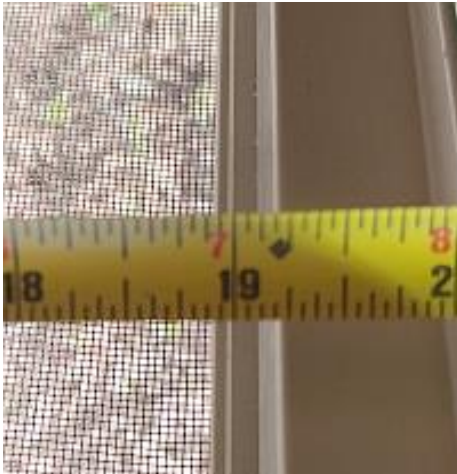
The window is not wide enough to be considered an egress window.

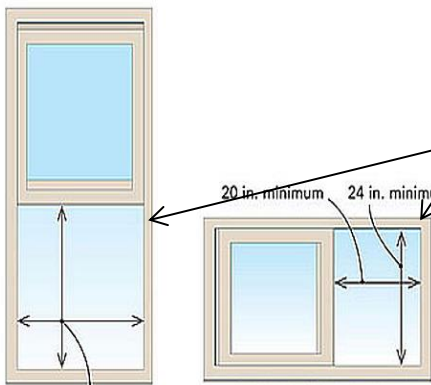
A 28-in. by 30-in. opening gives 5.8 sq. ft. of net-clear opening.

A 20-in. by 24-in. opening does not meet net-clear opening requirements.

Inspector's Note: A word about Egress Windows. Emergency escape and rescue openings shall have a minimum net clear opening of 5.7 square feet (5.0 square feet for ground floors). The net clear opening is the normal operation of the window. This area is required to provide egress for firefighters and rescue personnel while wearing equipment. The minimum net clear opening height shall be 24". The net clear opening width shall be 20". The window shall also be no more than 44" from the floor.

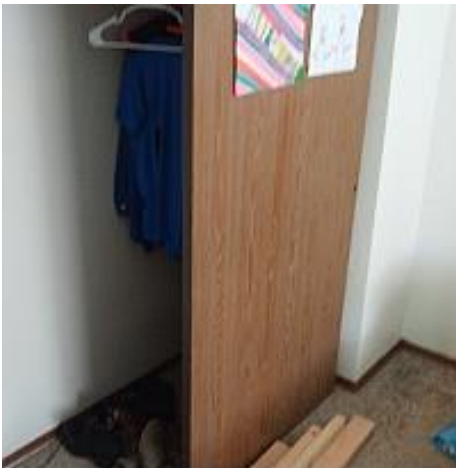
The closet doors are difficult to operate.

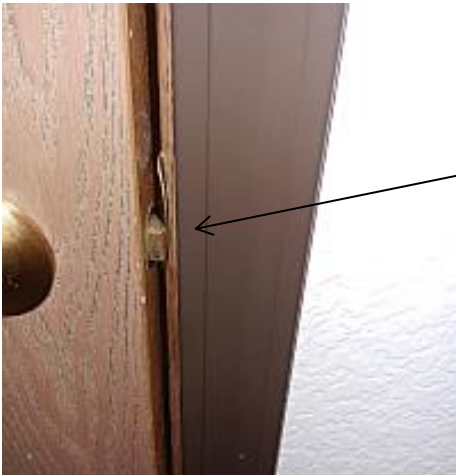
The latch bolt does not engage the strike plate. The door scrapes on the frame. Recommend Repair/Adjustment.

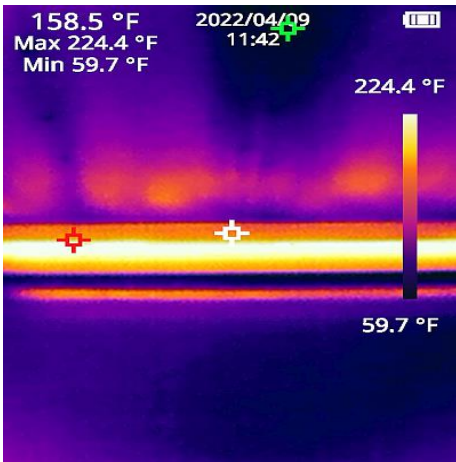
The baseboard electric heater is operating.

Inspector's Note. These heaters are not maintenance free. Annual cleaning of the heating element is recommended. Without preventative maintenance the heating element can clog with dust and as a result the unit can run hot.

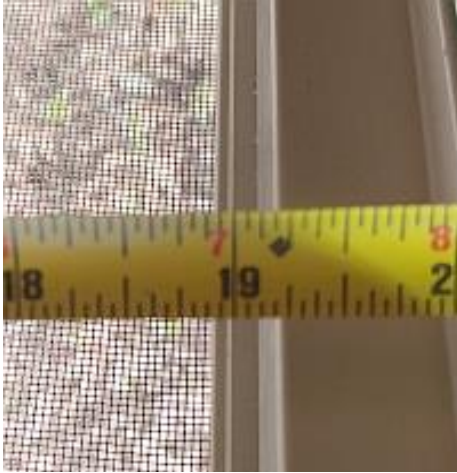
The window is not wide enough to be considered an egress window.

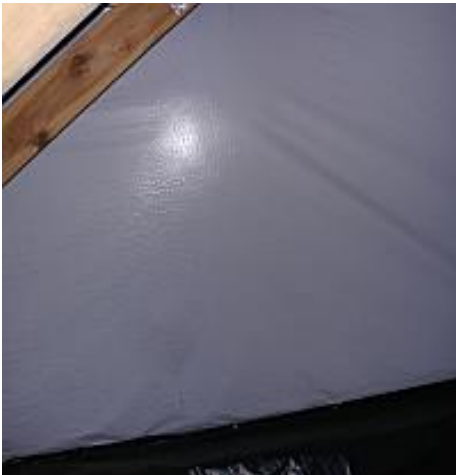
The foundation walls are covered and could not be visually inspected. There are no obvious indications of problems with the foundations.

There are indications of moisture in the crawl space. This appears to be ground sourced. Recommend Repair.

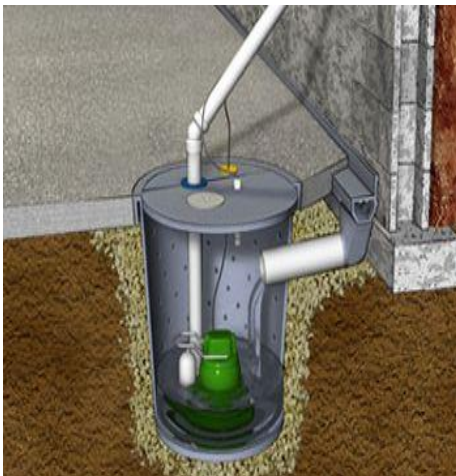
The inspector always recommends drainage of some type. If a sump pump is to be installed a sealed crack unit (illustrated) is recommended.

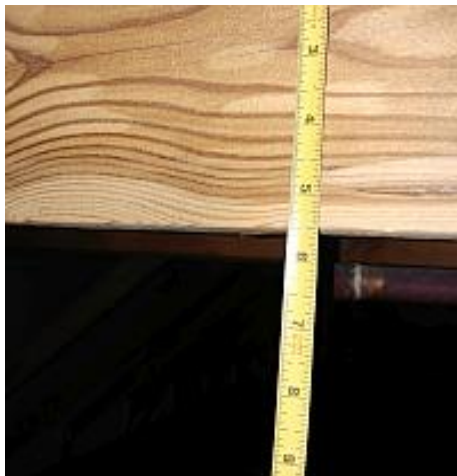
This is a truss system, not individual floor joists. The system is in Satisfactory Condition.

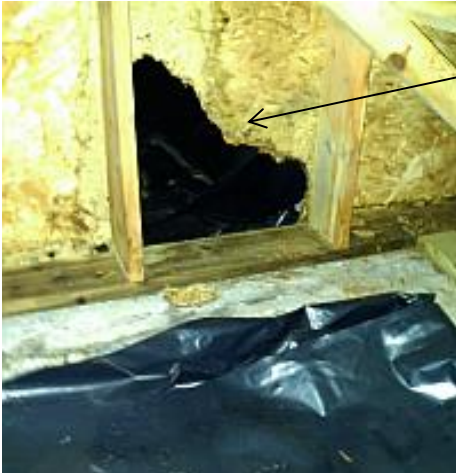
There is a hole in the OSB wall between the units. The area around the hole is moisture stained. Testing with a moisture meter showed the area to be dry. This hole could be the result of long term contact with water. There are no indications of current leaks in the crawl space. Recommend Repair.

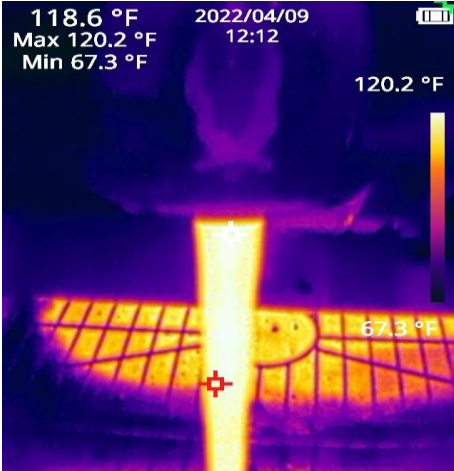
Water temperature is 120.2°F. A water temperature of 120°F is considered optimal for domestic use.

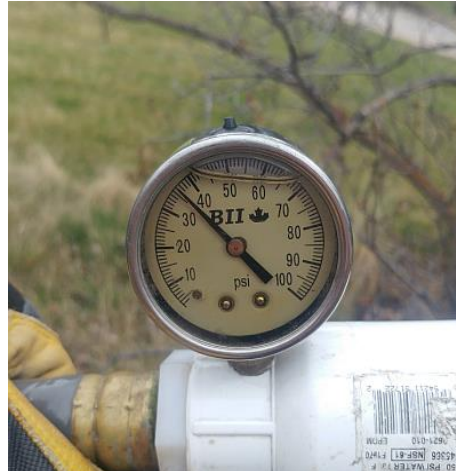
The water pressure is 36psi, which is within acceptable limits.

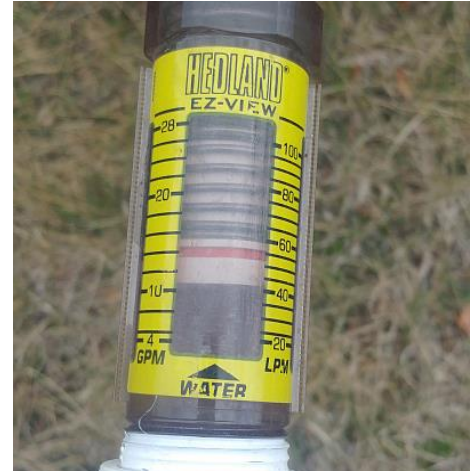
The flow rate is 14gpm, which is within acceptable limits.

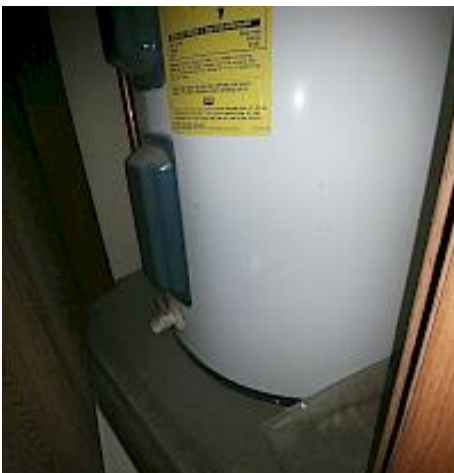
There is no drip pan installed. Current standards state that where water heaters tanks are installed in locations where leakage of the tanks or connections will cause damage, the tank shall be installed in a galvanized steel pan having a minimum thickness of 24 gage, or other pans approved for such use. Ideally the pan should be plumbed to an approved drain. Recommend Repair.

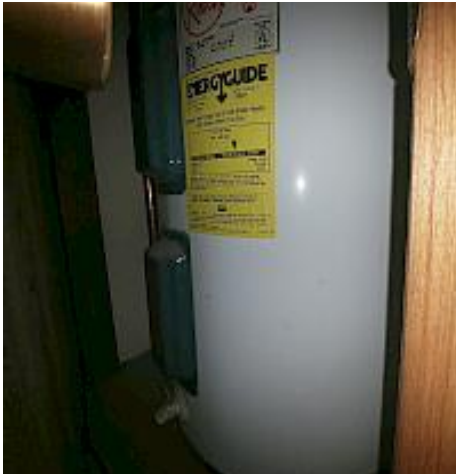
There are no seismic restraints on the water heater. Current standards require seismic restraints in this region of Montana. Water heaters shall be anchored or strapped to resist horizontal displacement due to earthquake motion. Strapping shall be at points within the upper one-third (1/3) and lower one third (1/3) of its vertical dimensions. At the lower point, the strapping will be a minimum distance of four (4) inches above the controls.

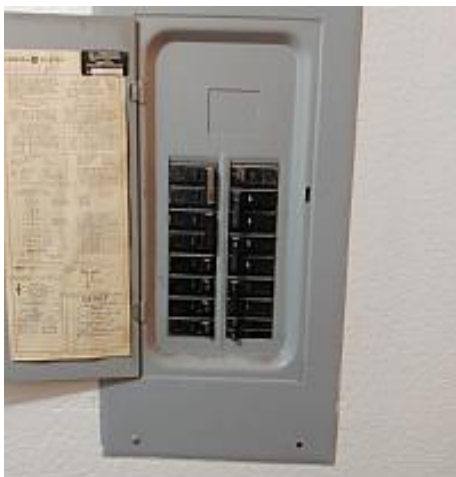
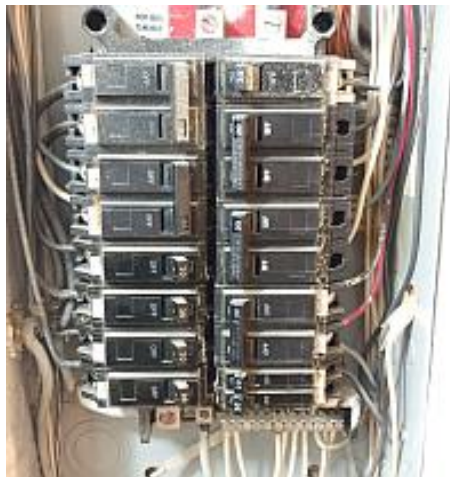
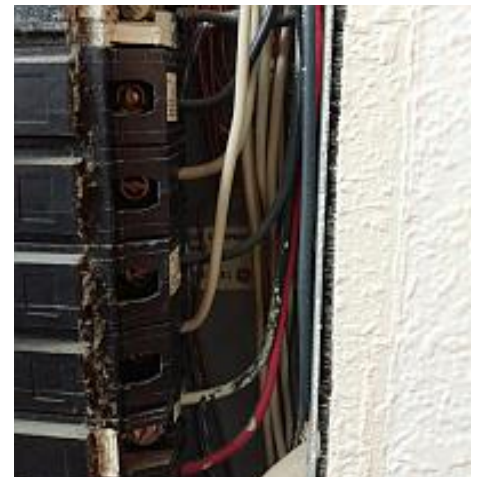
The main panel is in Satisfactory Condition.

White (neutral) wires used as black (live or line) wires should be color coded black.

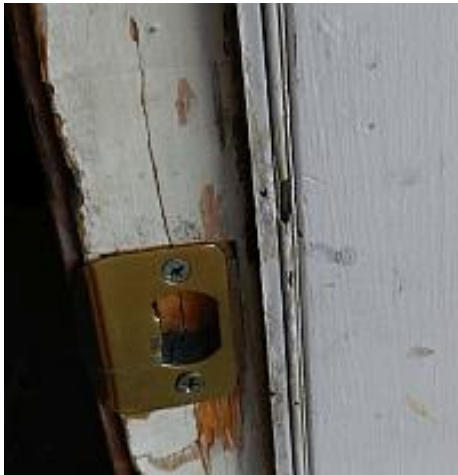
The weather stripping is torn/holed. The door frame is cracked. Recommend Repair/Replacement.

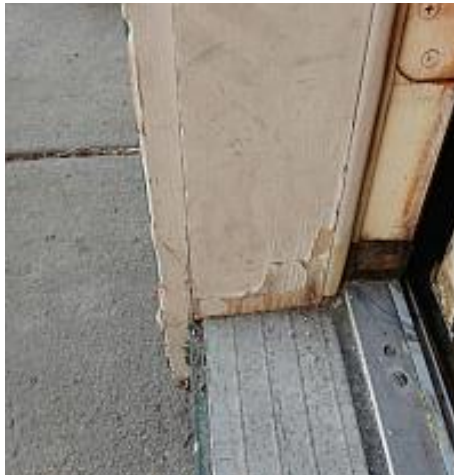
The exterior door frame is weathered. Recommend prepping and sealing (painting/staining). Recommend Repair

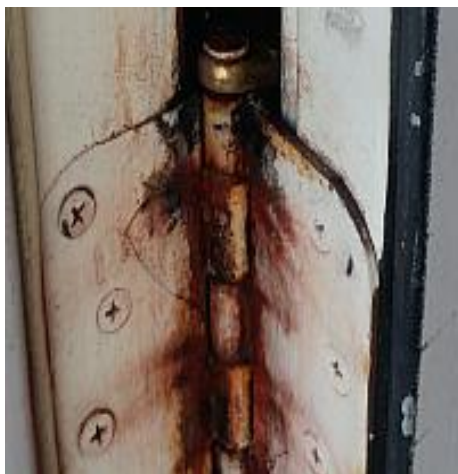
The lower door hinge is rusting. Recommend Repair.

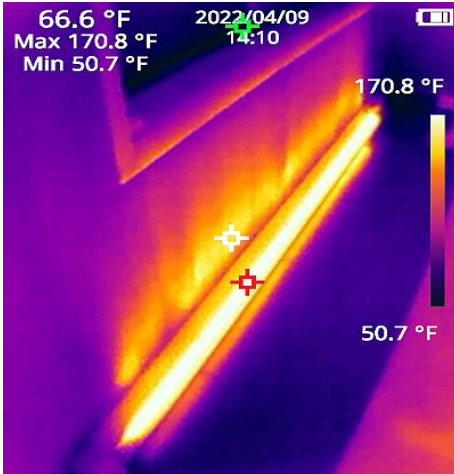
The baseboard electric heater is operating.

Inspector's Note. These heaters are not maintenance free. Annual cleaning of the heating element is recommended. Without preventative maintenance the heating element can clog with dust and as a result the unit can run hot.

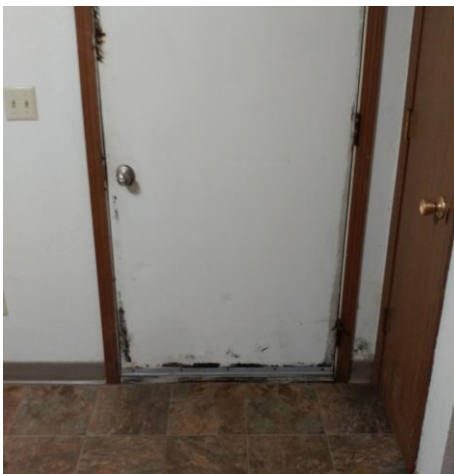
Indications of mold growth in numerous areas. The presence or absence of mold can only be verified by testing. Recommend Removal.

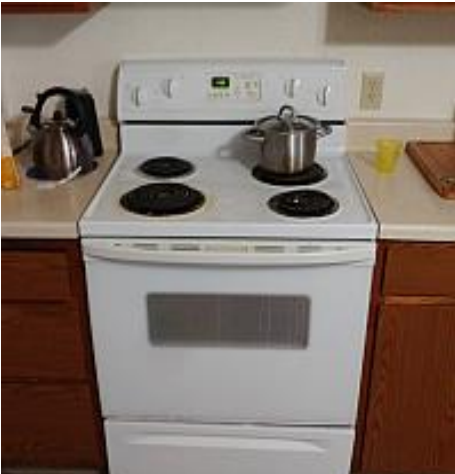
The range tip bracket is missing. The tip bracket keeps the range from tilting forward (could happen with the oven door open). Recommend Replacement.

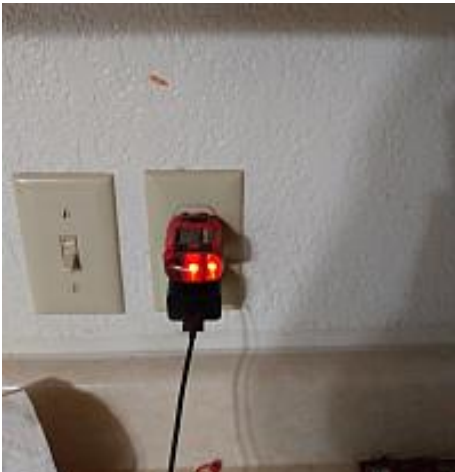
The kitchen outlets are not GFCI. While required by current standards, this home was constructed before those standards were in place. It is highly recommended that all kitchen outlets be GFCI. Recommend Repair/Replacement.

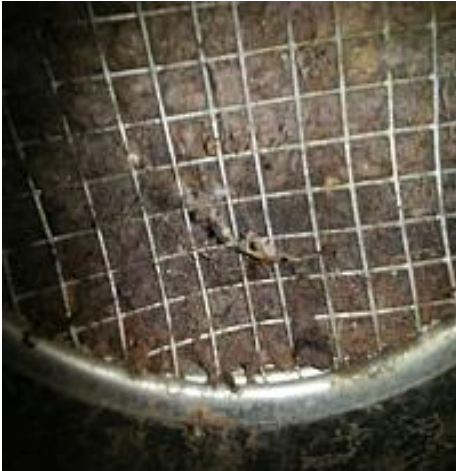
Dryer duct properly vented to the exterior.

There is a screen installed on the dryer duct termination. Screens should never be installed on dryer duct terminations as they can trap dryer lint and cause the dryer duct to clog.

The dryer duct is clogged. Dryer lint is very flammable. This is a Major Concern. Recommend Repair.

Dryer duct is dirty. Recommend cleaning and annual cleaning thereafter.

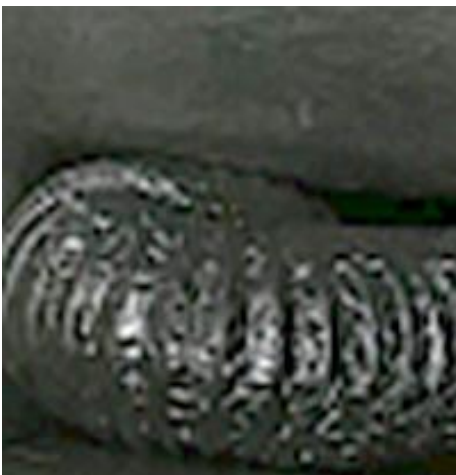
Wire bound vinyl or plastic ducting should not be used to connect the dryer to the dryer duct. This ducting can melt and will not contain a fire within the dryer.

The most preferred material for connecting the dryer to dryer duct, aluminum flexible duct, is being used.

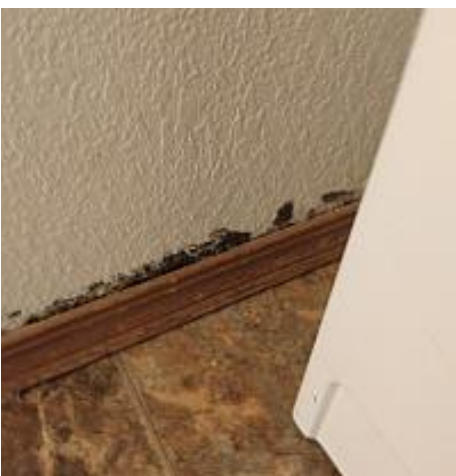
Indications of mold growth on the walls to the side of and behind the clothes dryer. The actual presence or absence of mold growth can only be determined by testing. Recommend Removal.

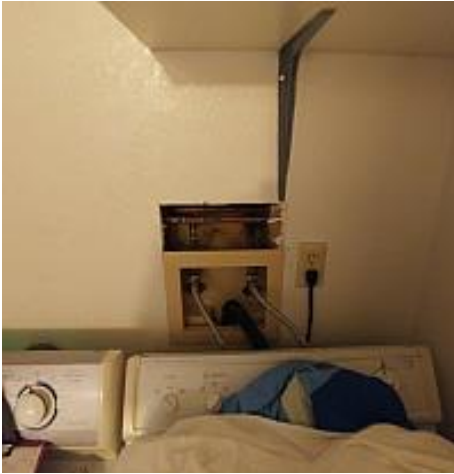
There is a hole cut in the wall above the washer connections. Recommend Repair.

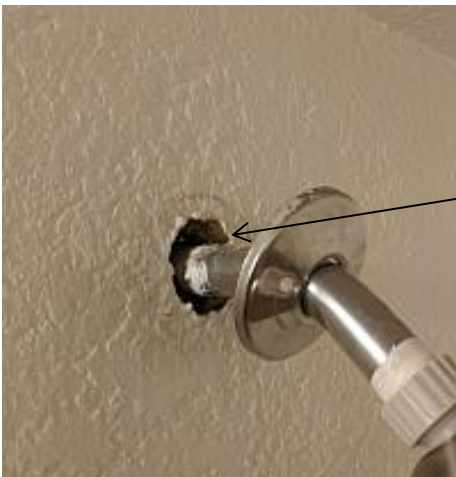
Recommend calking where indicated to help prevent moisture penetration into the walls.

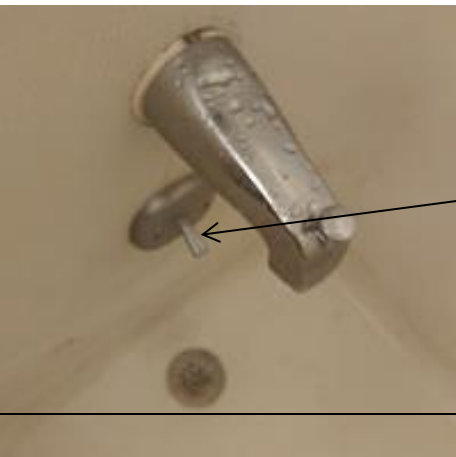
The built in stopper is not operating. Recommend Repair,

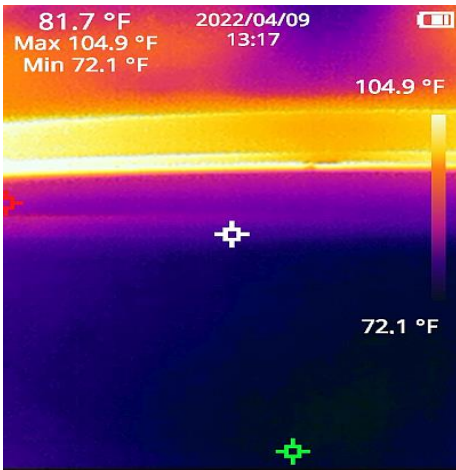
The baseboard electric heater is operating.

The housing is rusting. Recommend Repair.

Inspector's Note. These heaters are not maintenance free. Annual cleaning of the heating element is recommended. Without preventative maintenance the heating element can clog with dust and as a result the unit can run hot.

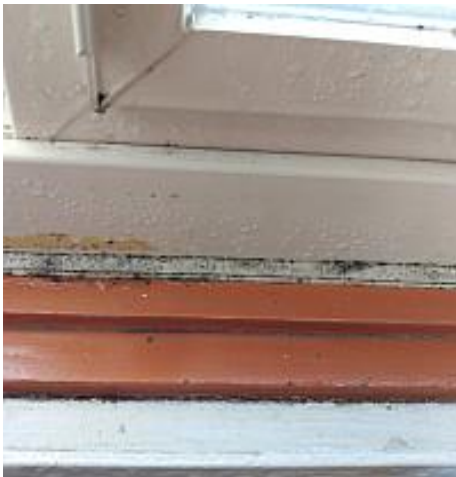
Indications of mold growth on the windows. The actual presence or absence of mold growth can only be determined by testing. Recommend Removal.

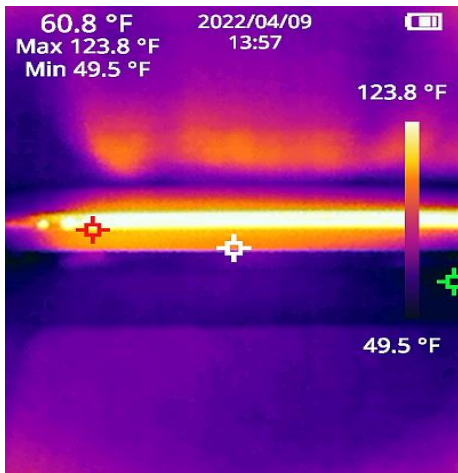
The baseboard electric heater is operating.

Part of the housing is loose. Recommend Repair.

Inspector's Note. These heaters are not maintenance free. Annual cleaning of the heating element is recommended. Without preventative maintenance the heating element can clog with dust and as a result the unit can run hot.

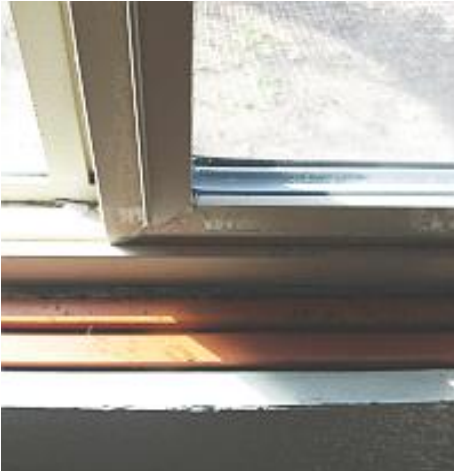
Indications of mold growth on the windows. The actual presence or absence of mold growth can only be determined by testing. Recommend Removal.

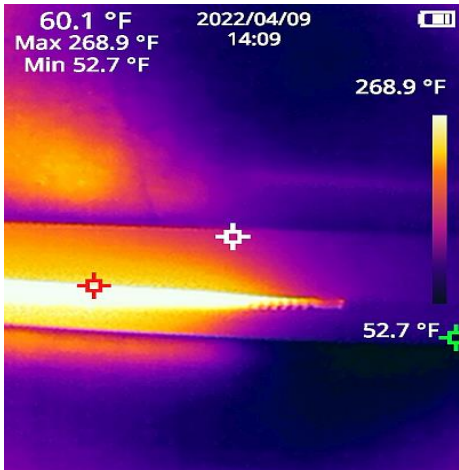
The baseboard electric heater is operating.

Inspector’s Note. These heaters are not maintenance free. Annual cleaning of the heating element is recommended. Without preventative maintenance the heating element can clog with dust and as a result the unit can run hot.

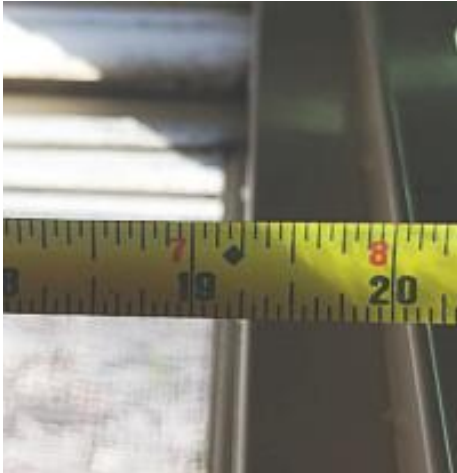
The window is not wide enough to be considered an egress window.

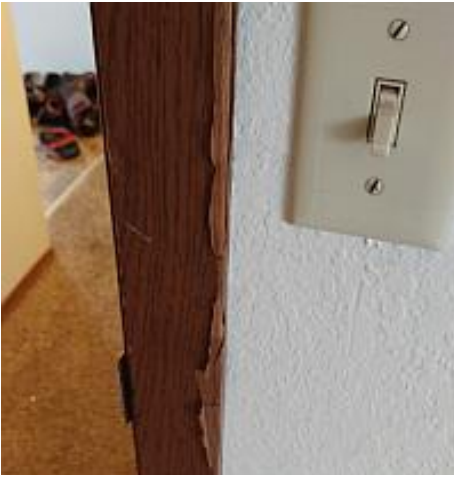
The plastic veneer is peeling off the door rim. Recommend Repair/Replacement.

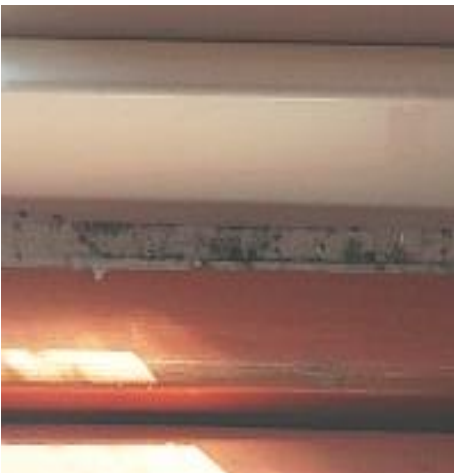
Indications of mold growth on the windows. The actual presence or absence of mold growth can only be determined by testing. Recommend Removal.
