**Inspection Date: 12<sup>th</sup> of Never**

**Prepared For: John and Jane Doe**

Gunstock Home Inspection LLC

**Report Number: JJD12NEVER**

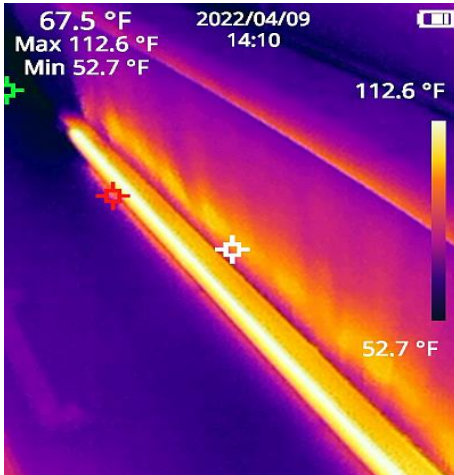
The baseboard electric heater is operating.

Inspector’s Note. These heaters are not maintenance free. Annual cleaning of the heating element is recommended. Without preventative maintenance the heating element can clog with dust and as a result the unit can run hot.

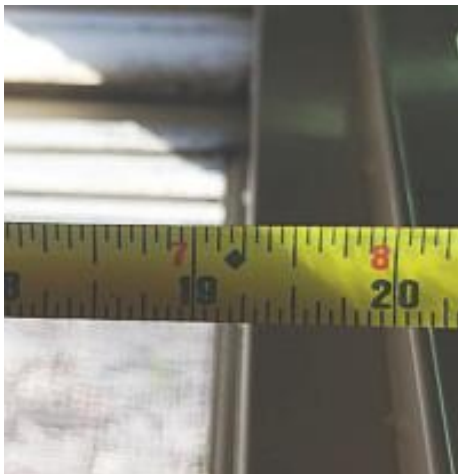
The window is not wide enough to be considered an egress window.

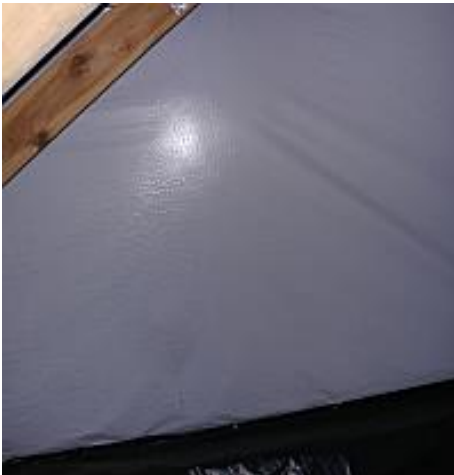
The foundation walls are covered and could not be visually inspected. There are no obvious indications of problems with the foundations.

There are indications of moisture in the crawl space. This appears to be ground sourced. Recommend Repair.

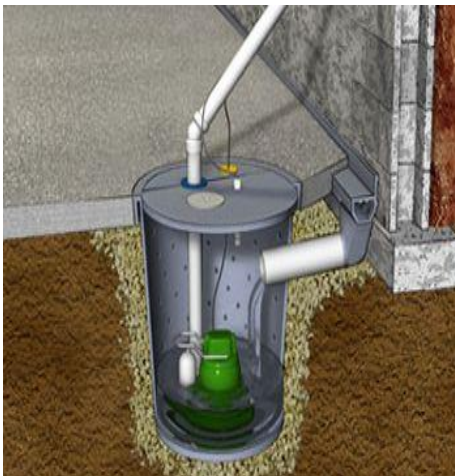
The inspector always recommends drainage of some type. If a sump pump is to be installed a sealed crock unit (illustrated) is recommended.

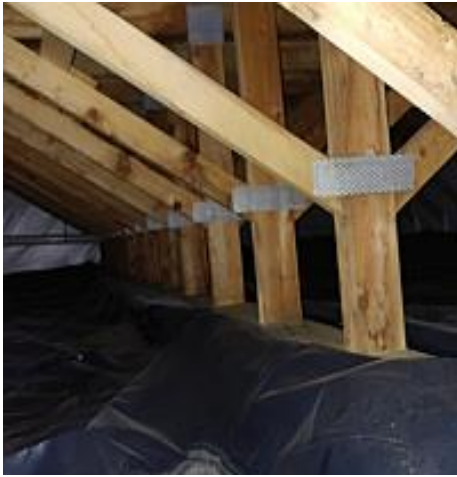
The footings and piers are in Satisfactory Condition.

Wood to earth/concrete contact. Untreated wood should never be allowed to be in contact with earth/concrete (can cause deterioration).

No deterioration detected at the time of the inspection. Recommend Monitoring.

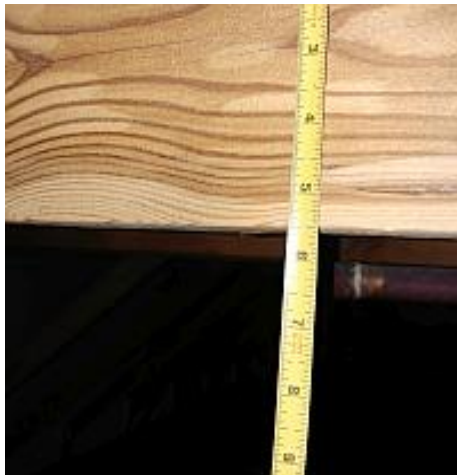
This is a truss system, not individual floor joists. The system is in Satisfactory Condition.

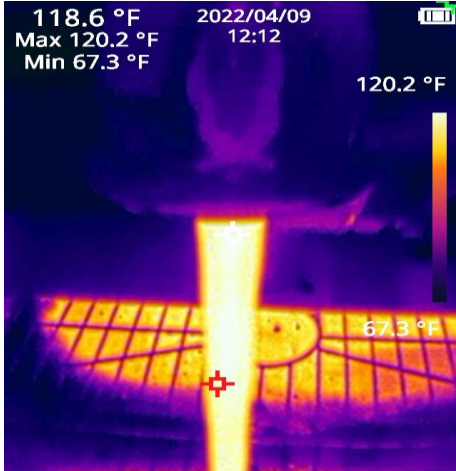
Water temperature is 120.2°F. A water temperature of 120°F is considered optimal for domestic use.

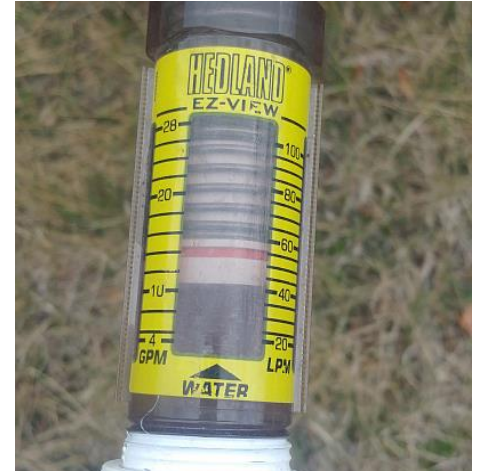
The flow rate is 14gpm, which is within acceptable limits.

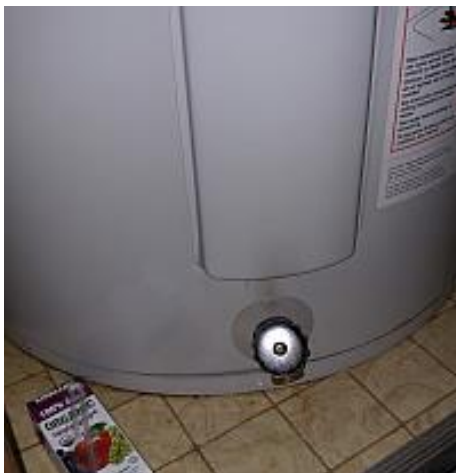
There is no drip pan installed. Current standards state that where water heaters tanks are installed in locations where leakage of the tanks or connections will cause damage, the tank shall be installed in a galvanized steel pan having a minimum thickness of 24 gage, or other pans approved for such use. Ideally the pan should be plumbed to an approved drain. Recommend Repair.

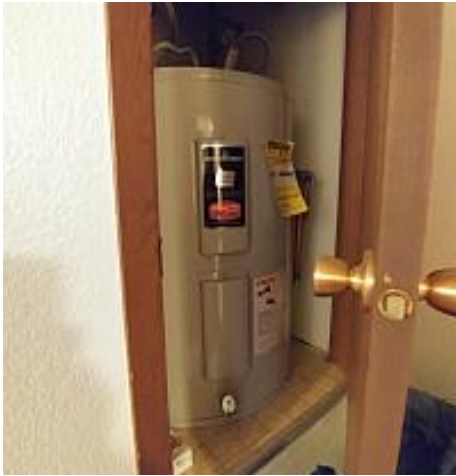
There are no seismic restraints on the water heater. Current standards require seismic restraints in this region of Montana. Water heaters shall be anchored or strapped to resist horizontal displacement due to earthquake motion. Strapping shall be at points within the upper one-third (1/3) and lower one third (1/3) of its vertical dimensions. At the lower point, the strapping will be a minimum distance of four (4) inches above the controls.

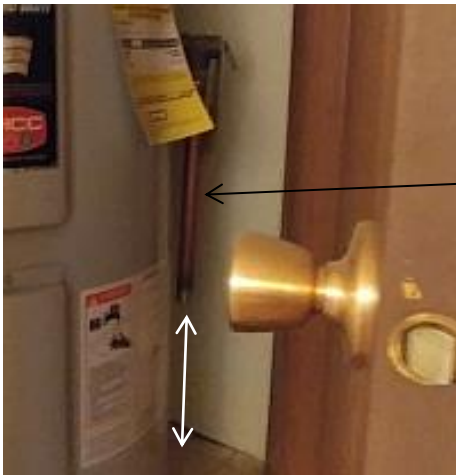
The temperature /pressure relief (TPR) valve extension is too short. It must extend to with 6 inches of the floor and terminate in a non-threaded end. Recommend Repair

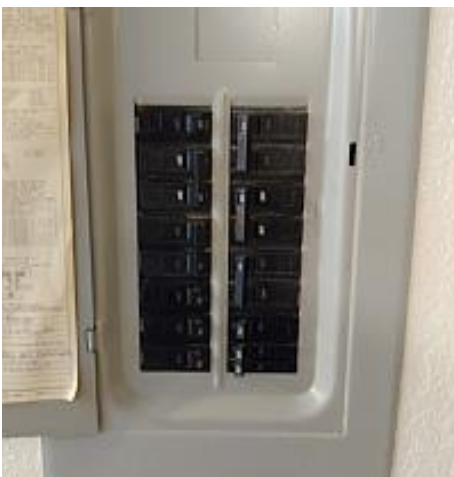
The main panel is in Satisfactory Condition.

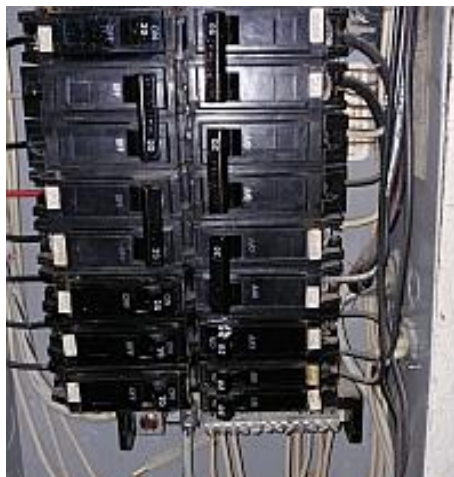
White (neutral) wires used as black (live or line) wires should be color coded black.

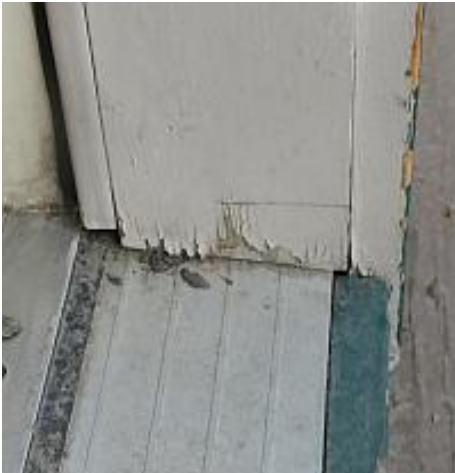
The exterior door frame is weathered. Recommend prepping and sealing (painting/staining). Recommend Repair

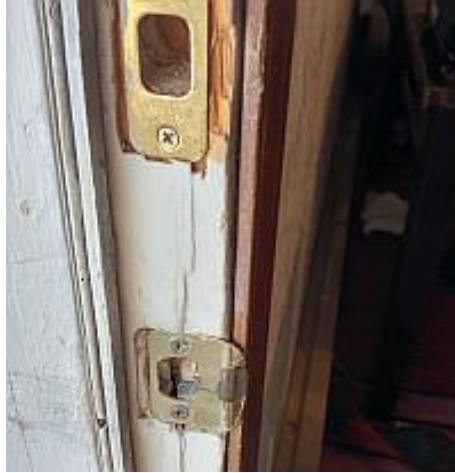
The weather stripping is torn/holed. The door frame is dinged/cracked. Recommend Repair/ Replacement.

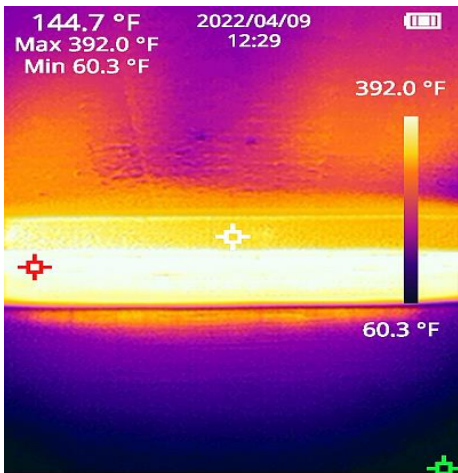
The baseboard electric heater is operating.

Inspector’s Note. These heaters are not maintenance free. Annual cleaning of the heating element is recommended. Without preventative maintenance the heating element can clog with dust and as a result the unit can run hot.

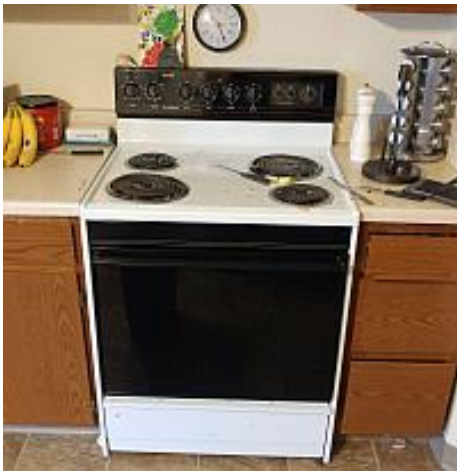
The range tip bracket is missing. The tip bracket keeps the range from tilting forward (could happen with the oven door open). Recommend Replacement.

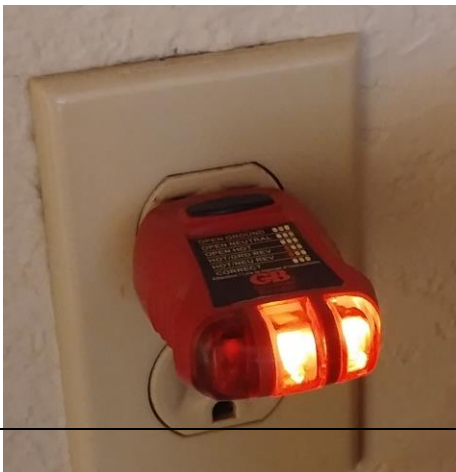
The kitchen outlets are not GFCI. While required by current standards, this home was constructed before those standards were in place. It is highly recommended that all kitchen outlets be GFCI. Recommend Repair/Replacement.

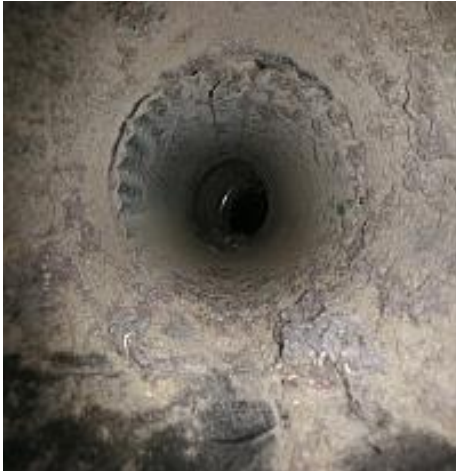
Dryer duct properly vented to the exterior.

Dryer duct is dirty. Recommend cleaning and annual cleaning thereafter.

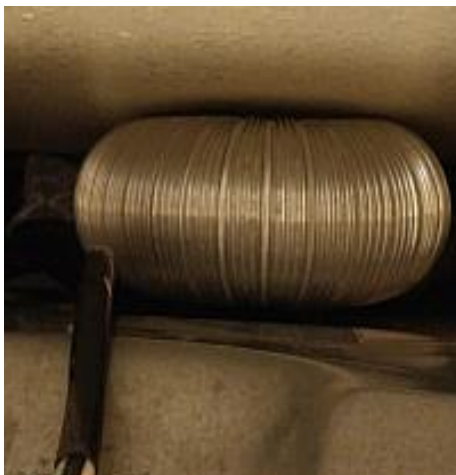
Wire bound vinyl or plastic ducting should not be used to connect the dryer to the dryer duct. This ducting can melt and will not contain a fire within the dryer.

The most preferred material for connecting the dryer to dryer duct, aluminum flexible duct, is being used.

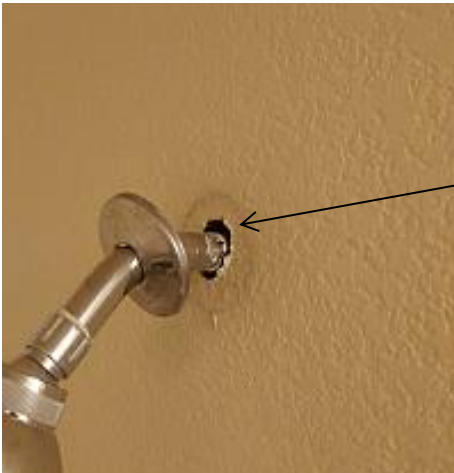
Recommend caulking where indicated to help prevent moisture penetration into the walls.

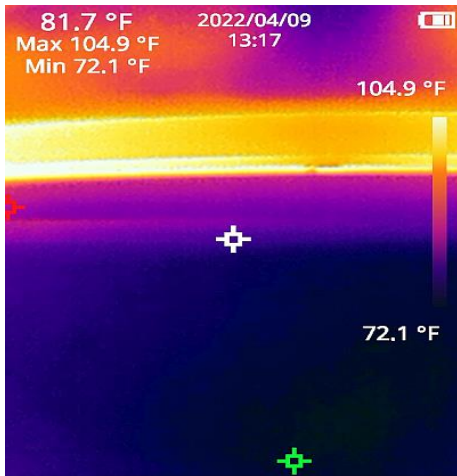
The baseboard electric heater is operating.

Inspector's Note. These heaters are not maintenance free. Annual cleaning of the heating element is recommended. Without preventative maintenance the heating element can clog with dust and as a result the unit can run hot.

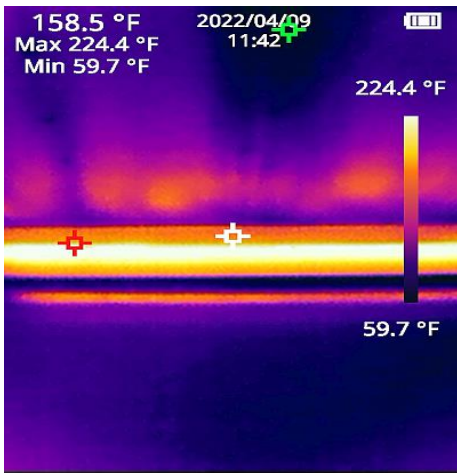
The baseboard electric heater is operating.

Inspector’s Note. These heaters are not maintenance free. Annual cleaning of the heating element is recommended. Without preventative maintenance the heating element can clog with dust and as a result the unit can run hot.

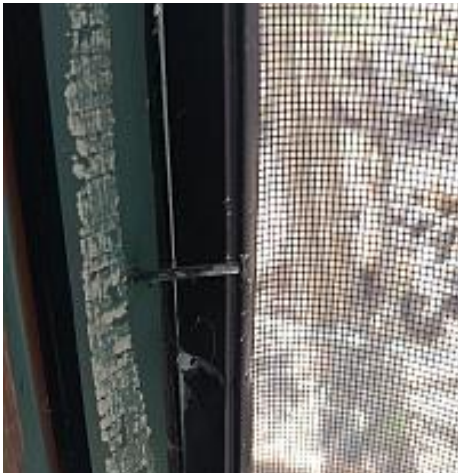
The screen is loose. Recommend Repair.

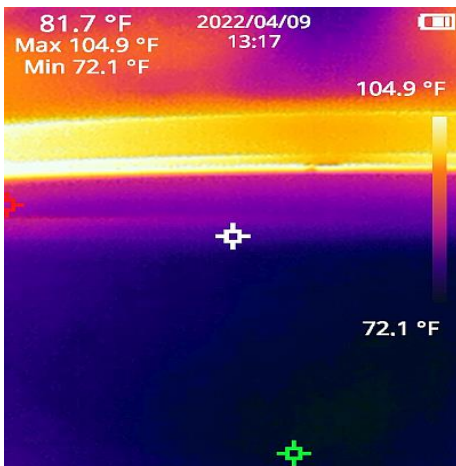
The baseboard electric heater is operating.

Inspector's Note. These heaters are not maintenance free. Annual cleaning of the heating element is recommended. Without preventative maintenance the heating element can clog with dust and as a result the unit can run hot.

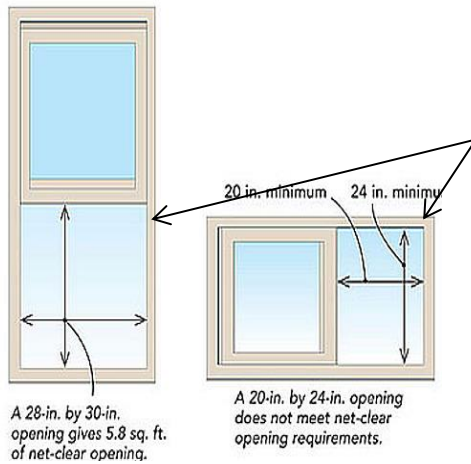
**Room Can be Used as A Bedroom:**  N/A  Yes  No 20 x 43 5.97 Sq. Ft.

Inspector's Note: A word about Egress Windows. Emergency escape and rescue openings shall have a minimum net clear opening of 5.7 square feet (5.0 square feet for ground floors). The net clear opening is the normal operation of the window. This area is required to provide egress for firefighters and rescue personnel while wearing equipment. The minimum net clear opening height shall be 24". The net clear opening width shall be 20". The window shall also be no more than 44" from the floor.

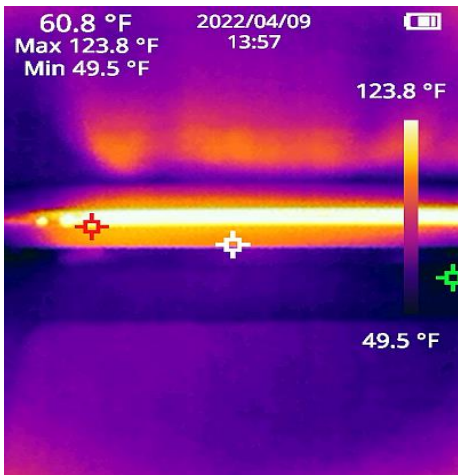
The baseboard electric heater is operating.

Inspector's Note. These heaters are not maintenance free. Annual cleaning of the heating element is recommended. Without preventative maintenance the heating element can clog with dust and as a result the unit can run hot.

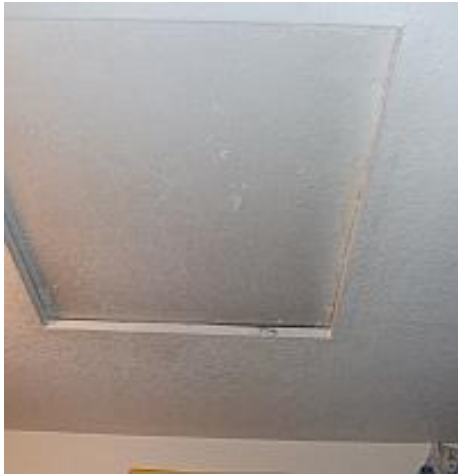
The attic access only measures 20 x 23. While current standards require a minimum clear opening 22 x 30, this apartment was built before those standards were in place.

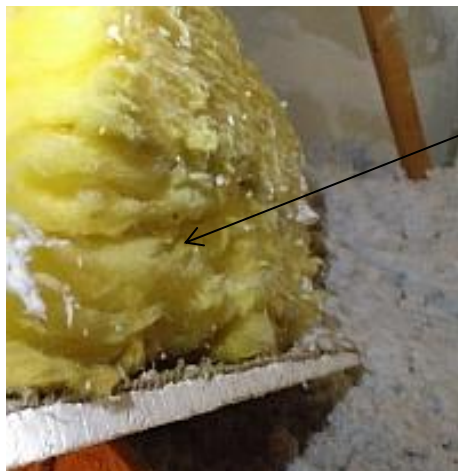
The hatch cover is properly insulated.  
 Insulation dams are installed around the access.  
 The attic access should be as well insulated as the attic.  
 Insulation dams help hold insulation away from the access.

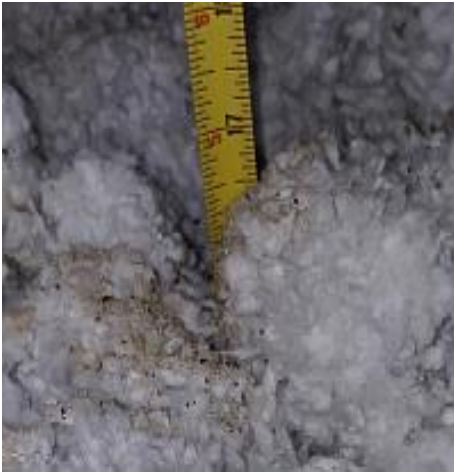
Seventeen inches of blown in/batt insulation equates to an R (Resistance) value of 42.5. R 39 is recommended for attics in this region.

The insulation is displaced in areas. Recommend Repair.

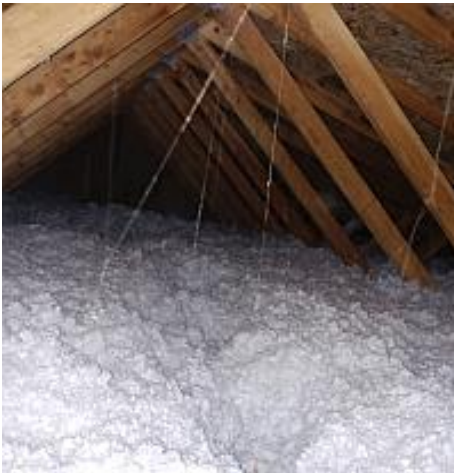
The attic structure is in Satisfactory Condition.

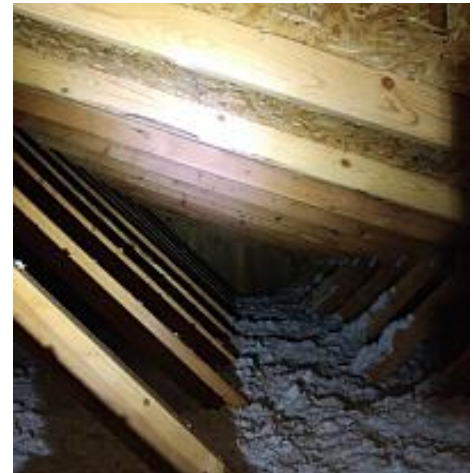
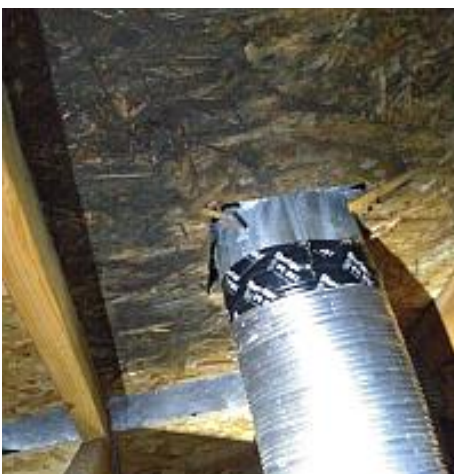
Possible mold growth observed around the kitchen exhaust fan ducting. The actual presence or absence of mold can only be verified by testing. Recommend removal.

The exhaust fan ducting should be insulated to help prevent condensation.

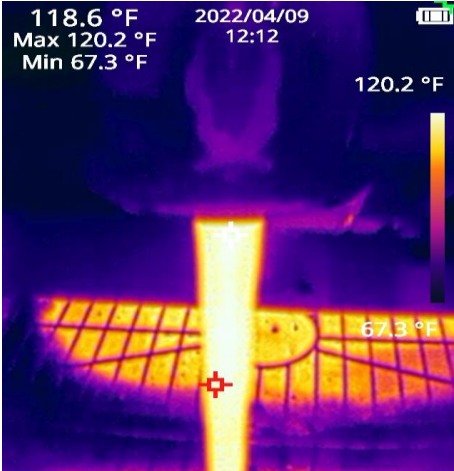
Water temperature is 120.2°F. A water temperature of 120°F is considered optimal for domestic use.

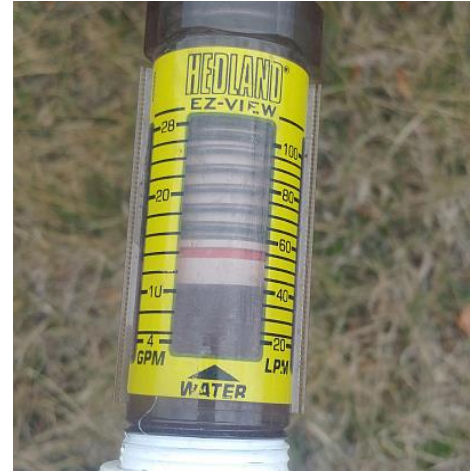
The flow rate is 14gpm, which is within acceptable limits.

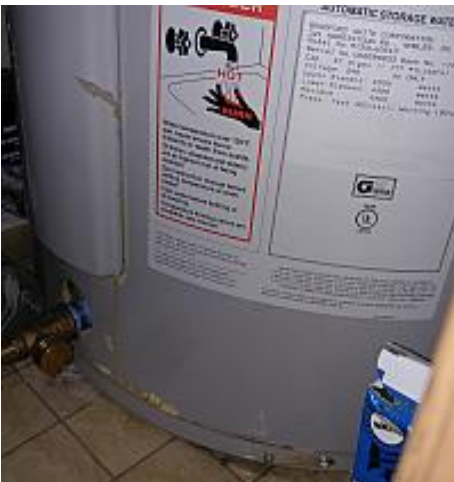
There is no drip pan installed. Current standards state that where water heaters tanks are installed in locations where leakage of the tanks or connections will cause damage, the tank shall be installed in a galvanized steel pan having a minimum thickness of 24 gage, or other pans approved for such use. Ideally the pan should be plumbed to an approved drain. Recommend Repair.

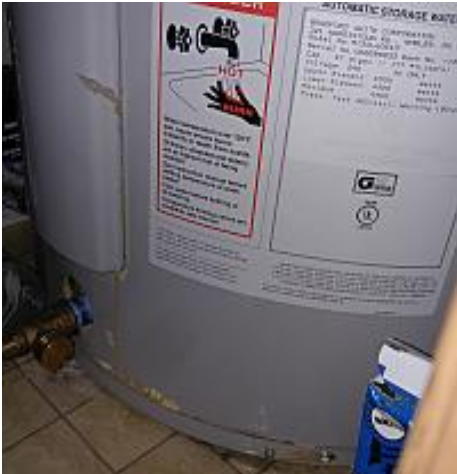
There are no seismic restraints on the water heater. Current standards require seismic restraints in this region of Montana. Water heaters shall be anchored or strapped to resist horizontal displacement due to earthquake motion. Strapping shall be at points within the upper one-third (1/3) and lower one third (1/3) of its vertical dimensions. At the lower point, the strapping will be a minimum distance of four (4) inches above the controls.

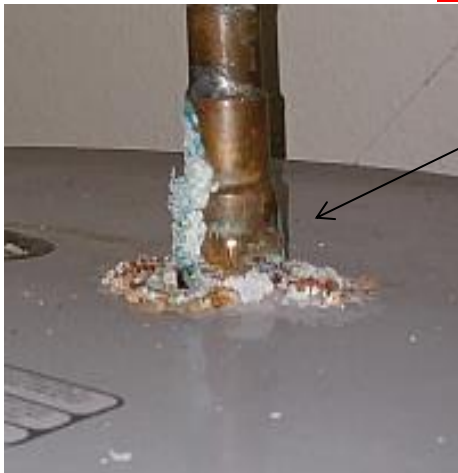
Indications of a leak at the input water line.  
 Indications of a leak at the lower heating element.  
 Recommend Repair.

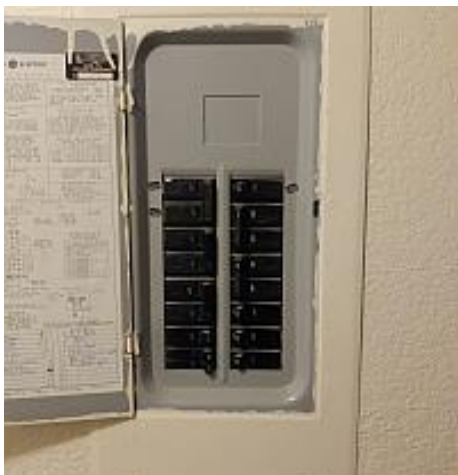
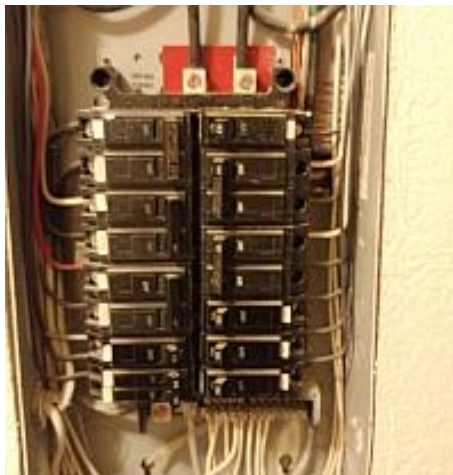
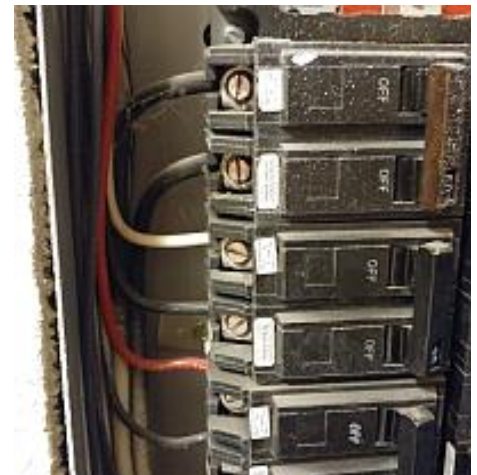
The main panel is in Satisfactory Condition.

White (neutral) wires used as black (live or line) wires should be color coded black.

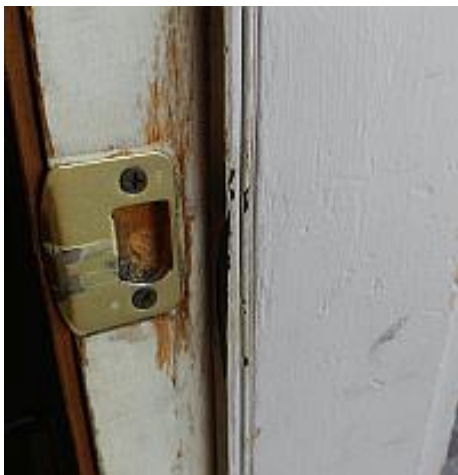
The weather stripping is torn/holed. Recommend Repair/Replacement.

The weather stripping is painted, which causes it to loose flexibility and therefore effectiveness. Recommend Repair/Replacement.

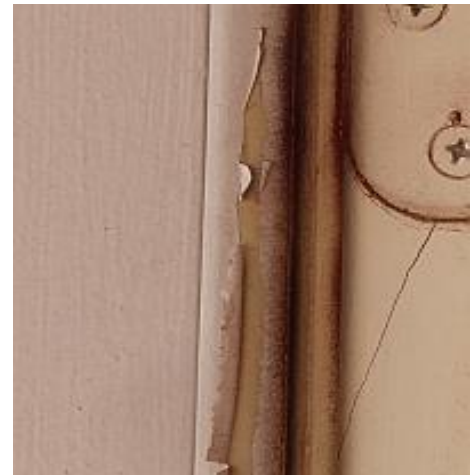
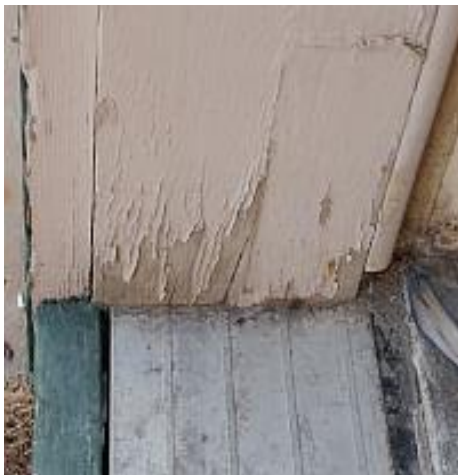
The exterior door frame is weathered. Recommend prepping and sealing (painting/staining). Recommend Repair

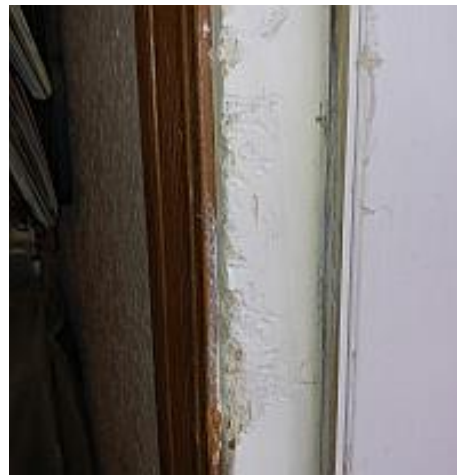
The interior door frame is dinged. Recommend Repair

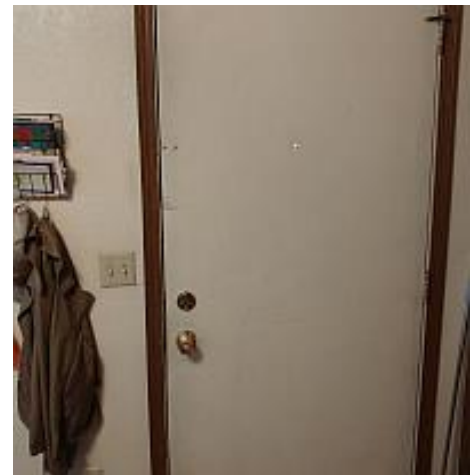
The door is dinged. Recommend Repair

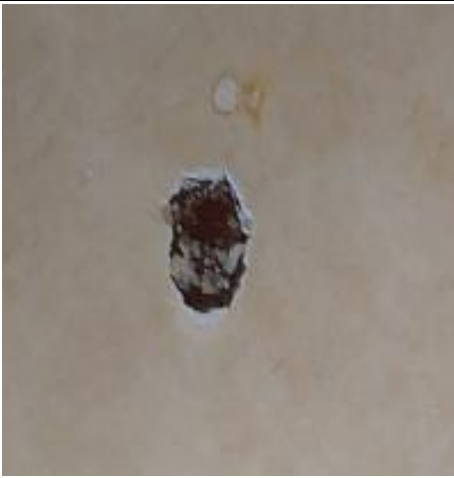
The floor is dinged. Recommend Repair/Replacement.

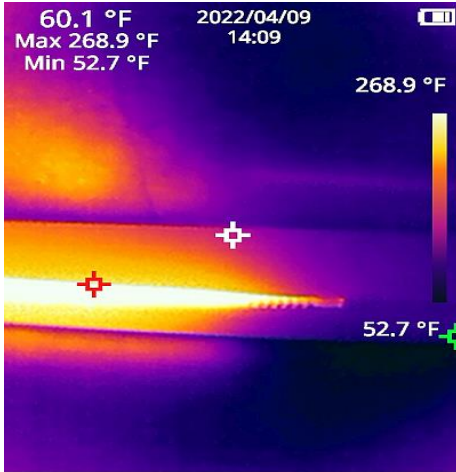
The baseboard electric heater is operating.

Inspector's Note. These heaters are not maintenance free. Annual cleaning of the heating element is recommended. Without preventative maintenance the heating element can clog with dust and as a result the unit can run hot.

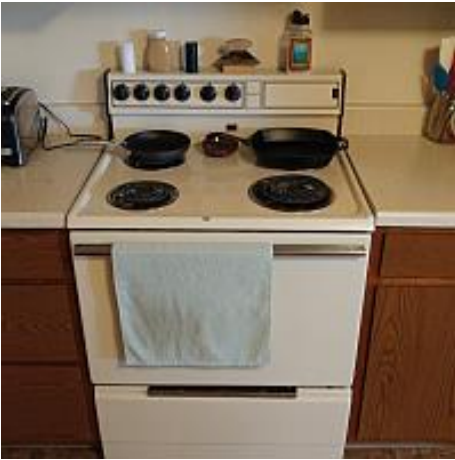
The range tip bracket is missing. The tip bracket keeps the range from tilting forward (could happen with the oven door open). Recommend Replacement.

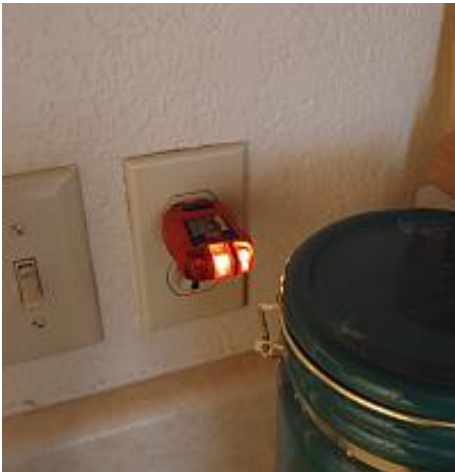
The kitchen outlets are not GFCI. While required by current standards, this home was constructed before those standards were in place. It is highly recommended that all kitchen outlets be GFCI. Recommend Repair/Replacement.

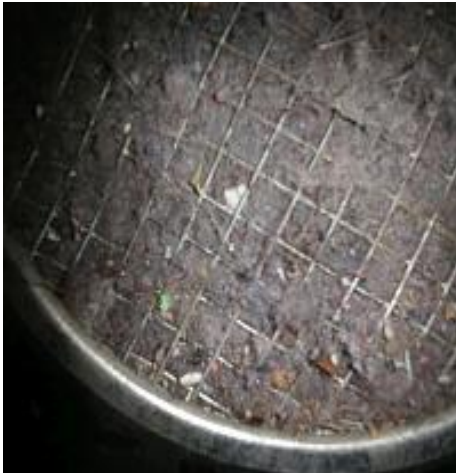
Dryer duct properly vented to the exterior.

There is a screen installed on the dryer duct termination. Screens should never be installed on dryer duct terminations as they can trap dryer lint and cause the dryer duct to clog.

The dryer duct is clogged. Dryer lint is very flammable. This is a Major Concern. Recommend Repair.

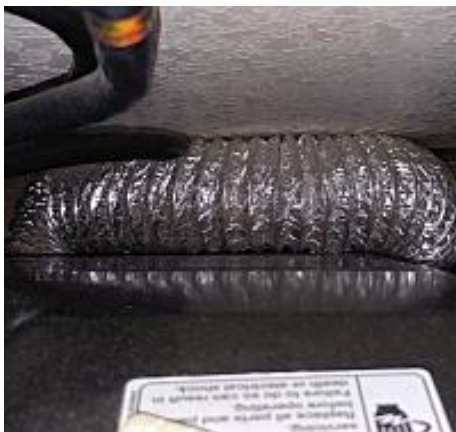
Wire bound vinyl or plastic ducting should not be used to connect the dryer to the dryer duct. This ducting can melt and will not contain a fire within the dryer.

The most preferred material for connecting the dryer to dryer duct, aluminum flexible duct, is being used.

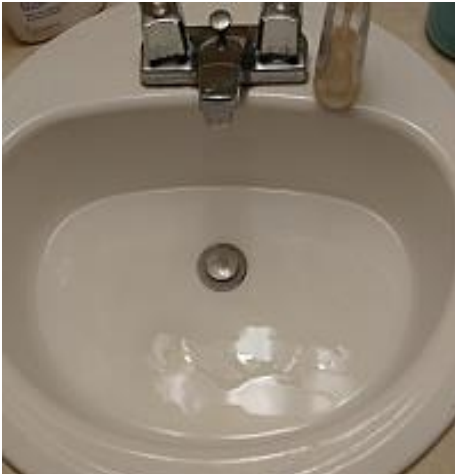
The sink drains slowly. Recommend Repair.

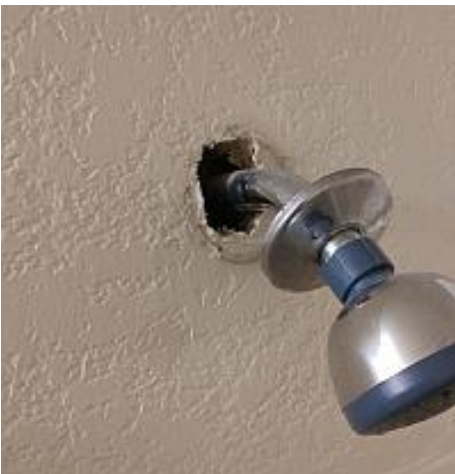
Recommend calking where indicated to help prevent moisture penetration into the walls.

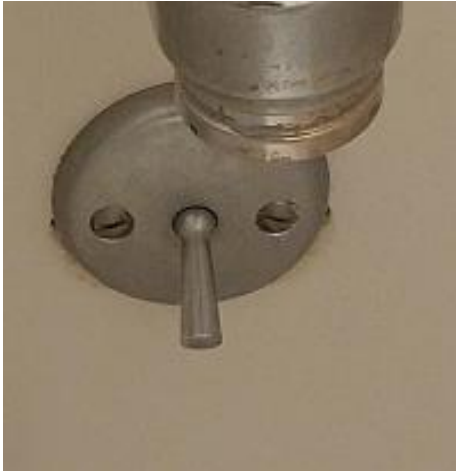
The faucet drips. Calk at the faucet/wall junction is cracked. Recommend Repair.

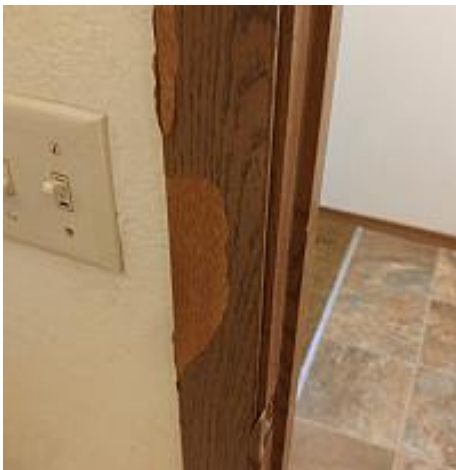
The plastic veneer on the door trim is peeling. Recommend Repair/Replacement.

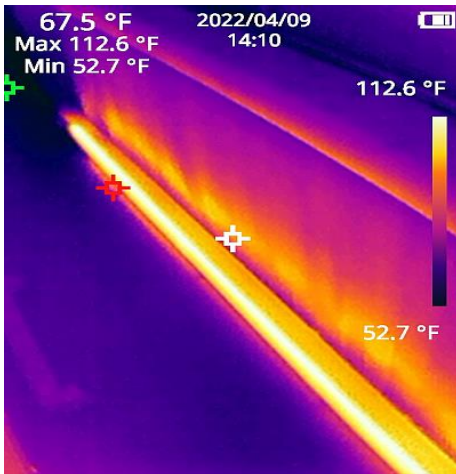
The baseboard electric heater is operating.

Inspector's Note. These heaters are not maintenance free. Annual cleaning of the heating element is recommended. Without preventative maintenance the heating element can clog with dust and as a result the unit can run hot.

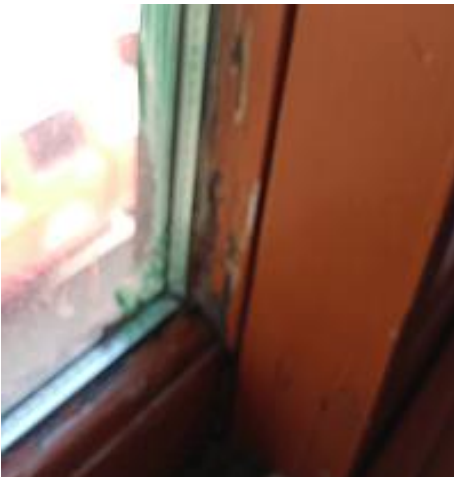
The wood windows are weathered. Recommend Repair.

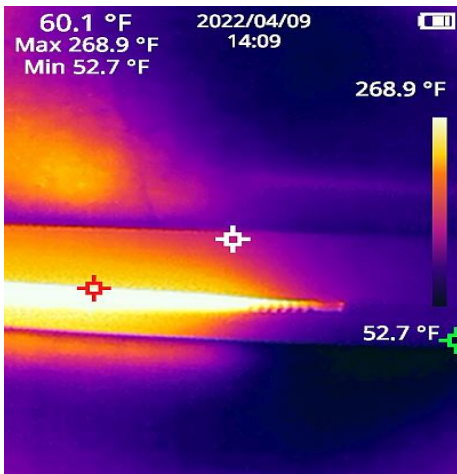
The baseboard electric heater is operating.

Inspector’s Note. These heaters are not maintenance free. Annual cleaning of the heating element is recommended. Without preventative maintenance the heating element can clog with dust and as a result the unit can run hot.

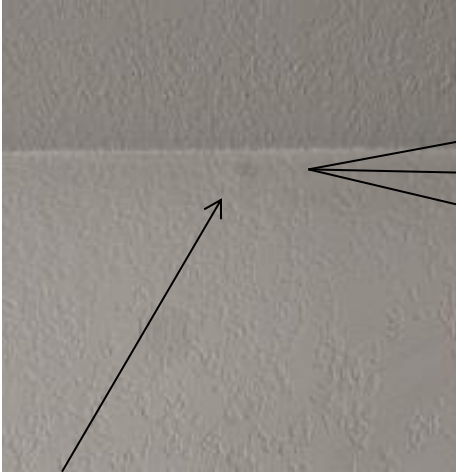
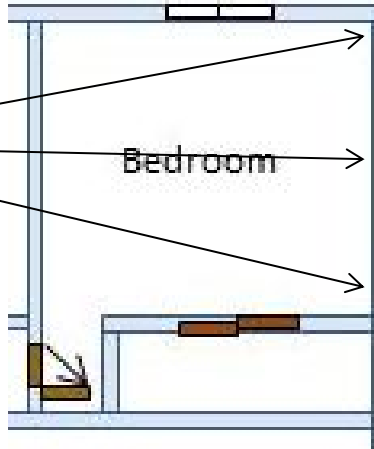
Inspector's Note: There are many reasons why drywall screws 'pop'. The most common reason is shrinkage of the wood framing (as the wood ages, it loses moisture content and shrinks). Any gaps between the drywall and the framing studs will create a space where the drywall can move. Movement forces the head of the drywall screw through the drywall mud. Walls with exterior doors are particularly susceptible to this. Normally resetting and re-mudding the screws will fix the problem.

Popped dry wall screws where indicated. Recommend Repair.

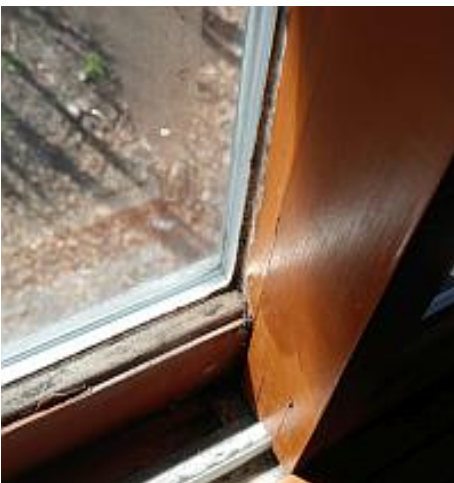
The wood windows are weathered. Recommend Repair.

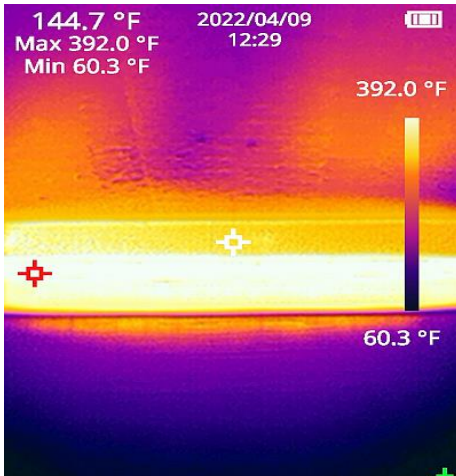
The baseboard electric heater is operating.

Inspector’s Note. These heaters are not maintenance free. Annual cleaning of the heating element is recommended. Without preventative maintenance the heating element can clog with dust and as a result the unit can run hot.

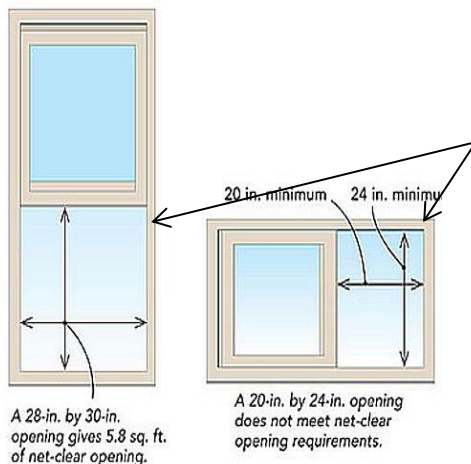
Inspector’s Note: A word about Egress Windows. Emergency escape and rescue openings shall have a minimum net clear opening of 5.7 square feet (5.0 square feet for ground floors). The net clear opening is the normal operation of the window. This area is required to provide egress for firefighters and rescue personnel while wearing equipment. The minimum net clear opening height shall be 24". The net clear opening width shall be 20". The window shall also be no more than 44" from the floor.

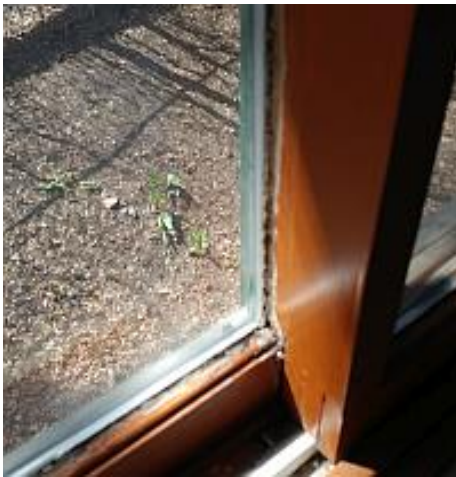
The wood windows are weathered. Recommend Repair.

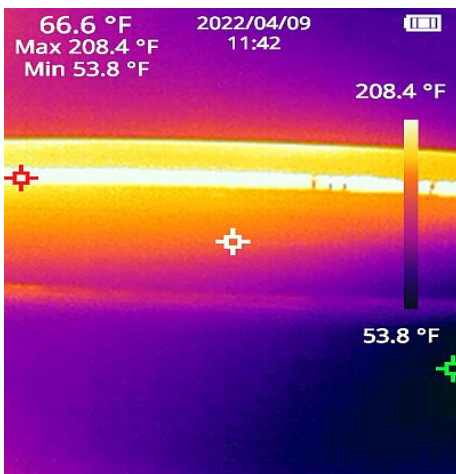
The baseboard electric heater is operating.

Inspector’s Note. These heaters are not maintenance free. Annual cleaning of the heating element is recommended. Without preventative maintenance the heating element can clog with dust and as a result the unit can run hot.

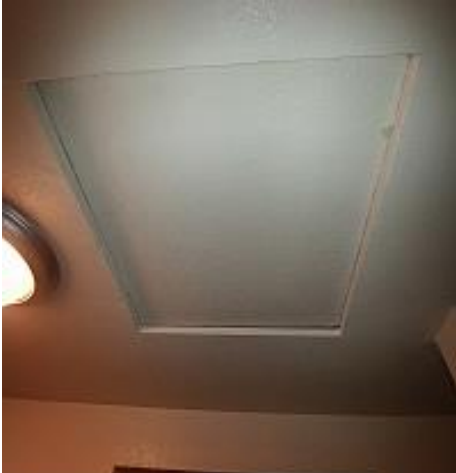
The attic access only measures 20 x 23. While current standards require a minimum clear opening 22x30, this apartment was built before those standards were in place.

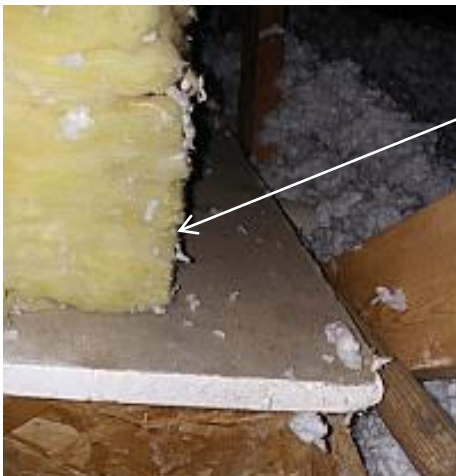
The hatch cover is properly insulated. Insulation dams are installed around the access. The attic access should be as well insulated as the attic. Insulation dams help hold insulation away from the access.

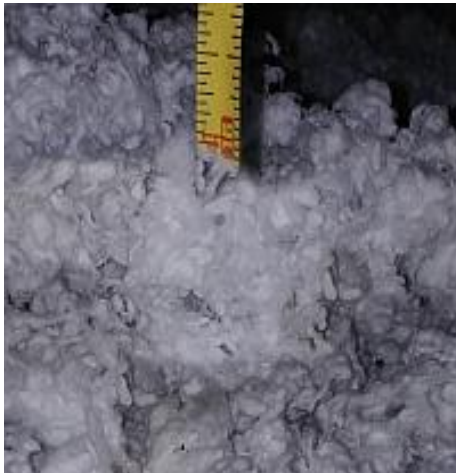
Sixteen inches of blown in/batt insulation equates to an R (Resistance) value of 40. R 39 is recommended for attics in this region. The insulation is displaced in areas. Recommend Repair.

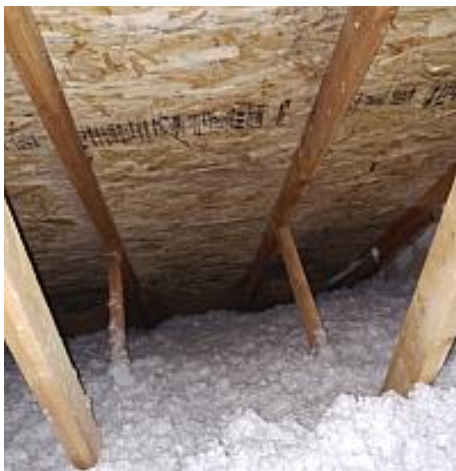
The attic structure is in Satisfactory Condition.

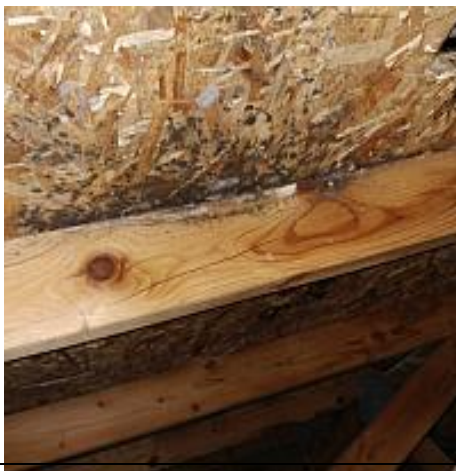
Possible mold growth observed near the kitchen exhaust fan ducting. The actual presence or absence of mold can only be verified by testing. Recommend removal.

The exhaust fan ducting should be insulated to help prevent condensation.

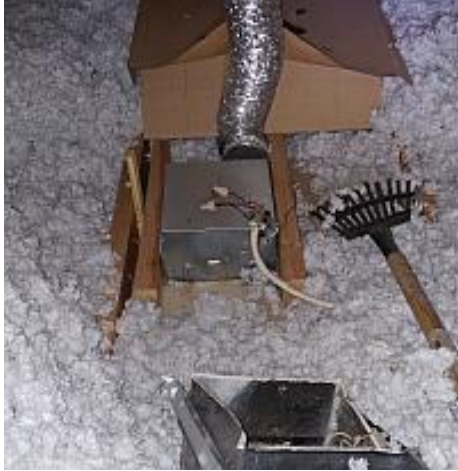
Insulation has been removed from around the bath exhaust fan. Recommend Repair.

Open junction box observed. The ground wire is not attached. This is a potential Safety Hazard. Recommend Repair.

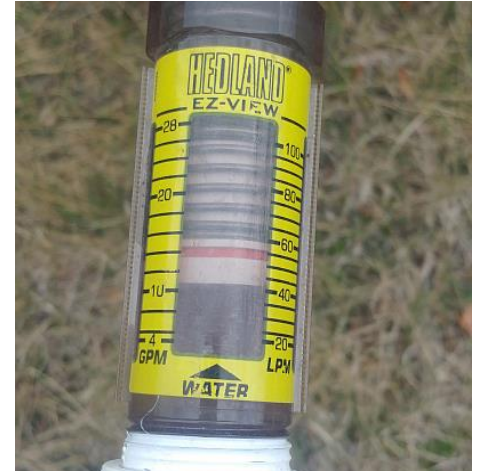
Water temperature is 120.2°F. A water temperature of 120°F is considered optimal for domestic use.

The water pressure is 36psi, which is within acceptable limits.

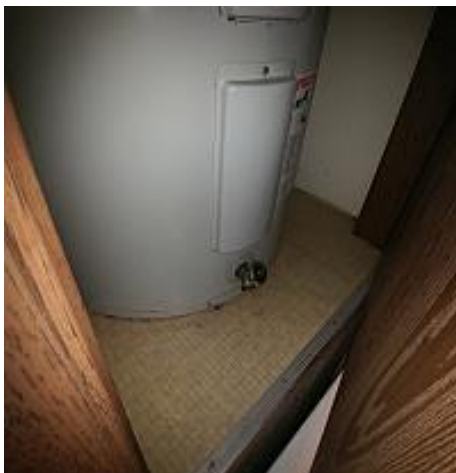
There is no drip pan installed. Current standards state that where water heaters tanks are installed in locations where leakage of the tanks or connections will cause damage, the tank shall be installed in a galvanized steel pan having a minimum thickness of 24 gage, or other pans approved for such use. Ideally the pan should be plumbed to an approved drain. Recommend Repair.

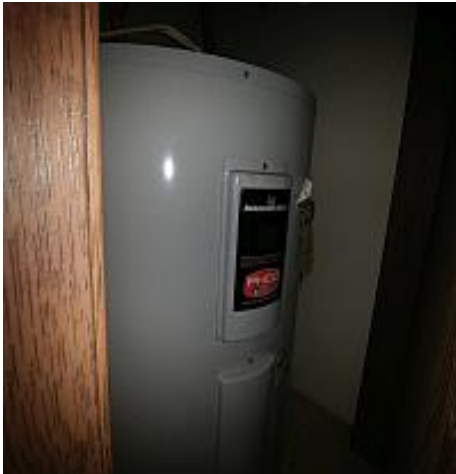
There are no seismic restraints on the water heater. Current standards require seismic restraints in this region of Montana. Water heaters shall be anchored or strapped to resist horizontal displacement due to earthquake motion. Strapping shall be at points within the upper one-third (1/3) and lower one third (1/3) of its vertical dimensions. At the lower point, the strapping will be a minimum distance of four (4) inches above the controls.

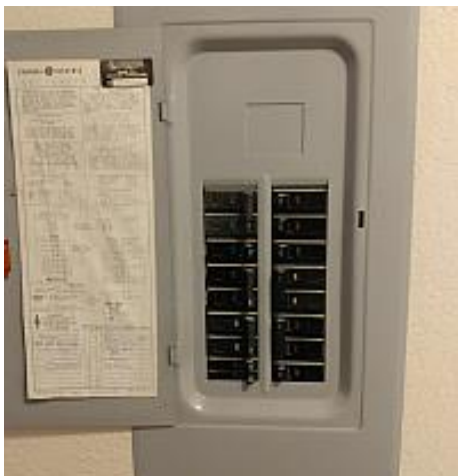
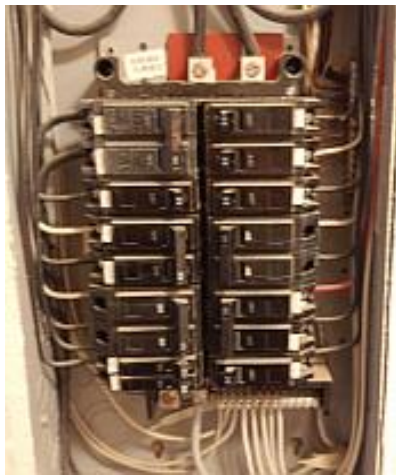
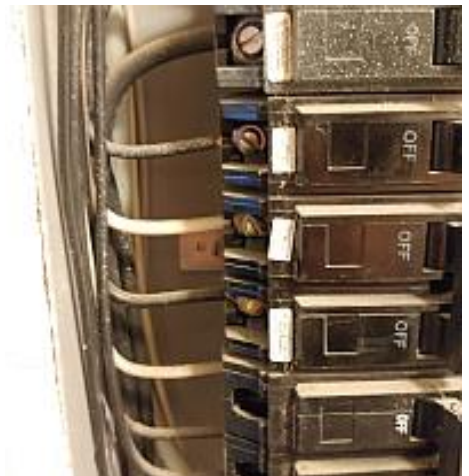
The main panel is in Satisfactory Condition.

White (neutral) wires used as black (live or line) wires should be color coded black.
