State of Montana Licensed Home Inspector  
HI0163

**Inspection Date: 12<sup>th</sup> of Never**

**Report Number: JJD00000000**

**Inspector: Michael Parker**

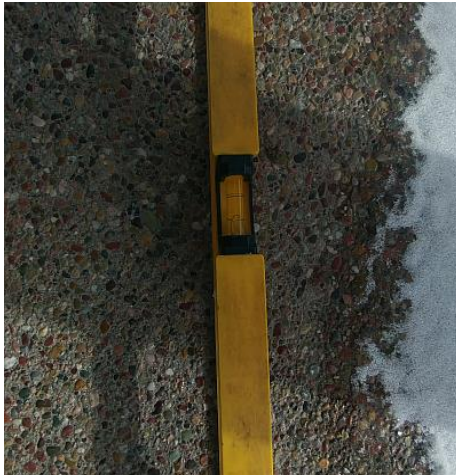
The service walks are properly pitched away from the home.

The service walks are partially snow covered and could not be completely visually inspected.

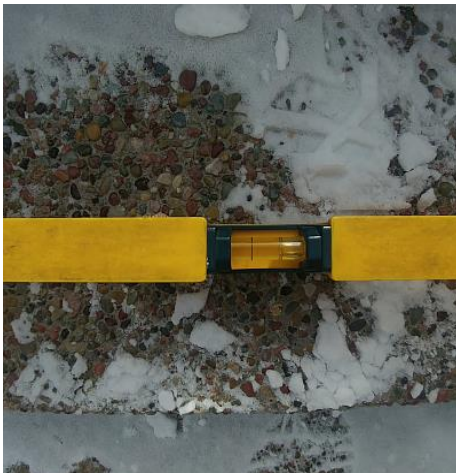
The steps are not properly pitched. Repair would likely not be

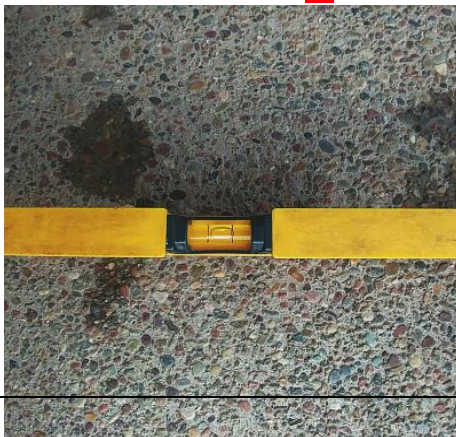
The driveway is pitched toward the garage. The driveway should be pitched so that runoff flows away from the garage. Repair would likely not be practical.

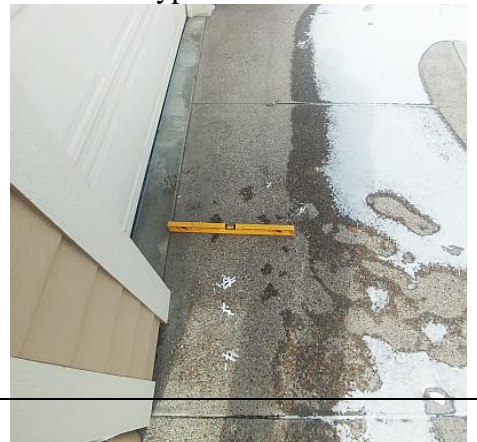
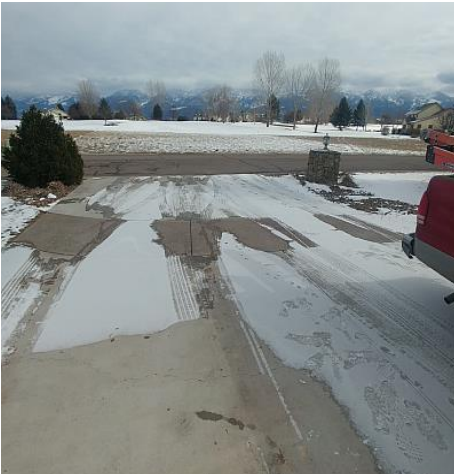
Settling at the driveway/public service walk junction has created a potential Trip Hazard. Recommend Repair.

The driveway is partially snow covered and could not be completely visually inspected.

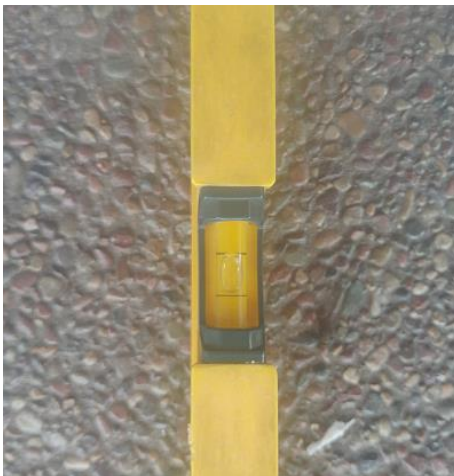
The patio is properly pitched away from the home.

Large settling cracks observed. Recommend sealing to help prevent moisture intrusion.

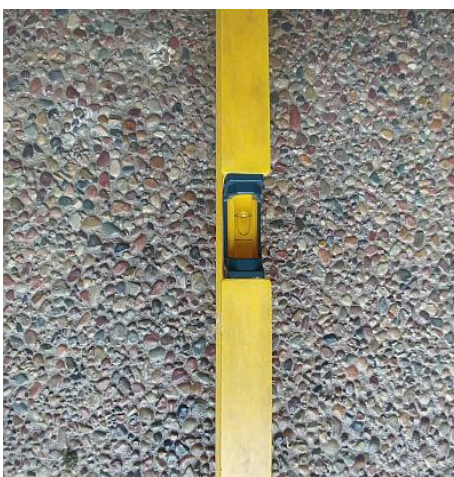
The floor is in Satisfactory Condition. Properly pitched away from the home.

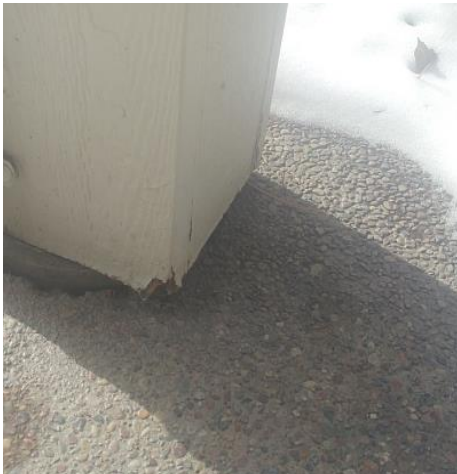
Wood to concrete contact. Untreated wood should never be allowed to be in contact with concrete (can cause deterioration). Deterioration detected at the time of the inspection. Recommend Repair.

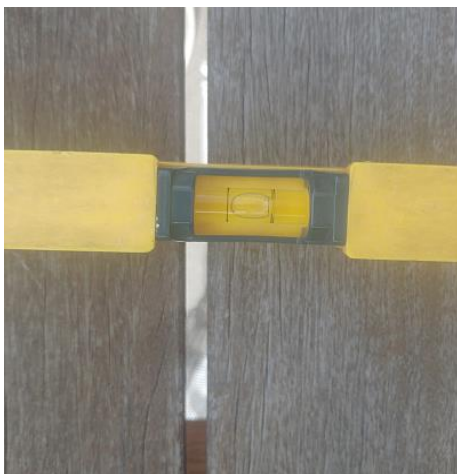
The floor is properly pitched away from the home. The floor is weathering. Recommend prepping and sealing (painting/staining). Recommend Repair.

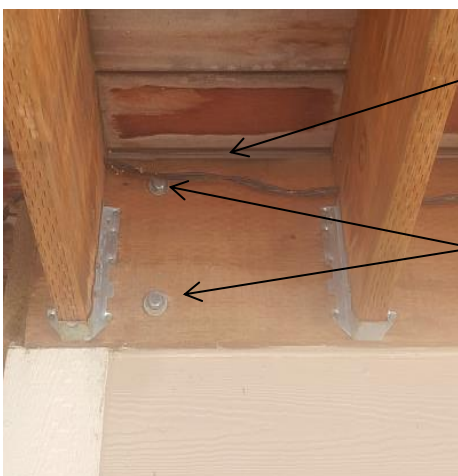
The floor is properly flashed. Flashing helps prevent moisture intrusion at the deck/home junction. Proper attachment between the ledger board and home structure observed.

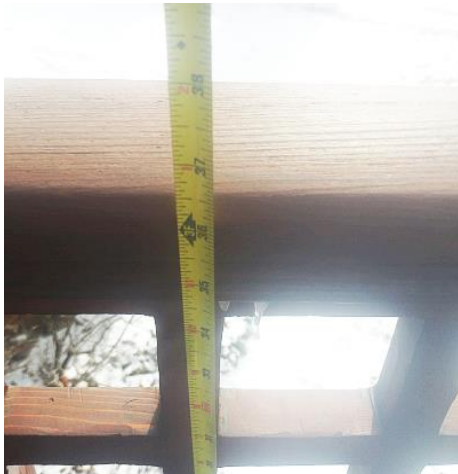
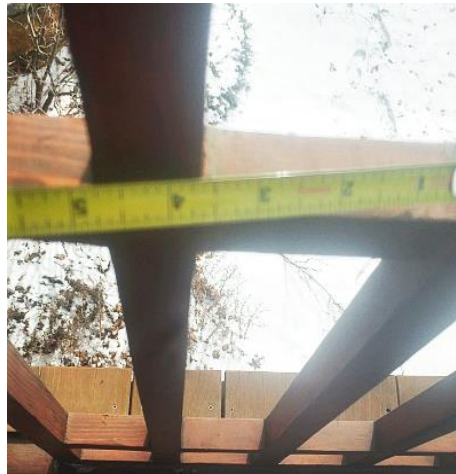
The railing is the proper height. Balusters are properly spaced.

The railings are weathering. Recommend prepping and sealing (painting/staining). Recommend Repair.

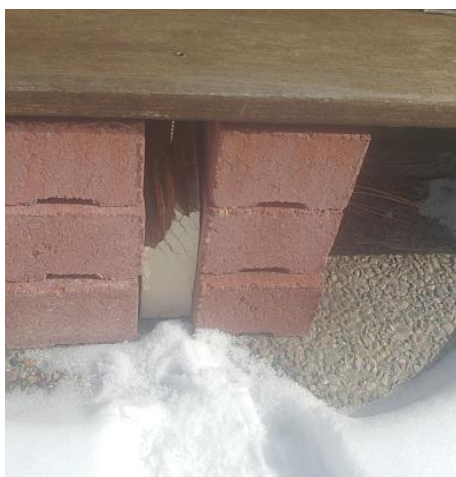
The center riser is cracked/broken. The bricks installed to support the steps are not permanently installed. Recommend Repair.

Wood to concrete contact. Untreated wood should never be allowed to be in contact with concrete (can cause deterioration).

Early indications of deterioration detected at the time of the inspection. Recommend Repair.

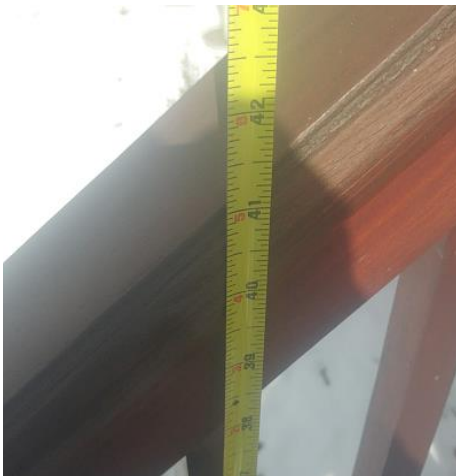
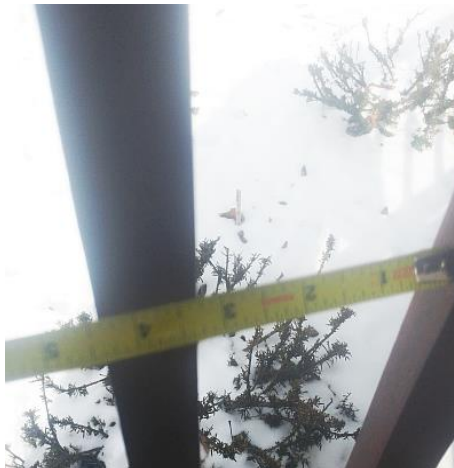
The railing is the proper height. Balusters are properly spaced.

The railings are weathering, obvious repairs observed. Recommend prepping and sealing (painting/staining). Recommend Repair.

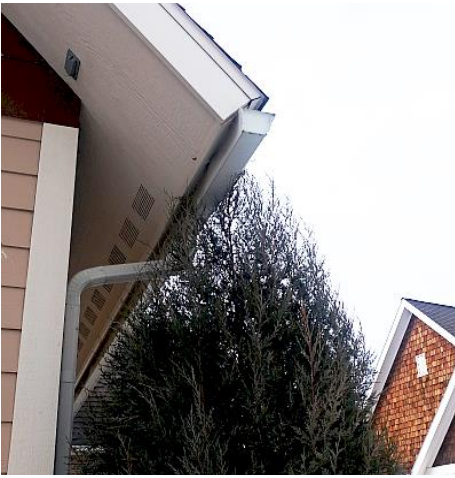
Vegetation in several areas is in direct contact with/overgrowing the home. Recommend Trimming.

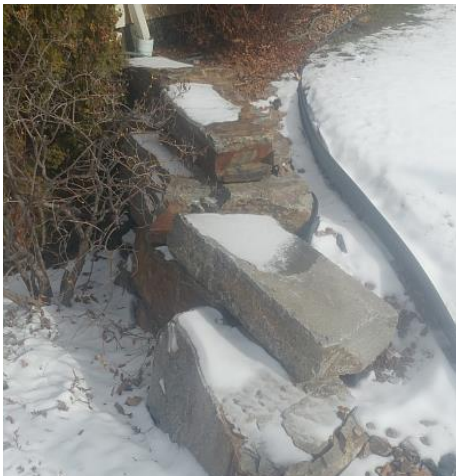
The stone retaining walls are in Satisfactory Condition.

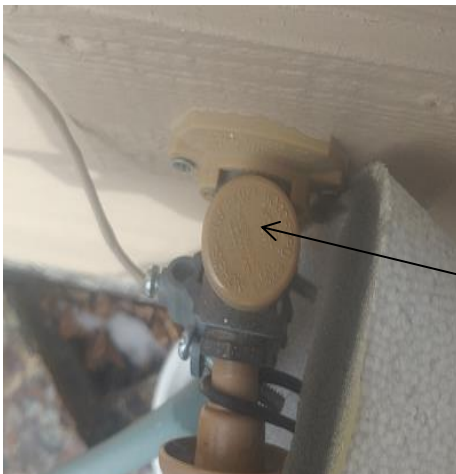
External faucets (bibs) should have either a frost free valve or a means of internally turning the water off (isolation valve) to keep them from freezing in temperatures below 32°F.

← Proper anti-siphon valve installed on all external faucets (bibs).

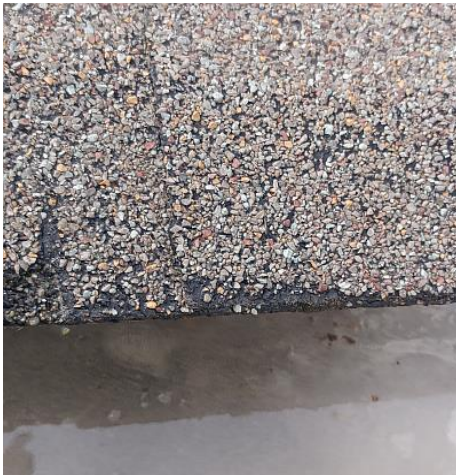
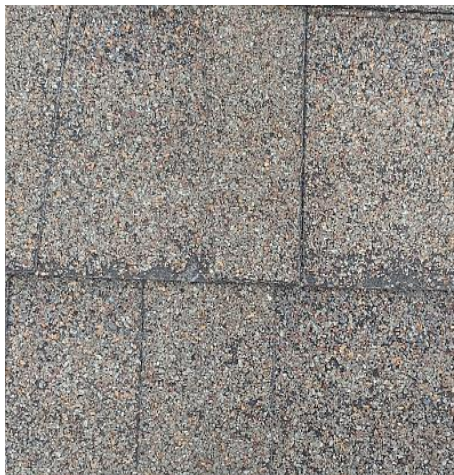
Missing granules observed. Minor damage observed (likely occurred during installation). The gutters are full of granules. This can be an indication that the roof cover is nearing the end of its operational life expectancy. Recommend evaluation by a licensed roofer. Recommend Repair.

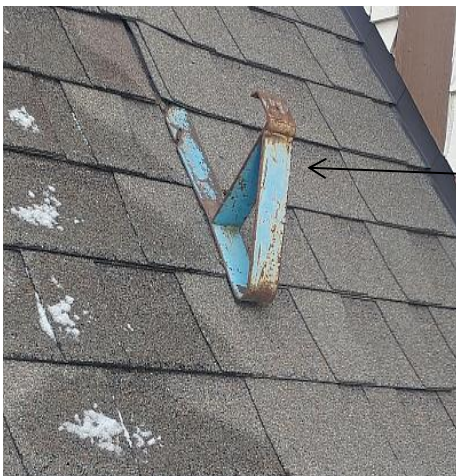
There is a scaffolding bracket installed where indicated. These are used during installation of the roof cover and then removed. There is no obvious reason why this bracket is still in place. Recommend Removal.

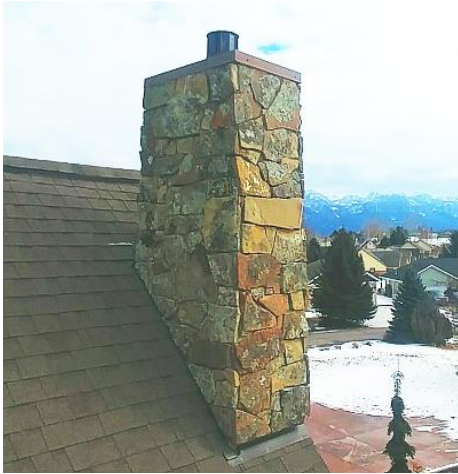
The Chimney is in Satisfactory Condition.

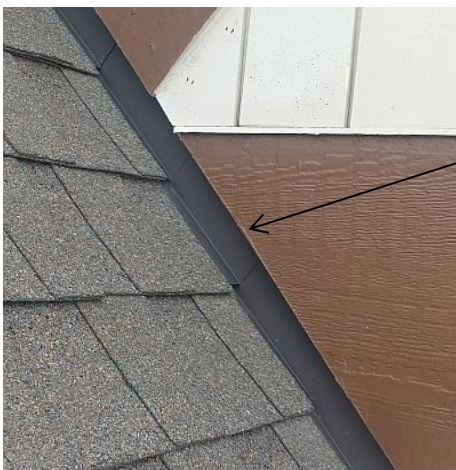
Proper step flashing used on all sidewalls.

The headwall flashing properly overlaps the highest course of shingles.

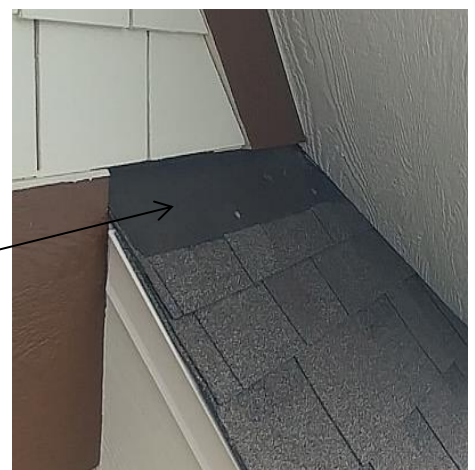
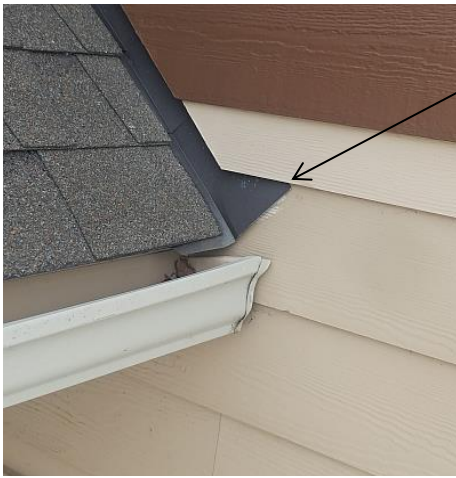
There is no kick out flashing installed. Kick out flashing is used where a lower roofline terminates against a vertical wall. The kick out is installed above the rain gutter or drip edge where the roof meets a vertical wall. It keeps rainwater out and diverts it away from the lower wall. This is an incorrect install. Recommend Repair.

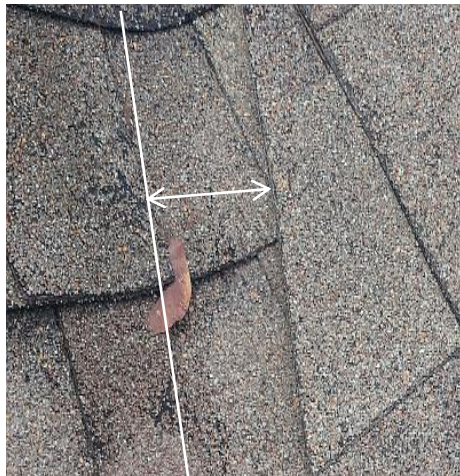
The shingle edges are properly offset from the valleys.

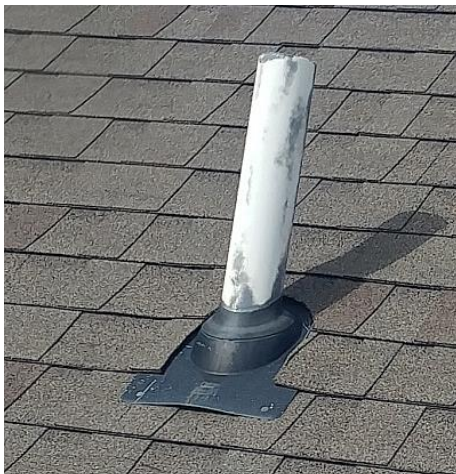
The plumbing vents are in Satisfactory Condition.

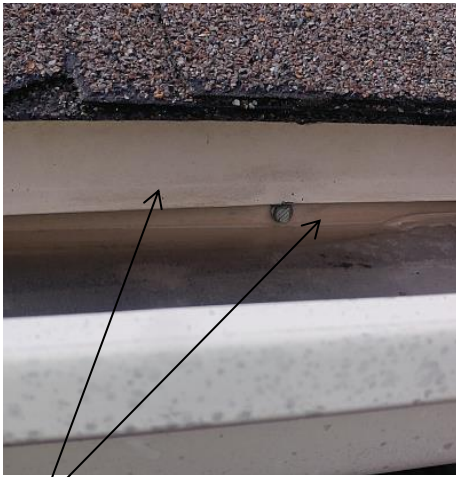
The homes drip edge properly overlaps the gutters. This helps keep runoff from getting between the gutters and fascia.

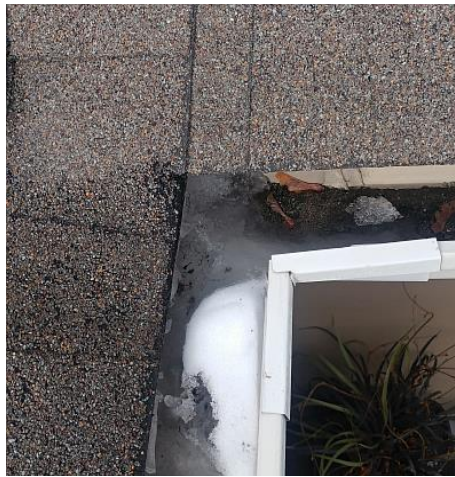
The gutters are dirty. Recommend Cleaning and seasonal cleaning thereafter.

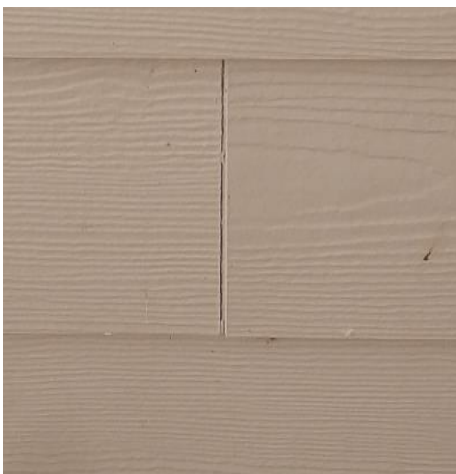
Calking needed on numerous siding joints. Recommend Repair.

Inspector's Note: Siding joint covers are an alternative to calking.

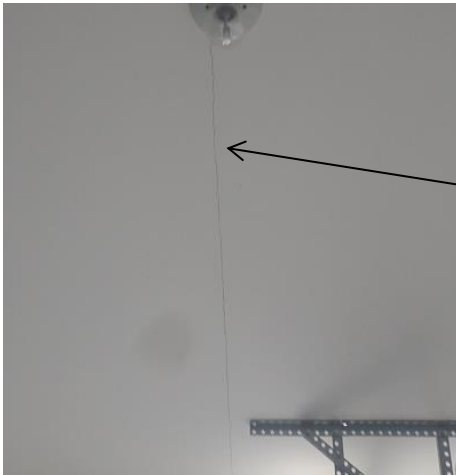
Cracked dry wall seams where indicated. These do not appear structural. Recommend Repair.

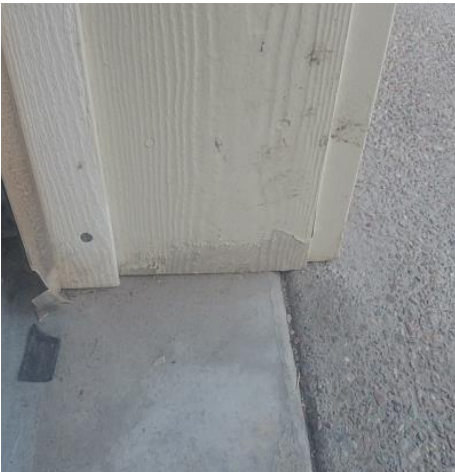
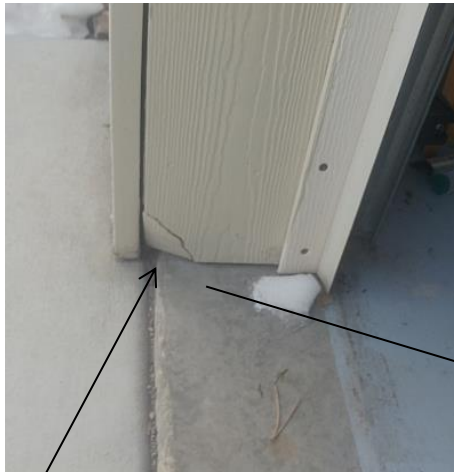
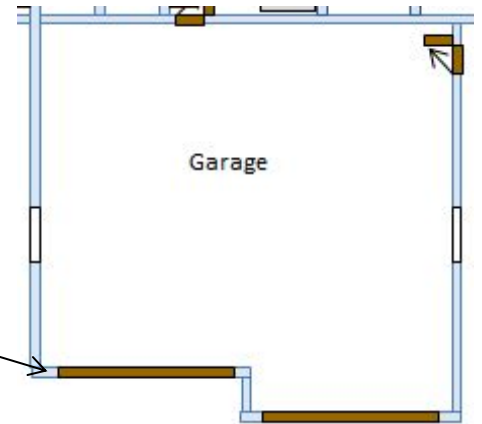
The exterior door trim is weathering. Damaged trim where indicated. Recommend Repair/Replacement.

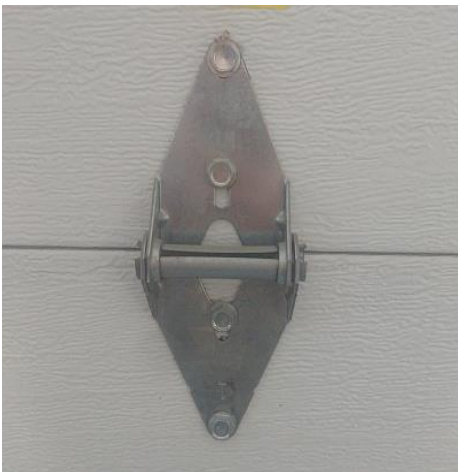
Recommend lubricating all rollers and hinges and annually thereafter.

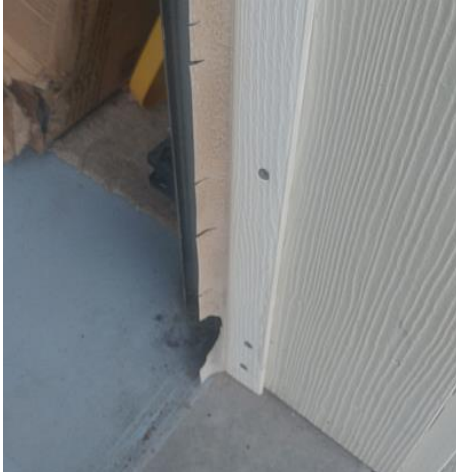
All of the side weather stripping is torn. Recommend Replacement.

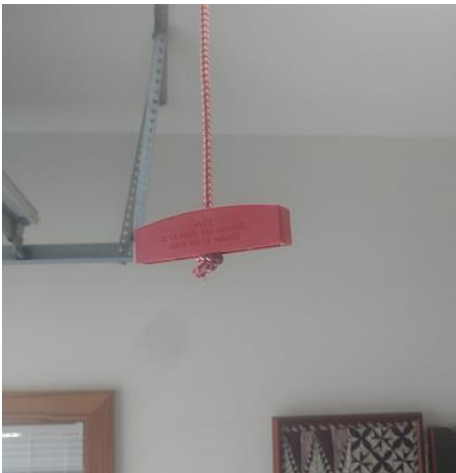
The emergency release handles are too high. Recommend Repair/Adjustment.

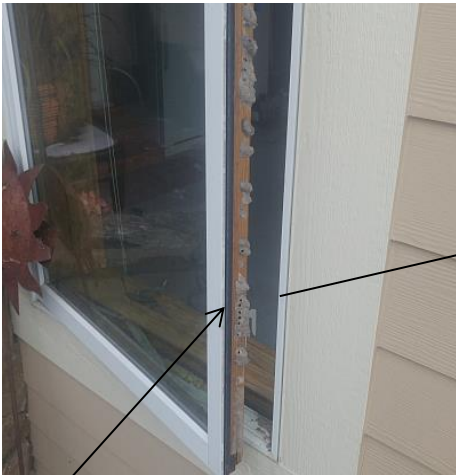
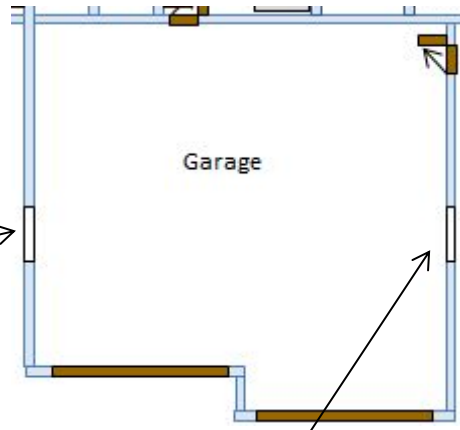
Mud dauber wasps are nesting in the inner portion of the window indicated. This could be an indication that the window is not properly sealed. The screen is not installed in this window. Recommend Repair/ Replacement.

Access to the window indicated is blocked by personal items. This window could not be completely inspected or operated.

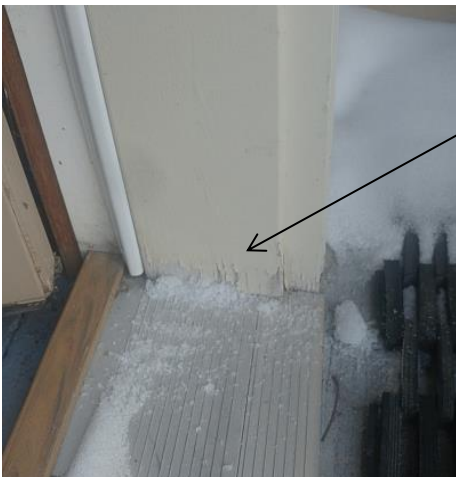
The exterior door frame is weathered. Recommend prepping and sealing (painting/staining). Recommend Repair

Door scrapes on the frame when opened/closed. Recommend Repair/Adjustment.

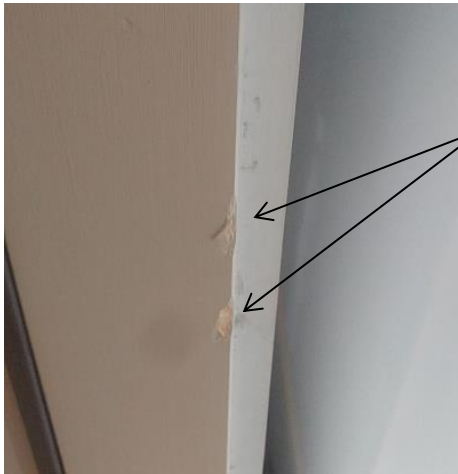
The door frame is slightly dinged. Recommend Repair.

The fire separation door should be self-closing. The self-closing hinges have been disabled. Recommend Repair.

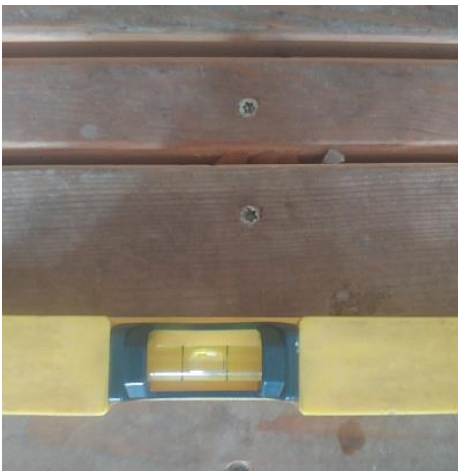
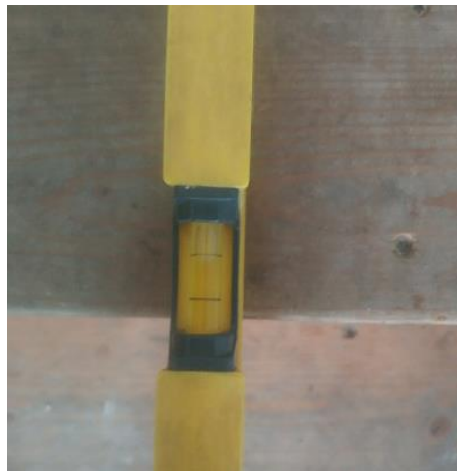
The steps are properly pitched. The hand rail (not required) is too high (38 inches maximum) and loose.

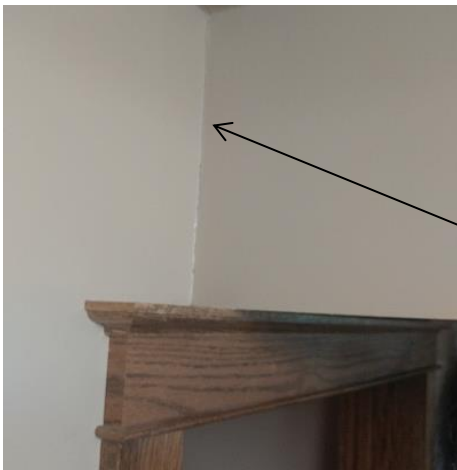
Cracked dry wall seam where indicated. This does not appear structural. Recommend Repair.

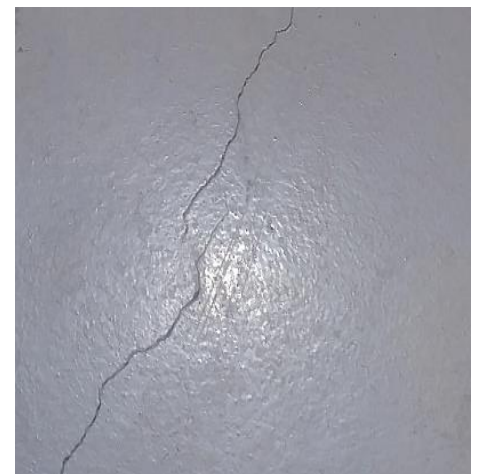
Typical cracks on the garage floor. No indication of recent movement, no trip hazard.

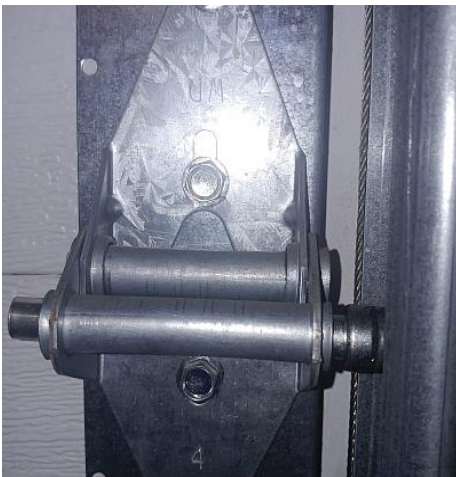
Recommend lubricating all rollers and hinges and annually thereafter.

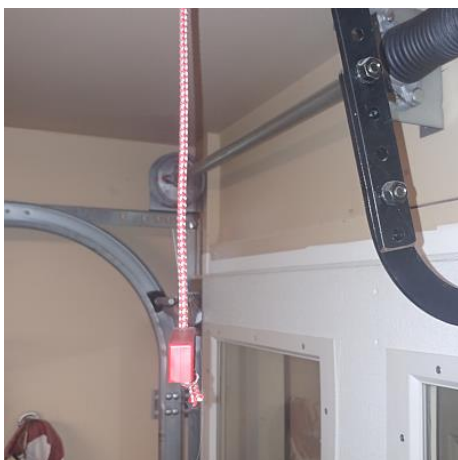
The emergency release handle is too high. Recommend Repair/Adjustment.

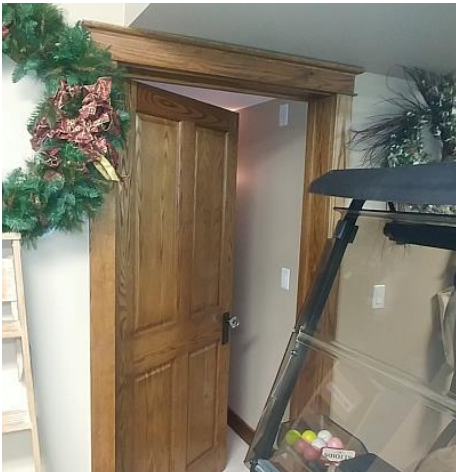
This is not a fire separation door. This is a potential Safety Hazard. Recommend Repair.

The fire separation door should be self-closing. Recommend Repair.

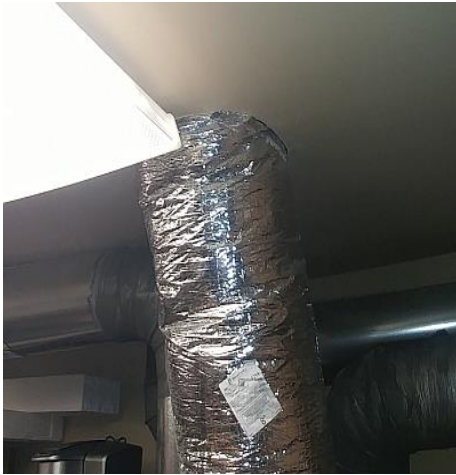
Flexible ducting penetrating the fire separation wall, the PVC ducting for the central vacuum penetrating the fire separation wall, and large gaps around the metal ductwork penetrating the fire separation wall are breaks in the fire separation wall and are potential Safety Hazards. Recommend Repair.

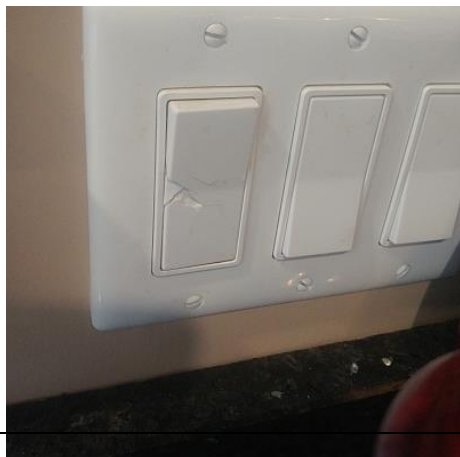
The switch indicated is cracked (the switch operates). Recommend Replacement.

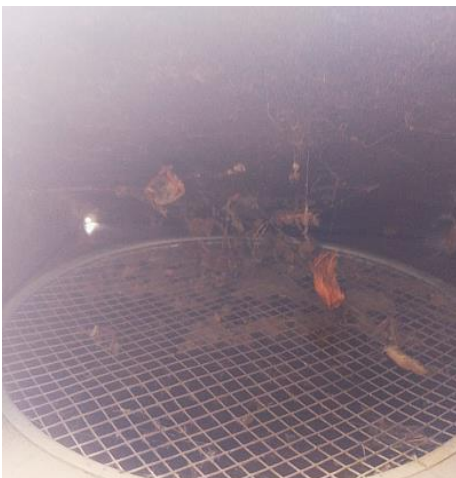
The dryer duct termination does not have a backdraft damper (automatically closing door). Recommend Replacement.

There is a screen installed on the dryer duct. Screens can collect dryer lint (as this one has). Recommend Removal.

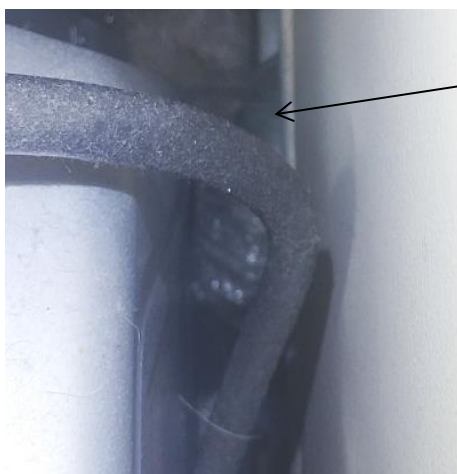
Wire bound vinyl or plastic ducting is being used to connect the dryer to the dryer duct. This ducting can melt and will not contain a fire within the dryer.

The most preferred material for connecting the dryer to dryer duct is aluminum flexible duct.

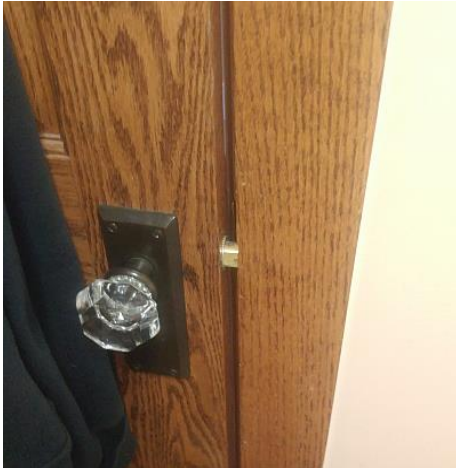
Latch bolt does not engage the strike plate. Recommend Repair/Adjustment.

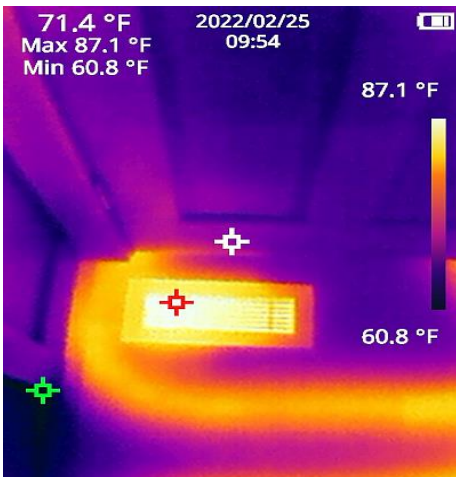
The register is in Satisfactory Condition.  
The in floor hydronic heating system is operating.

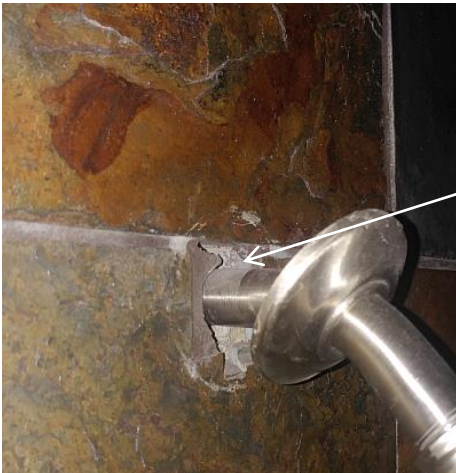
Recommend caulking where indicated to help prevent moisture penetration into the walls.

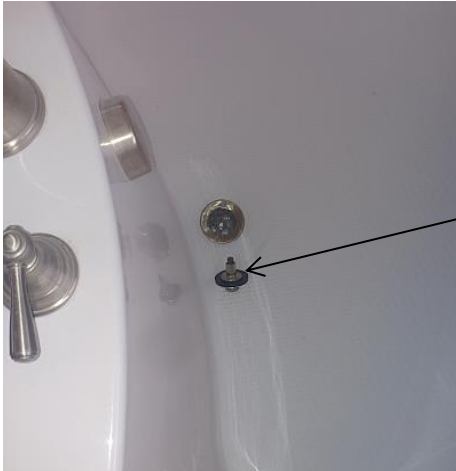
The built in stopper is not installed.

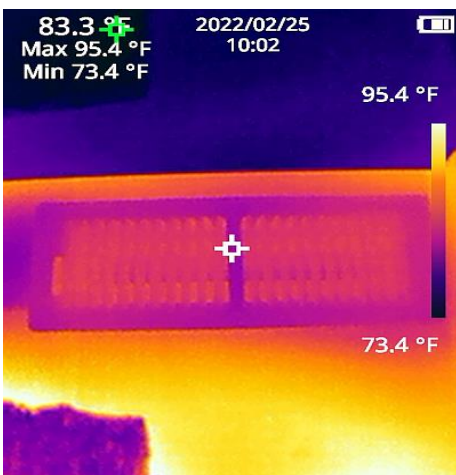
The register is in Satisfactory Condition. The in floor hydronic heating system is operating.

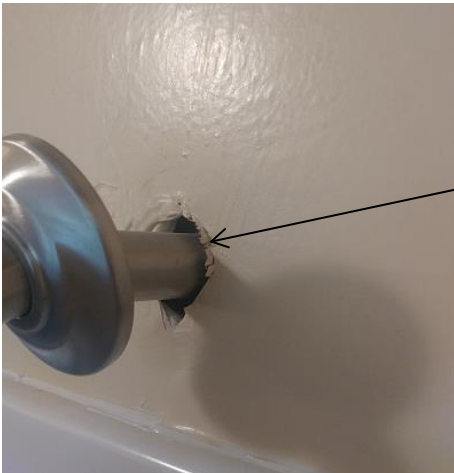
Recommend caulking where indicated to help prevent moisture penetration into the walls.

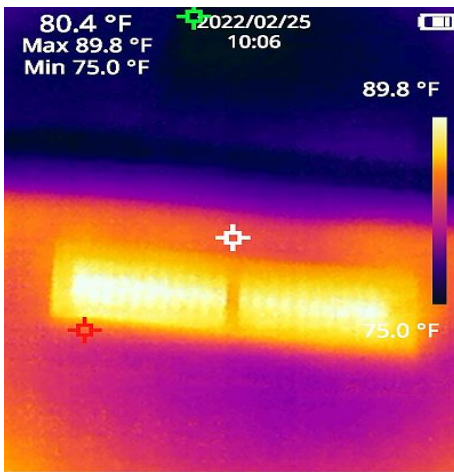
The register is in Satisfactory Condition.  
The in floor hydronic heating system is operating.

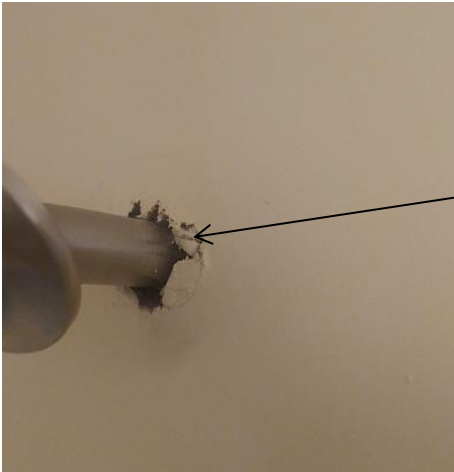
Recommend calking where indicated to help prevent moisture penetration into the walls.

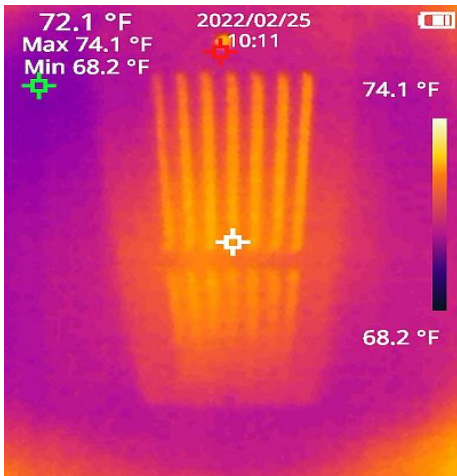
The register is in Satisfactory Condition. There does not appear to be in floor hydronic heating in this bathroom.

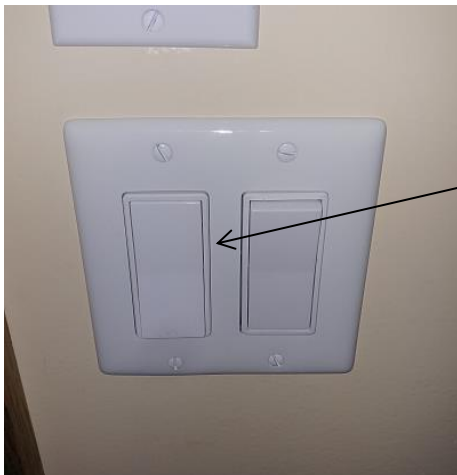
When the exhaust fan was turned on the GFCI would trip. This could be an indication of a problem with the bathroom electric system. This is a Major Concern. Recommend Repair.

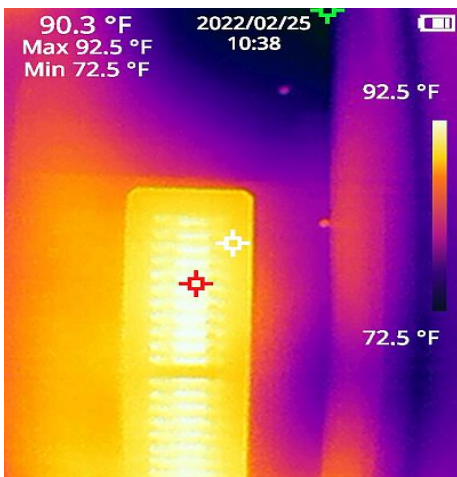
The register is in Satisfactory Condition.  
The in floor hydronic heating system is operating.

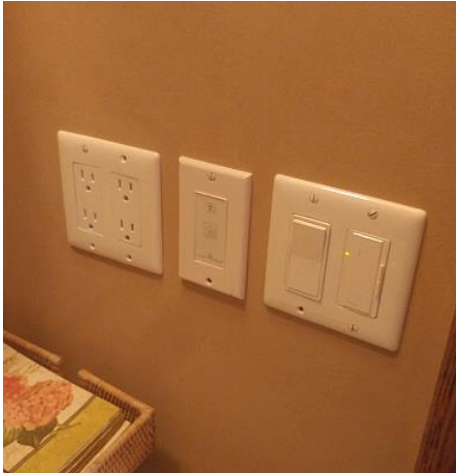
Numerous screws are missing from the cover plates. Recommend Replacement.

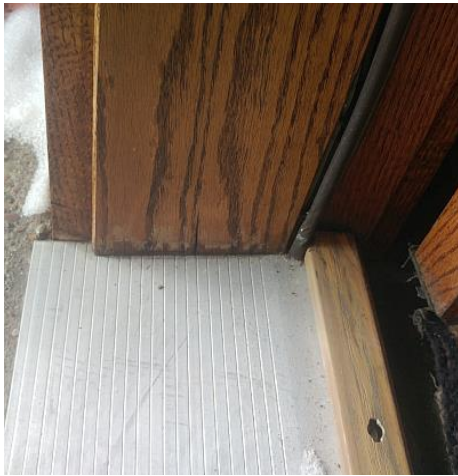
The exterior door frame is weathered. Recommend prepping and sealing (painting/staining). Recommend Repair

The weather stripping is loose. Recommend Repair.

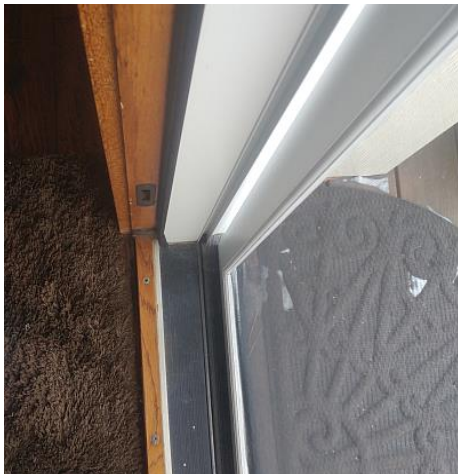
The screen door is out of track and bent. Recommend Repair/Replacement.

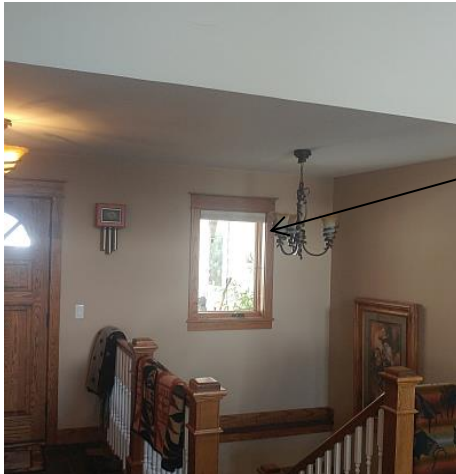
The screen is not installed in the window indicated. Recommend Replacement.

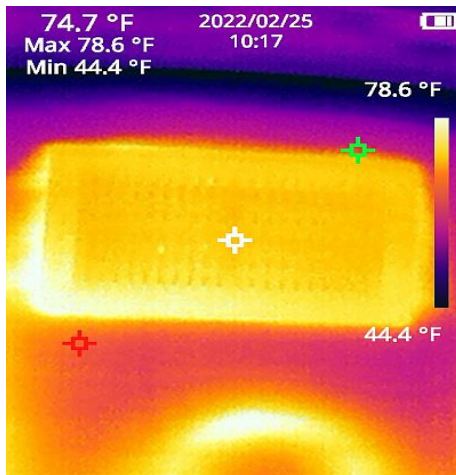
The register is in Satisfactory Condition.  
 The in floor hydronic heating system is operating.

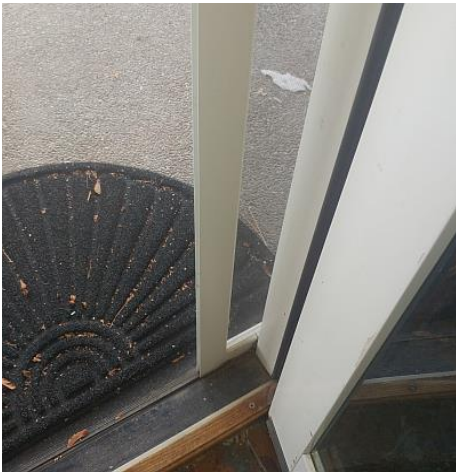
The screen door is difficult to operate. Recommend Repair/Adjustment.

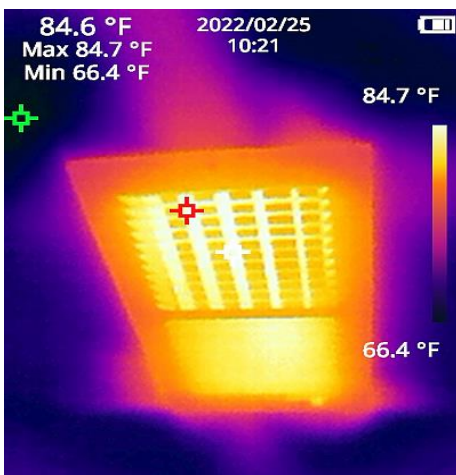
The register is in Satisfactory Condition.

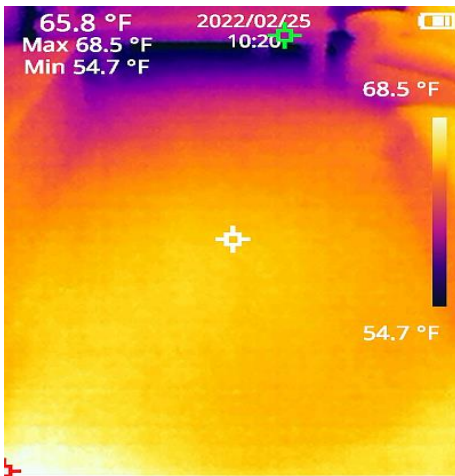
The in floor hydronic heating system is operating.  
The hydronic heat for this room was off when the inspector arrived. Hydronic heating systems, while efficient, are slow to heat up. While a heat rise was not detected with an infra-red camera, a heat rise using a contact thermometer was detected.

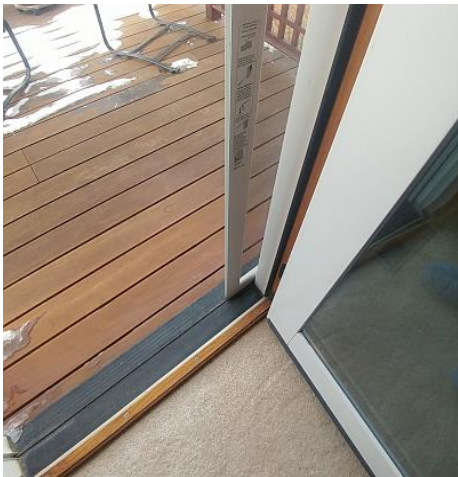
The screen door is difficult to operate. Recommend Repair/Adjustment.

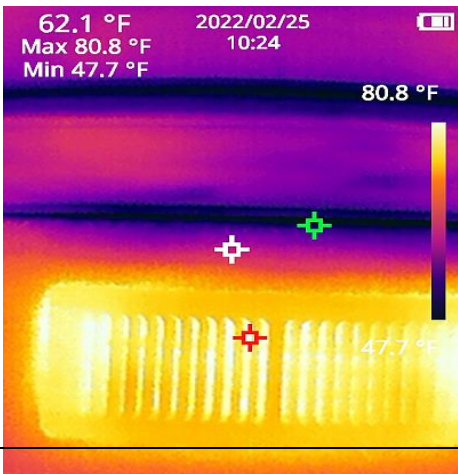
The register is in Satisfactory Condition. The in floor hydronic heating system is operating.

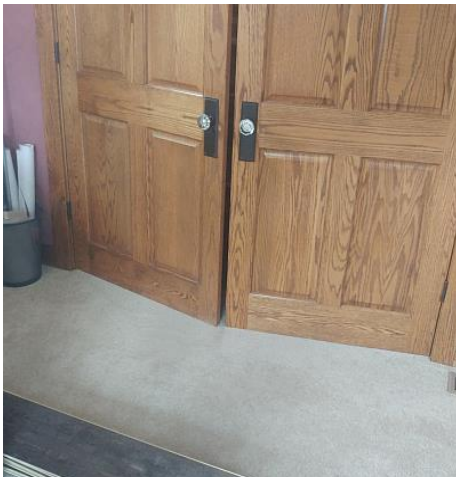
The closet doors scrape on the floor cover when operated. Recommend Repair/Adjustment.

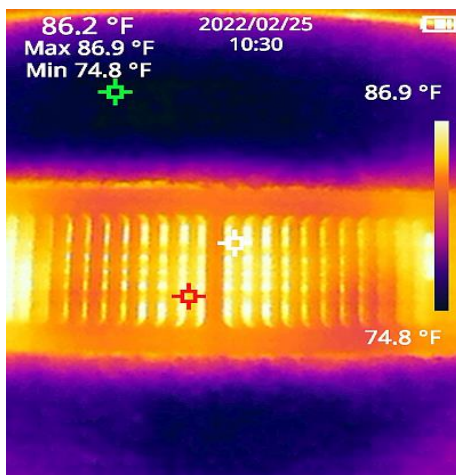
The register is in Satisfactory Condition. The in floor hydronic heating system is operating.

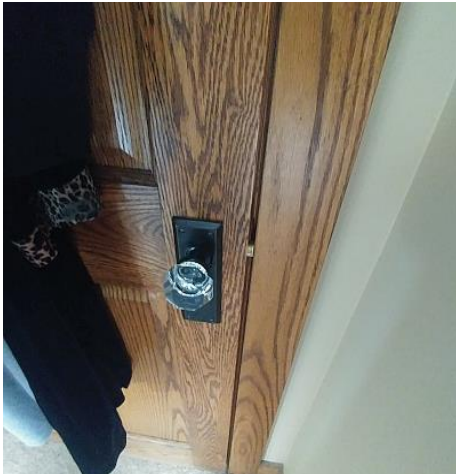
Latch bolt does not engage the strike plate. Recommend Repair/Adjustment.

Door scrapes on the floor cover when opened/closed. Recommend Repair/Adjustment.

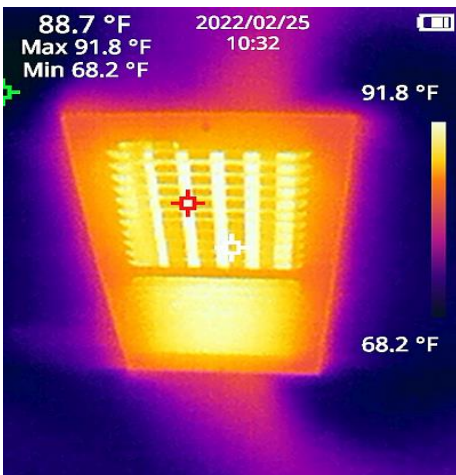
The register is in Satisfactory Condition.

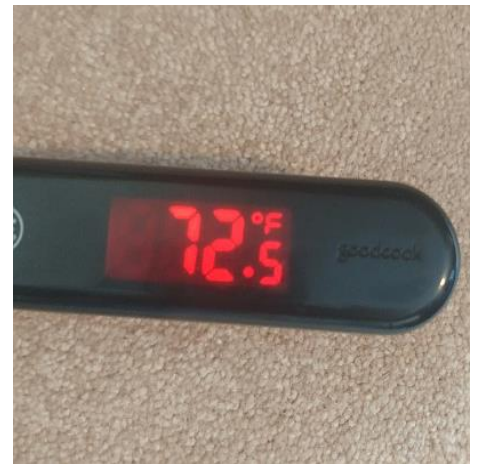
The in floor hydronic heating system is operating. The hydronic heat for this room was off when the inspector arrived. Hydronic heating systems, while efficient, are slow to heat up. While a heat rise was not detected with an infra-red camera, a heat rise using a contact thermometer was detected.

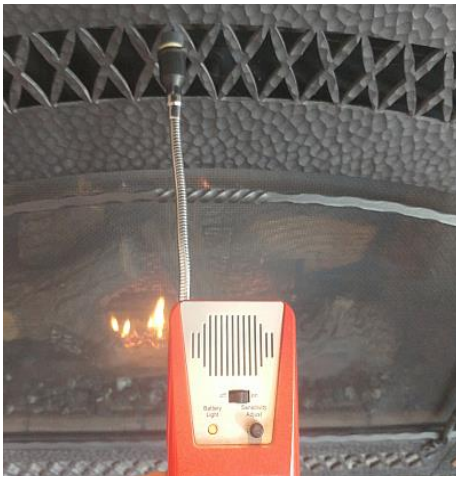
There are no Smoke or carbon monoxide detectors in the room with the fireplace. Recommend Replacement.  
Inspector's Note: Smoke and Carbon Monoxide (CO) detectors should always be installed in accordance with the manufacture's recommendations. As heated air rises, smoke detectors are typically placed high on the wall or ceiling. Carbon monoxide, however, mixes with air and diffuses evenly throughout a room. For this reason, CO detectors are typically installed at knee level – the approximate height of a sleeping person's nose and mouth.

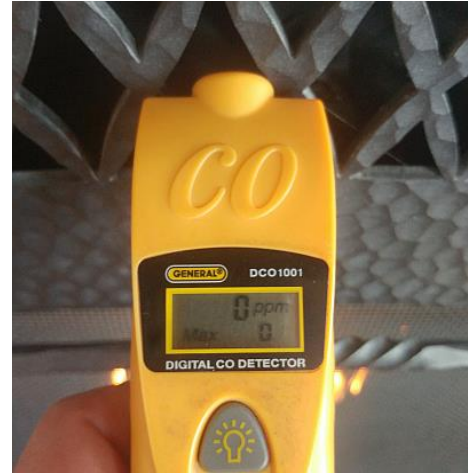
No gas or CO leaks detected.  
Testers TIF 8800/DCO 1001.

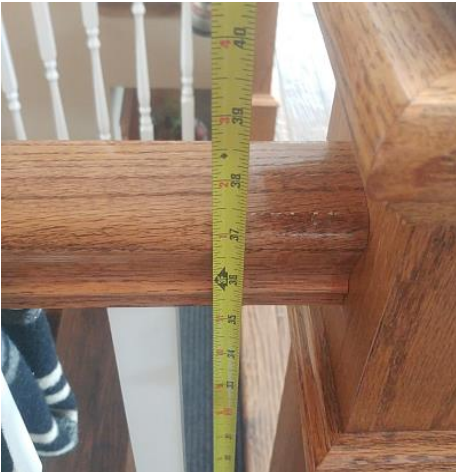
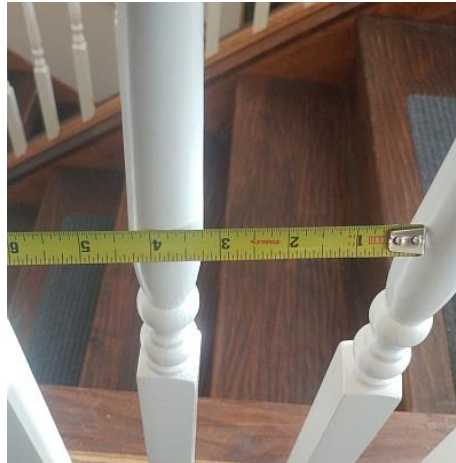
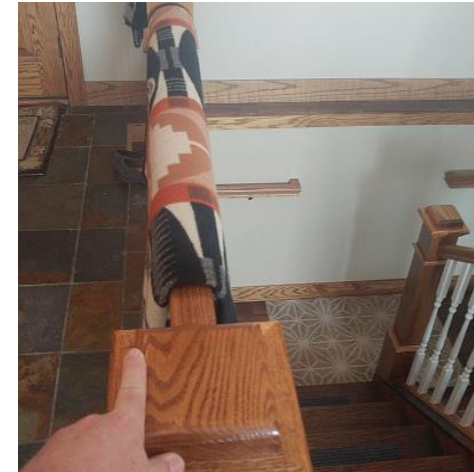
The stair guard is the proper height (36 inches minimum). Balusters are properly spaced (4 inches maximum).

Loose stair guards observed.  
Recommend Repair.

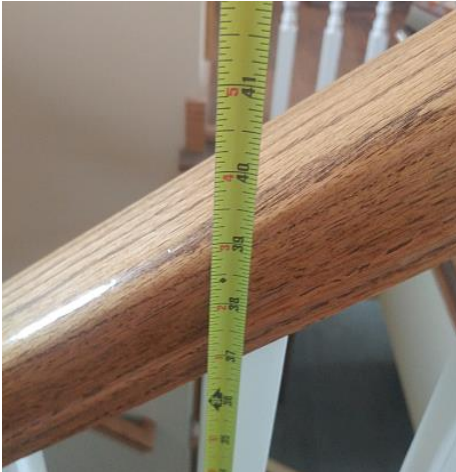
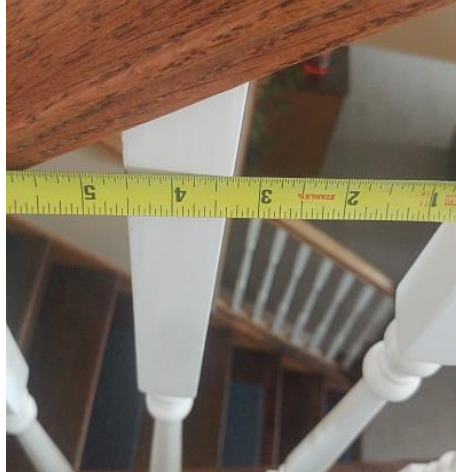
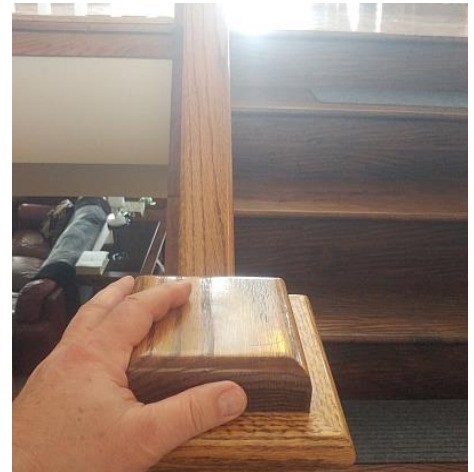
The handrail is the proper height (34 – 38 inches). Balusters are properly spaced (4 inches maximum).

Loose hand rail observed. Recommend Repair.

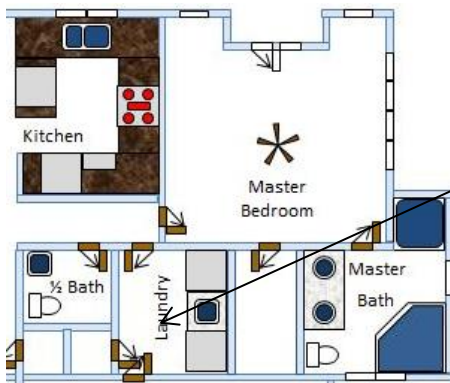
The attic access is where indicated.

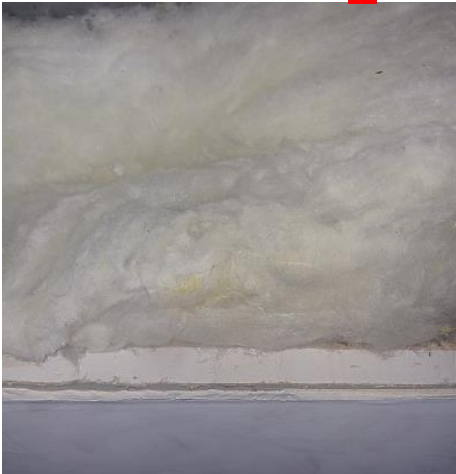
The hatch cover is properly insulated.  
 Insulation dams are installed around the access.  
 The attic access should be as well insulated as the attic.  
 Insulation dams help hold insulation away from the access.

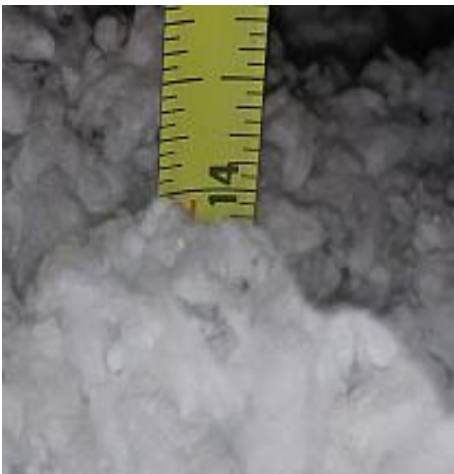
Fourteen inches of blown in insulation equates to an R (Resistance) value of 35. R 39 is recommended for attics in this region.

The insulation is displaced/compressed in areas. Recommend Repair.

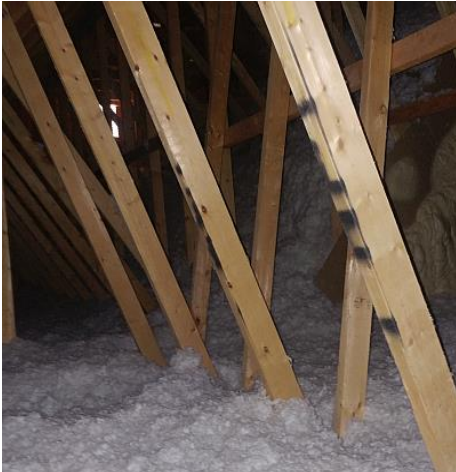
The attic structure is in Satisfactory Condition.

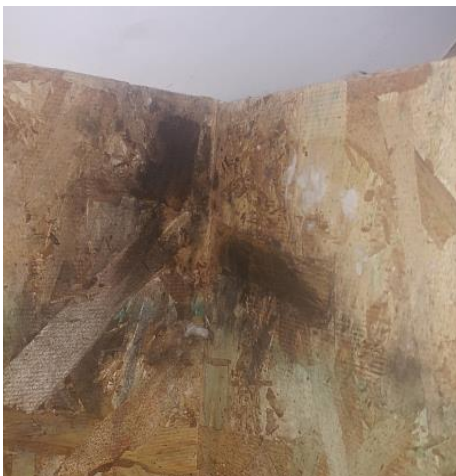
Black staining observed on the insulation dams. While this does not appear to be mold, the actual presence or absence of mold can only be verified by testing.

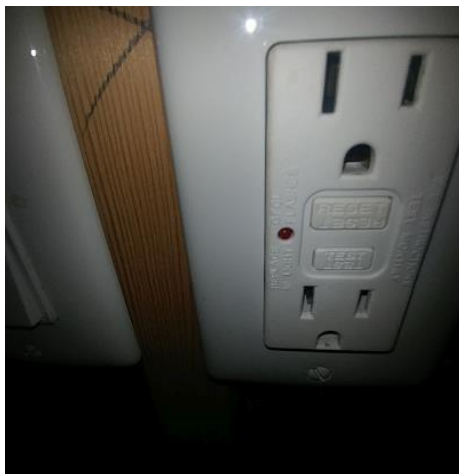
The indicator light for the GFCI in the utility room is flashing. This indicates that the GFCI needs to be replaced. Recommend Replacement.
