State of Montana Licensed Home Inspector  
HI0163

**Inspection Date: 12<sup>th</sup> of Never**

**Report Number: JJD00000000**

**Inspector: Michael Parker**

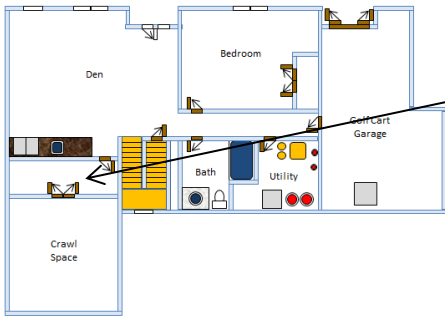
The crawl space access is where indicated. The crawl space is completely filled with personal items. The inspector could not enter the crawl space.

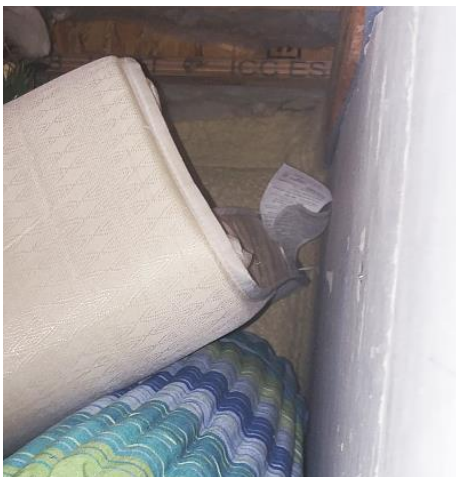
The foundation walls are covered by insulation and could not be visually inspected. There are no obvious indications of problems with the foundation walls.

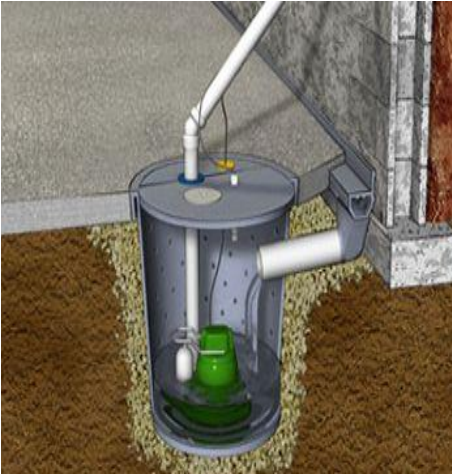
The inspector always recommends drainage of some type. If a sump pump is to be installed a sealed crock unit (illustrated) is recommended.

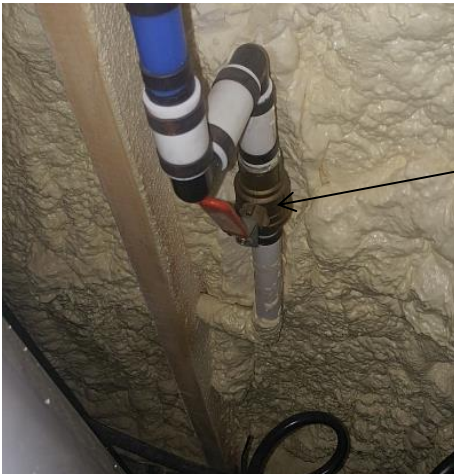
Main water shutoff is where indicated.

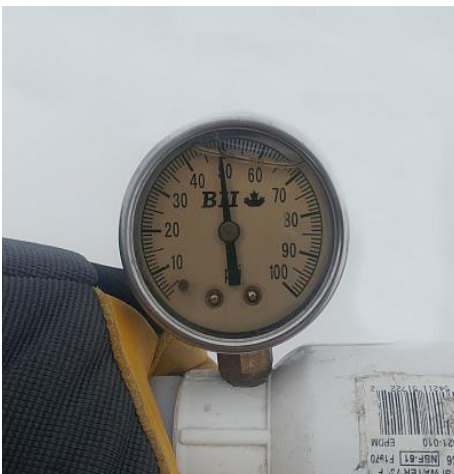
Water pressure is 48psi, which is within acceptable limits.

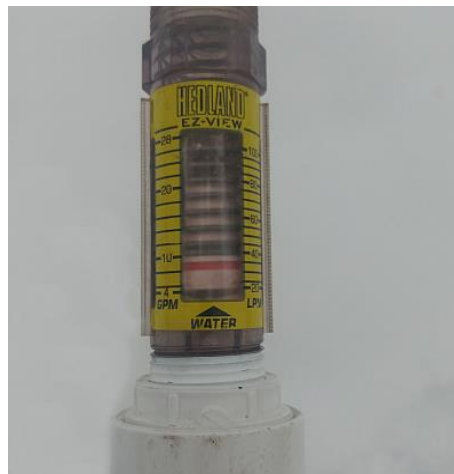
Water pressure is 9psi, which is within acceptable limits.

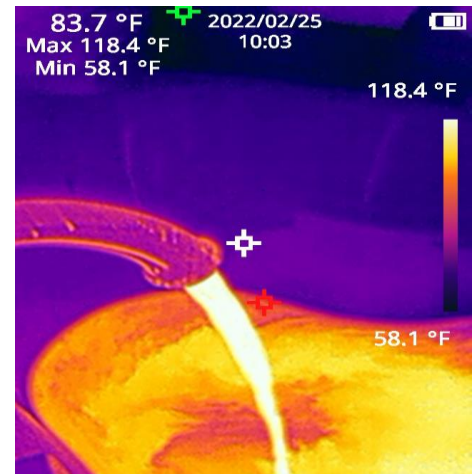
Water temperature is 118.4°F. A water temperature of 120°F is considered optimal for domestic use.

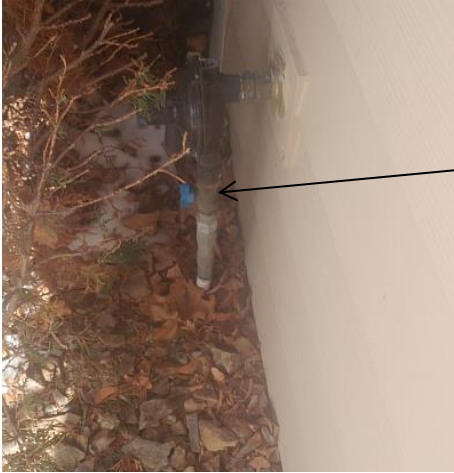
Main fuel shutoff is where indicated.

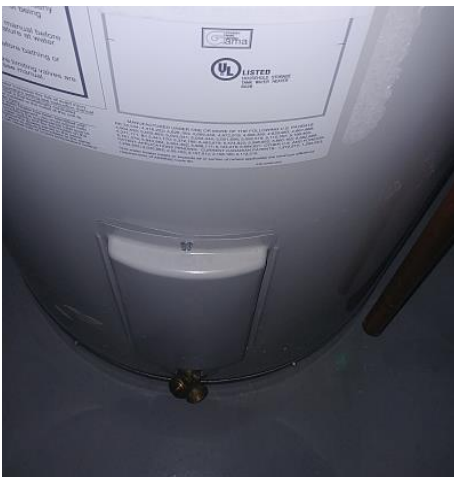
The unit is not elevated. Contact with concrete can cause the housing to rust. Recommend Repair.

Inspector's Note: There are products specifically designed for this.

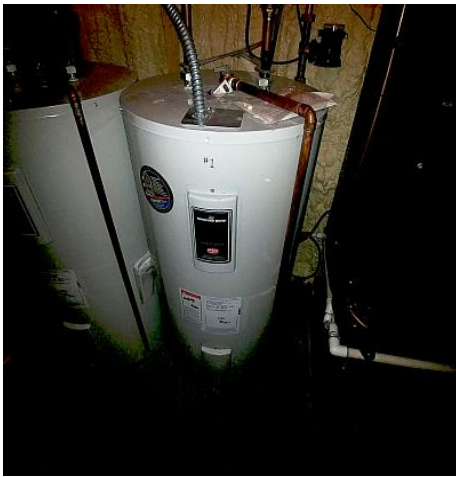
Seismic restraints are installed but they are not proper. Current standards require seismic restraints in this region of Montana. Water heaters shall be anchored or strapped to resist horizontal displacement due to earthquake motion. Strapping shall be at points within the upper one-third (1/3) and lower one third (1/3) of its vertical dimensions. At the lower point, the strapping will be a minimum distance of four (4) inches above the controls.

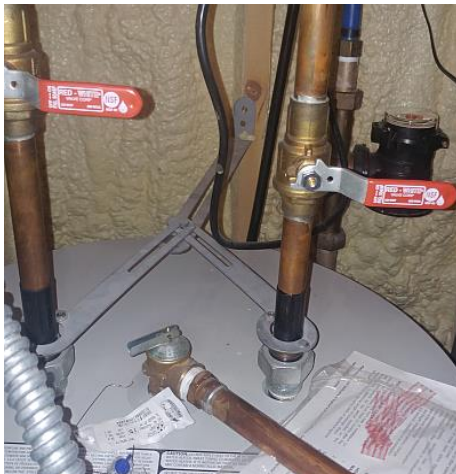
This water heater was off at the time of the inspection.

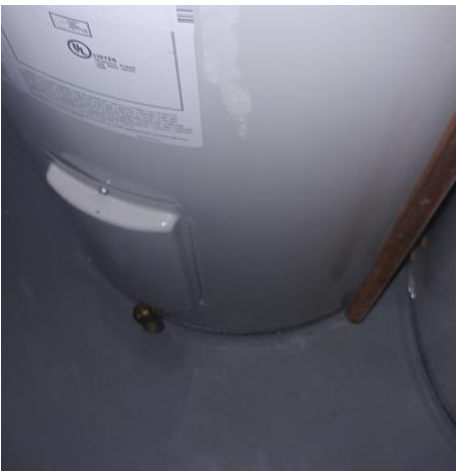
The unit is not elevated. Contact with concrete can cause the housing to rust. Recommend Repair.

Inspector's Note: There are products specifically designed for this.

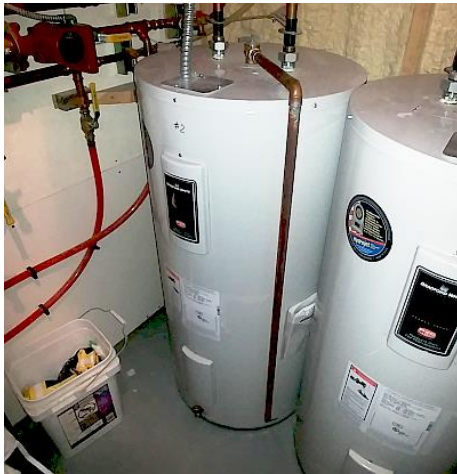
Seismic restraints are installed but they are not proper. Current standards require seismic restraints in this region of Montana. Water heaters shall be anchored or strapped to resist horizontal displacement due to earthquake motion. Strapping shall be at points within the upper one-third (1/3) and lower one third (1/3) of its vertical dimensions. At the lower point, the strapping will be a minimum distance of four (4) inches above the controls.

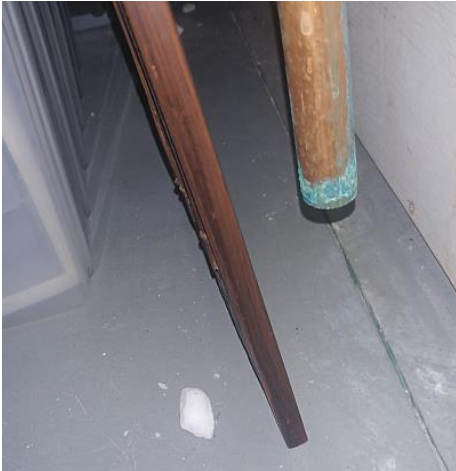
There are indications that the TPR valve on this unit may be leaking. Recommend Repair/Replacement.

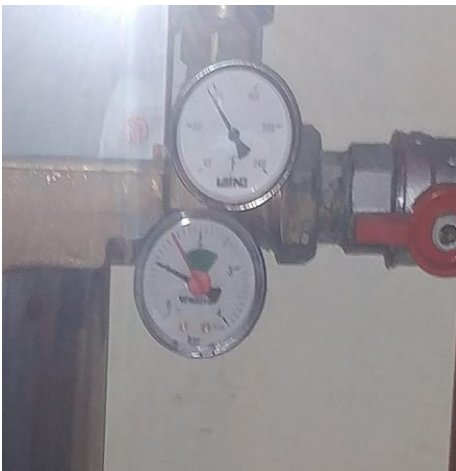
The temperature/pressure gauges are operating.

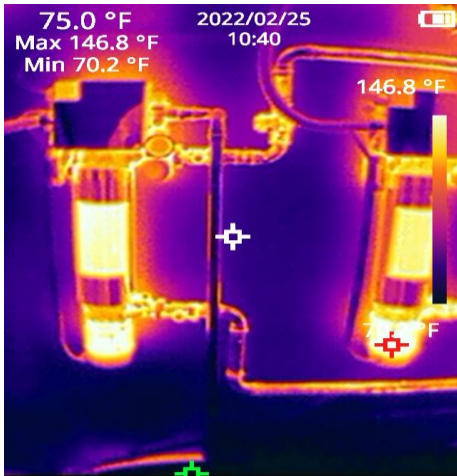
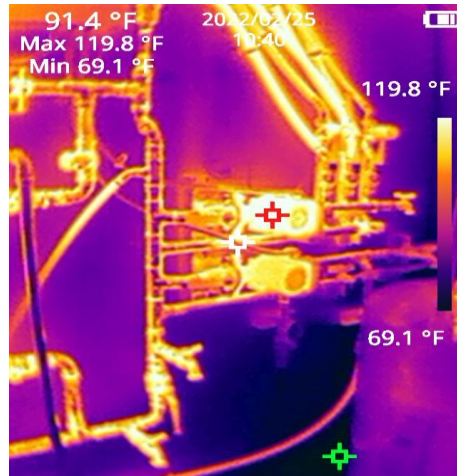
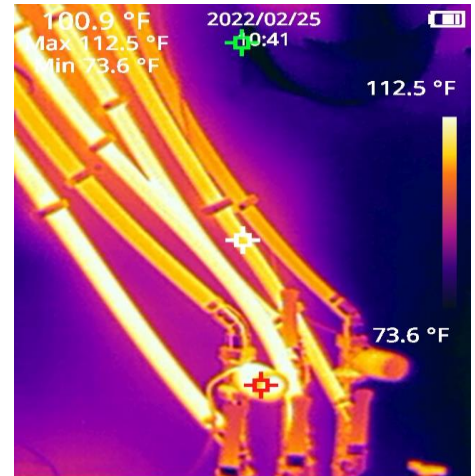
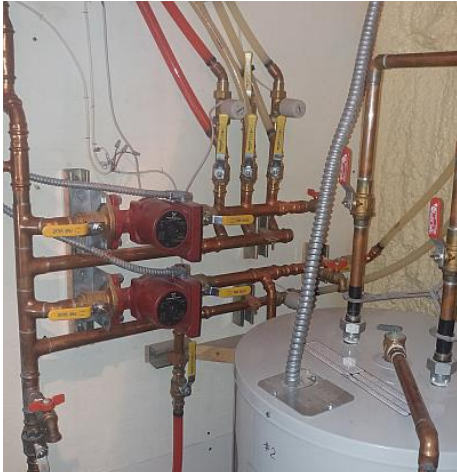
The system is operating.

This system has everything needed (pumps, zone controller, expansion tank, pressure regulator, air eliminator) for a well-balanced hydronic heating system.

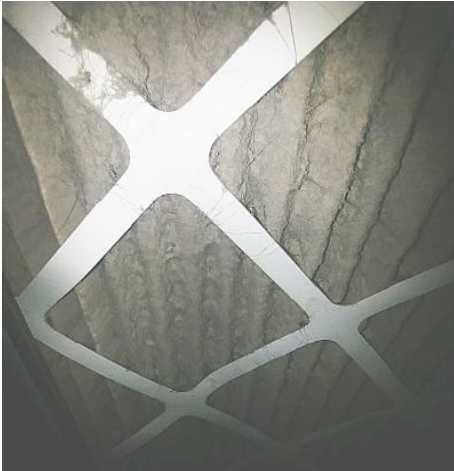
The filter is very dirty. A clogged filter can cause the unit to operate less efficiently and possibly shorten the life expectancy of the unit. Recommend Replacement.

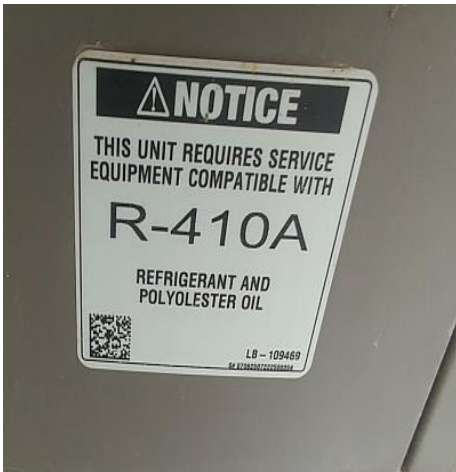
This system used R410 refrigerant. This refrigerant is scheduled for elimination from all new systems in January 2023 and is being replaced with R-32. R410A systems are not designed to operate using this refrigerant and would require extensive modification and laboratory validation to confirm that the safety level has been increased to a level that satisfies the requirements of international standards set for systems that use R32. It is not known at this time how long R410 refrigerant will be available. Budgeting for a new system is recommended.

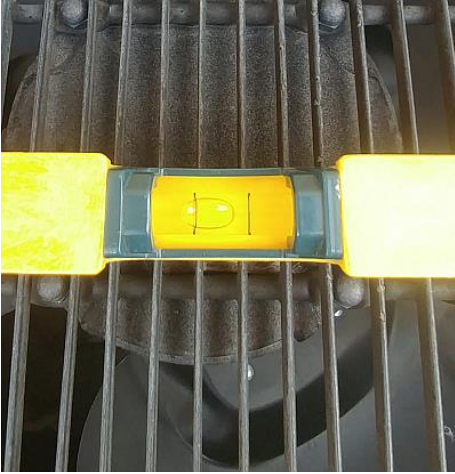
The condensing unit is relatively level on both axis. Keeping the condensing unit level can help extend its service life.

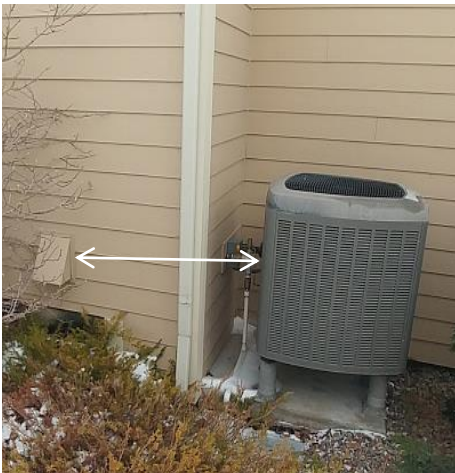
The condensing unit is within 10 feet of the dryer vent. While not a code requirement, this is considered a ‘best practice’ as lint from the dryer can clog the compressor evaporator coils, making the unit less efficient and possibly shortening the life expectancy of the unit. The unit is properly mounted on a slab. Material is eroded from under the slab. Recommend Repair (backfill).

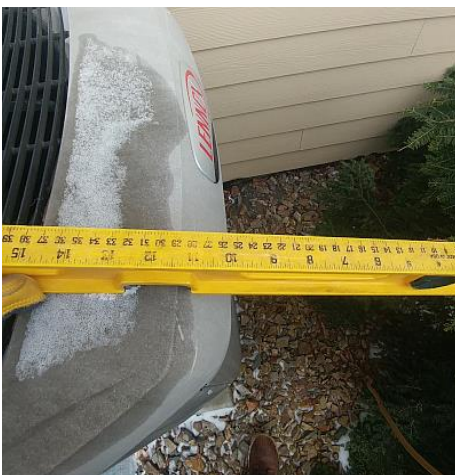
The condensing unit is within 24 inches of vegetation. Debris from vegetation can clog the condensing unit evaporator coils, making the unit less efficient and possibly shortening the life expectancy of the compressor. Recommend Repair.

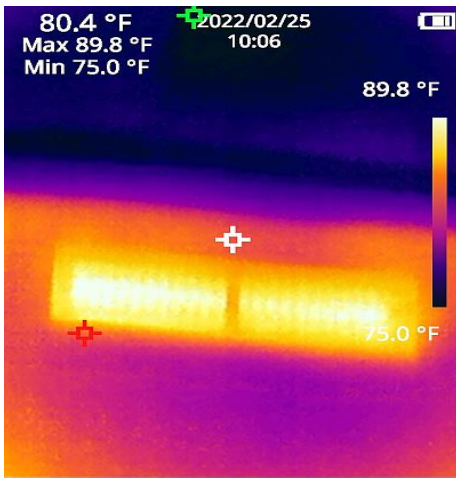
The Emergency Heat is operating. Emergency Heat, also known as “auxiliary heat”, is the second stage of heat that your heat pump runs on when the outside air temperature is too cold for the heat pump to extract heat from the outside air. Emergency Heat is typically triggered at 35°F. Since this second stage heat source is designed to be just that, secondary, running your heat pump on emergency heat increases your HVAC system’s energy usage and results in increased energy bills.

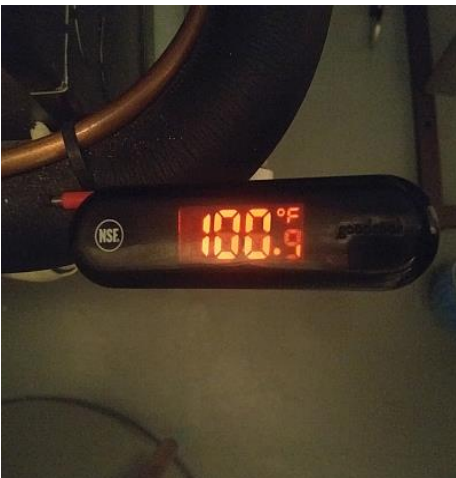
Temperatures are within limits.

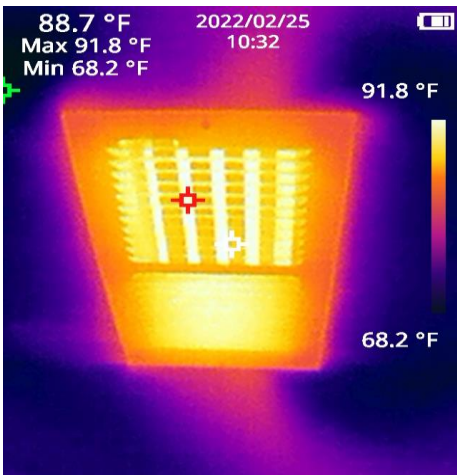
Temperature readings taken at opposite ends of the home/on different floors. A temperature differential of 4.9°F was measured. A temperature differential of less than 10°F is indicative of a well-balanced cooling system.

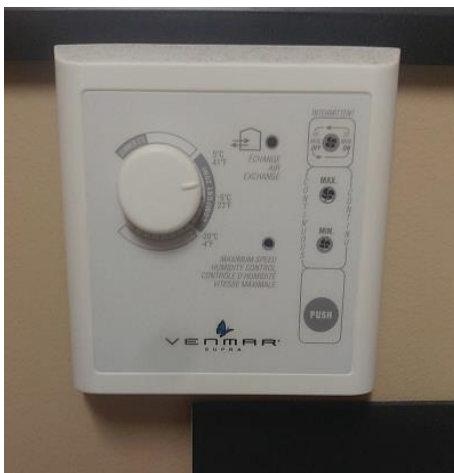
The home is equipped with an air exchange/humidification system. The controls are in the laundry room and the air handler is in the golf cart garage. The system appears to be operating correctly.

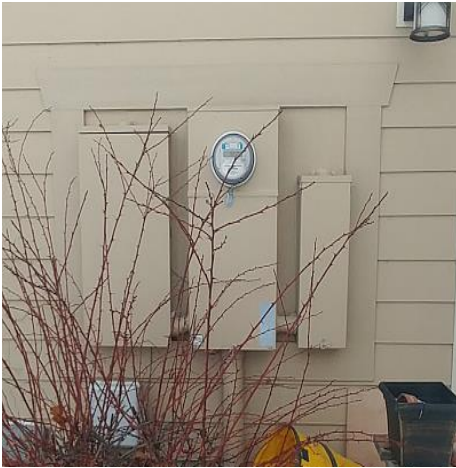
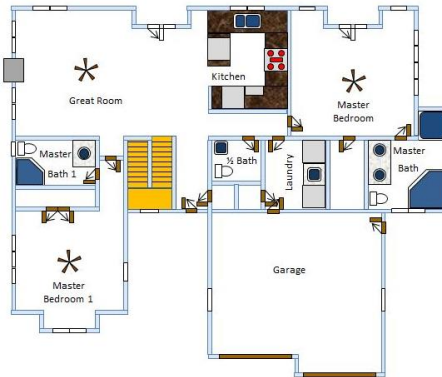
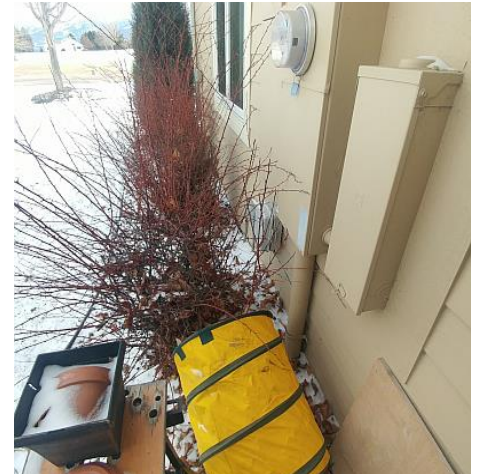
The underground service entry is in Satisfactory Condition. This is also the location of the main electrical disconnect.

There should be clear access to the service entry. Recommend removing vegetation.

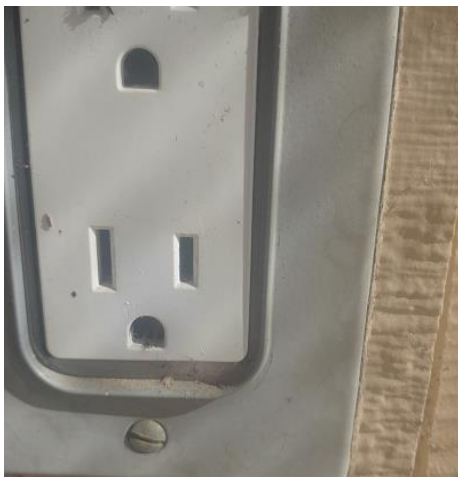
None of the exterior outlets have a visible GFCI. As the GFCI is likely in the garage, the inspector did not test the outlets (see Garage, page 20).

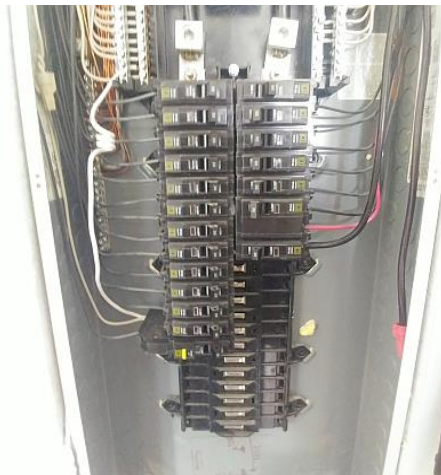
The main panel is in Satisfactory Condition.

There are numerous double tapped ground wires. Unless otherwise marked these terminals are designed for one wire per lug. Recommend Repair.

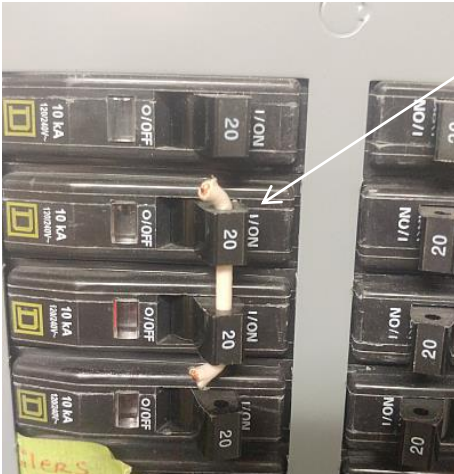
Improper handle tie observed. Handle ties are designed so that both breakers will move as one. Using the proper handle tie is the only way to ensure this. The improper handle tie is a potential Safety Hazard. Recommend Repair. There are products specifically designed for this.

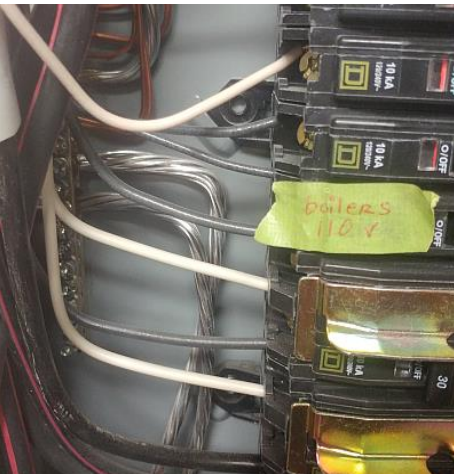
White (neutral) wires used as black (live or line) wires should be color coded black or red with electricians tape.

There are numerous double tapped ground wires. Unless otherwise marked these terminals are designed for one wire per lug. Recommend Repair.
